All Pro Home Inspections

STANDARD RESIDENTIAL INSPECTION AGREEMENT

Client Name:
Inspection Address: 1234 Apartment Avenue
San Diego, CA 92101

Date: April 8, 2011
Time: 8:00 AM

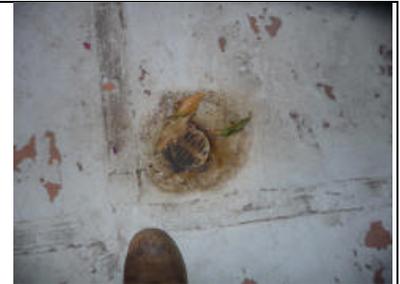
Yard drains are noted but are not tested in the course of this inspection. They need to be flushed out at least annually to ensure that they are clean and free flowing, and I recommend that you do so before the next rainy period. Unfortunately, any problems can go undetected until then. [FE] [CR] I strongly recommend further evaluation and repair of the drainage system at this time. The system appears to be original and could have substantial deficiencies that we can not see today. Because of their age and how critical these drains are, you should consider having these drains scoped with a camera just like the sewer drain. See plumbing notes for recommendation. [CR] One drain in the walkway in front of unit K clearly doesn't drain at all and repair is needed and this section may need to be replaced.

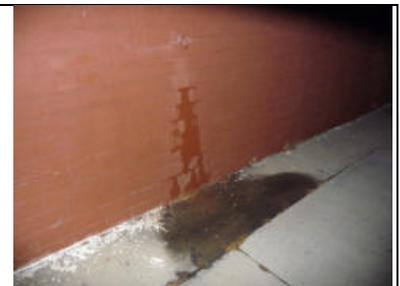
3.2

[FE] When the decks were washed down later in the day, water started coming out of small pipe on the side of the retaining wall. My biggest concern is that this is just too small for a drain pipe to handle much flow. Also, the drains shouldn't dump onto the city sidewalk. This just increases my general concern about the quality and adequacy of the drains.

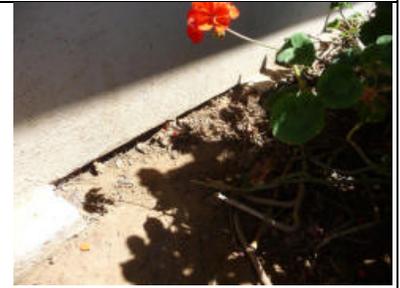
[NOTE] I was concerned about the possibility of water migrating from the exterior onto the wood framing that supports the outside walls. From inside the crawl space I looked for any evidence of water intrusion or damage to the wood. Although I could see water stains in a few areas on the wood, I am happy to report that I did not see any damaged wood. Also, see the termite report for any

potential rot or termite activity. Under California law, they are responsible for any rot or termite activity or damage and will be looking at the same areas.

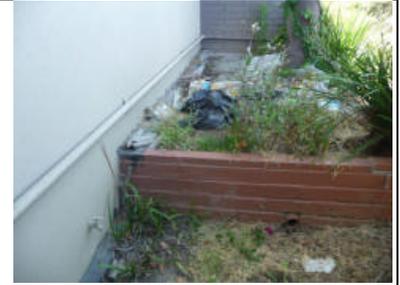
3.4

[CR] A raised planter enclosure adjacent to the front of the left or east wing raises the soil level outside above the framing and floor level of unit I. These planters are notorious for leaking through the back wall and into the framing cavity where they wet the wood and cause rot. I have seen substantial damage when walls have been opened up, and most efforts to waterproof the wall have high failure rates. The code no longer will allow a raised planter in front of a wood framed wall unless there is a two inch air space between the back of the planter wall and the house wall, and this planter does not meet that requirement. You should consider opening the wall to check for damage, and removing the planter or rebuilding it properly. An alternative is to remove the planter and lower the soil level six inches below the top of the foundation.

[FE] [CR] [CR] One tenant mentioned that there had been water intrusion into Unit I from this planter area during heavy rains in the past. Clearly any waterproofing on the back of this wall has clearly failed. I can see that some mastic was added to the top of the back planter wall and plastic was put of the soil inside the planter. I doubt that either of these will be completely successful. I recommend that the back wall of this planter be removed and rebuilt to current standards with a ventilated air space and flashing. It would also be wise to check inside the framed wall for any damage.

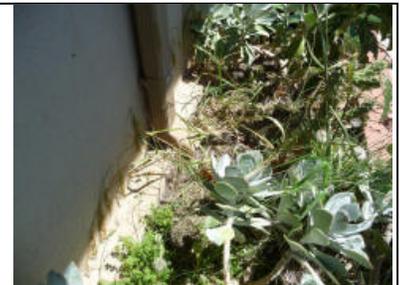
[CR] Downspouts should never discharge into a planter or planting area next to the house where water can become trapped close to the house by a planter wall, a curb, a sidewalk, or anything that can trap the water. At a minimum the downspout needs to be extended so that water can flow freely away from the house and the best thing to do is to tie the downspout directly into a drain line.

[CR] There is a downspout on the 24th Street side that dumps all its water into the planter. This needs to be tied into a drain like the other downspouts. I would put a high priority on this because the more water saturating into this area the more potential for continued deterioration to the retaining wall. See issues with retaining wall in next section.

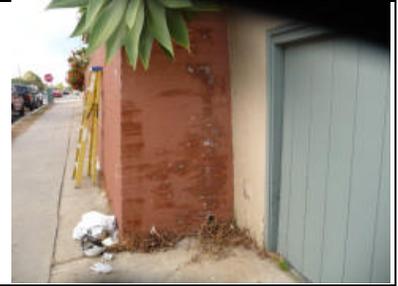
[FE] The waterproofing for the retaining wall on the 24th Street side has clearly failed. In This picture moisture is clearly leaking into the wall next to the garage door and causing some damage.

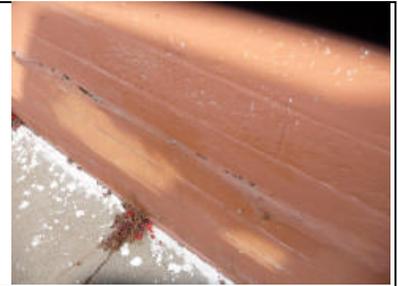
4.5

[FE] One of the problems when the waterproofing fails is that moisture migrates through the wall and the steel reinforcing will rust. This causes the grout to break out as it has in this picture. This is happening in several places and weakens the structural integrity of the wall.

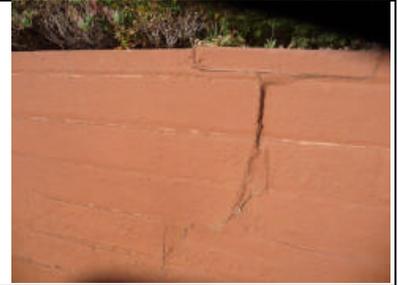
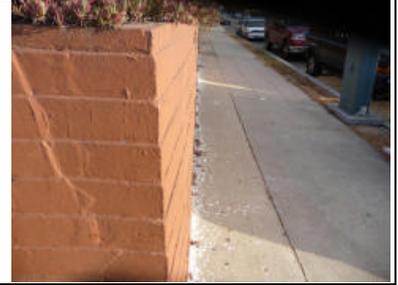
[FE] The portion of the wall closer to the corner has substantial cracks and needs to be considered in an early stage of failing. How long the wall will last is very difficult to predict. It is clearly very weak and the front corner section is badly cracked and has bulged.

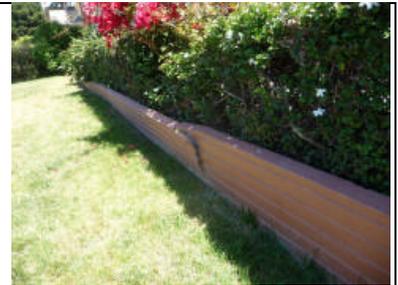
4.6 PLANTER WALLS:

[CR] The sections of the low planter walls are failing and need to be replaced.

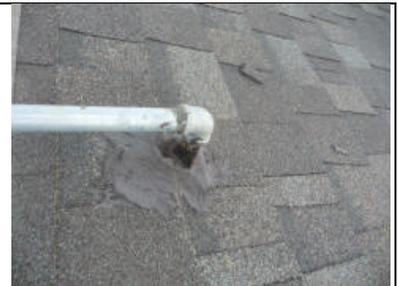
[CR] Some of the vent penetrations do not have metal flashings as they should and will be more prone to leaks as the mastic dries out.

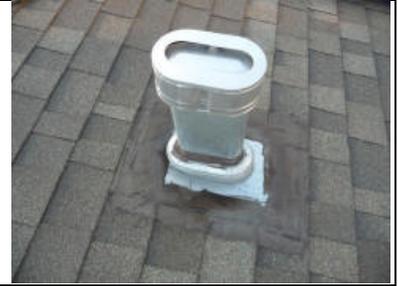
5.5

The flashing for the new heater for Unit A is not integrated into the roof and will be more prone to leaking and need regular service to keep it sealed.

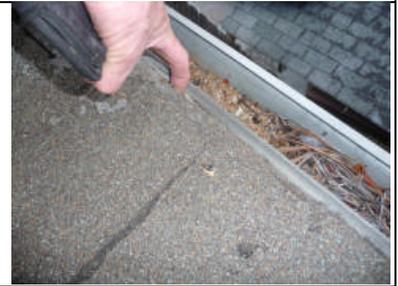
5.6 MODIFIED BITUMEN:

[CR] Over the back left corner are that used to be a patio next to Unit O the roofing material is modified bitumen. There is a spot along the edge that has come loose and needs maintenance. Any sealant used needs to be specifically designed to be compatible with the modified bitumen. Common roofing mastic is not compatible with this material, but is too often used when repairs are not done by a specialist in this material.

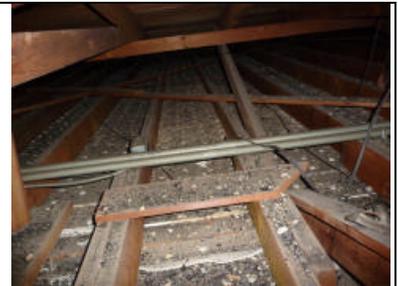
[RU] Recommended Upgrade: The insulation is much thinner or even bare in some areas and you should seriously consider adding insulation to the low areas to

improve energy efficiency and comfort.

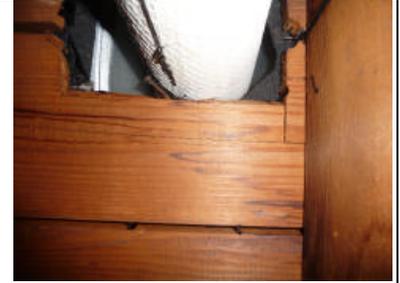
[SC] The vent was too close to or in contact with combustible materials, and this condition is a fire hazard that needs to be corrected. at roof line in attic. One inch clearance is required by code between the dual-wall vent and any wood or other flammable material. This picture is just one of the several that I noticed and expect that a lot of them are too close or touching and all of them need to be checked. Both water heater and wall heater vents are too close. I strongly suspect that the roofers pulled them out of place when the new roof was installed.

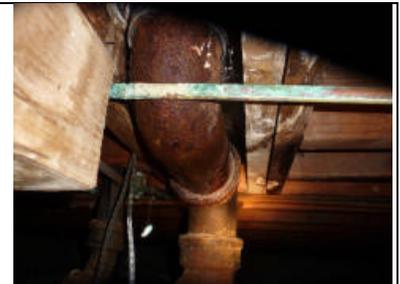
Whenever I can see evidence that part of the copper water system was replaced, as I can in Unit I, then I suspect there could be aggressive soil. You need to appreciate that any sections that remain in contact with the soil could be

susceptible to corrosion and possible leak in the future. Determining the increase in risk is impossible for me to quantify, but is real. You should ask the seller what caused the need to replace the copper water lines. You should also ask the seller if there have been other units with a similar problem. This will help to quantify the risk of future leaks. The more leaks that have been caused by electrolysis, the more potential for leaks in other areas. This cause of corrosion is very difficult to detect and potentially expensive to correct when it is under a slab. Under-slab leaks usually go undetected until it is bad enough that the moisture rises up through the slab.

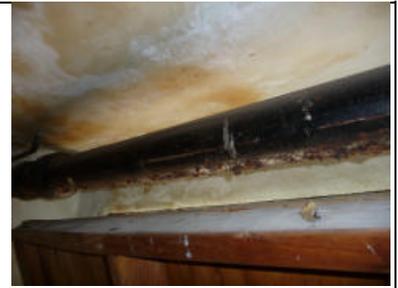
The picture is in the garage below Unit D that is closest to the crawl space.

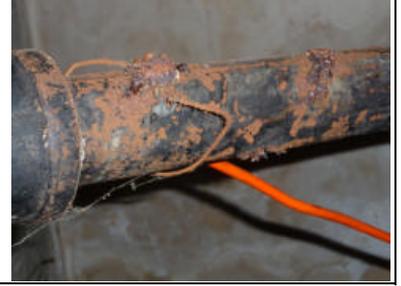
8.4 DRAIN LINES:

There are a lot more places where the cast iron has rusted completely through.

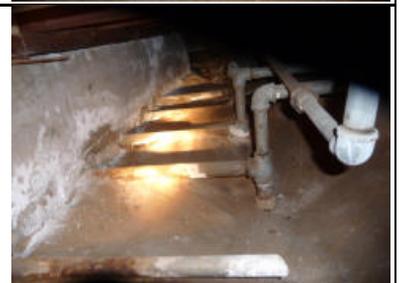
[SC] [FE] A section of steel gas line is in contact with the soil and this will greatly increase the potential for rust and eventual failure of the pipe. Any gas line in contact with the soil needs to be plastic, or if steel, needs to be protected with a plastic coating or specially wrapped. Galvanized gas pipe is not allowed to touch the soil because the galvanized coating is not effective in the soil. All steel gas piping whether galvanized or not is required to have 6 inches of clearance from the soil. The location for this problem is in the crawl space under Units A and B where all the gas lines come into the crawl space. The rust is bad and further evaluation is clearly needed.

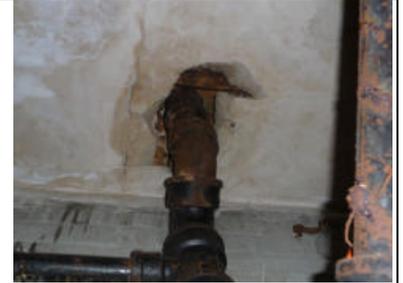
This is the section of the wall or ceiling that separates the garage from the house and must be covered to slow down the spread of fire from a garage to the house to meet the fire and building codes. Repairs are generally easy, but need to be taken seriously. The minimum material required on the garage side is 5/8" Type X drywall. Stucco which was often used in older homes can still be used today, and 3/4 inch or thicker wood is also acceptable. Sheet metal can also be used for smaller areas. Drywall mud will work on small gaps and stucco patch or any solid patching compound can be used as long as it is secure. Foam or insulation are not acceptable. I give you this information because some areas of the firewall are usually not visible, and you can use this information to make the necessary repairs if any holes are found later when the garage is clear. The reason for all this fuss is that you often have gasoline in the garage inside the car tank or maybe a lawn mower, and if it were ever to catch fire, it would be an incredibly hot and fast moving blaze, and we want to try and slow down the spread of the fire into the house.

[SC] Repair the damage or holes in the fire resistive wall between the garage and living space.

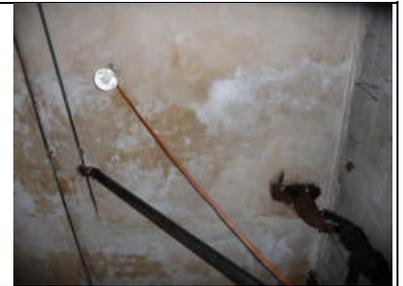
[FE] There are two large pattern of water staining on the ceiling of this garage that are likely due to plumbing leaks above. I suspect there will be more like this in other garages that we were not able to inspect.

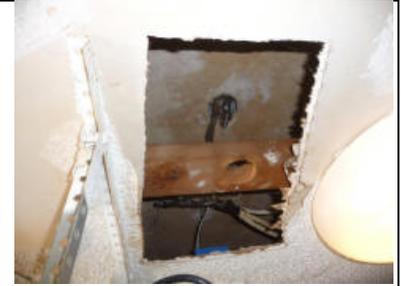
This is the section of the wall or ceiling that separates the garage from the house and must be covered to slow down the spread of fire from a garage to the house to meet the fire and building codes. Repairs are generally easy, but need to be taken seriously. The minimum material required on the garage side is 5/8" Type X drywall. Stucco which was often used in older homes can still be used today, and 3/4 inch or thicker wood is also acceptable. Sheet metal can also be used for smaller areas. Drywall mud will work on small gaps and stucco patch or any solid patching compound can be used as long as it is secure. Foam or insulation are not acceptable. I give you this information because some areas of the firewall are usually not visible, and you can use this information to make the necessary repairs if any holes are found later when the garage is clear. The reason for all this fuss is that you often have gasoline in the garage inside the car tank or maybe a lawn mower, and if it were ever to catch fire, it would be an incredibly hot and fast moving blaze, and we want to try and slow down the spread of the fire into the house.

[SC] Repair the damage or holes in the fire resistive wall between the garage and living space for the above. [SC] Before this hole can be patched, electrical repairs must be made. See the electrical section for notes.

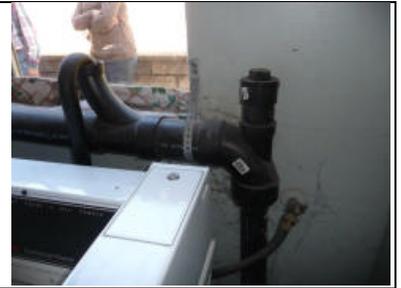
[CR] [CR] The 4 inch laundry drain connects into a 2 inch drain line. This causes a constriction that could cause a blockage or back-up. Reducing the size of any drain line is not approved due to this risk.

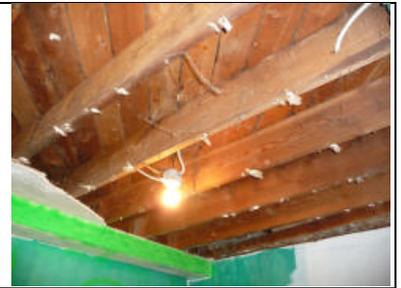
[CR] There is a storage room next to the laundry room and the ceiling has been removed and it needs to be replaced to meet fire wall separation requirements between storage areas and living space.

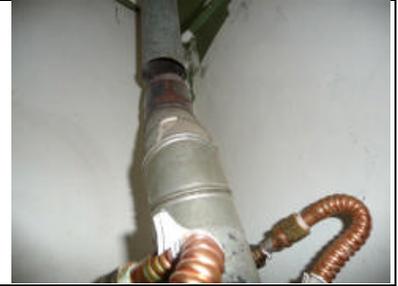
[SC] The vent needs to be replaced to improve safety. This can be done by a heating or plumbing contractor. This vent came apart because the parts don't fit together well.

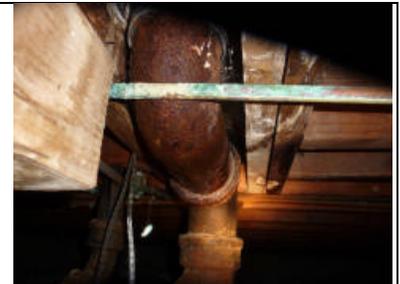
[FE] [FE] **There is a lot of water in the soil of the crawl space under a large area below this bathroom. There is a leak at the toilet, but considering how much water there is in the soil under this bathroom I don't think it all came from the toilet. A plumber needs to evaluate this further to determine the source of the water and make all necessary repairs.**

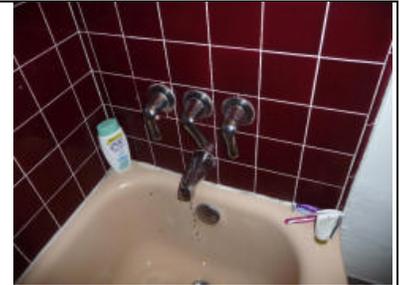
[CR] The faucet handles are not appropriate for use with a faucet that has handles 4 inches on center because the handles don't have enough room to turn around without hitting the next handle. The handles need to be replaced with a more compact style.

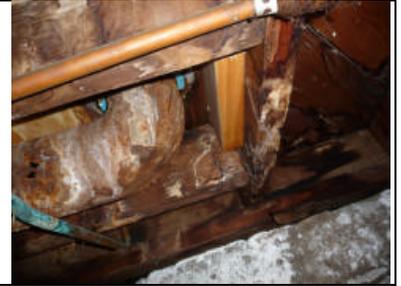
The toilet is a low-flush type that is designed to use 1.6 gallon per flush [gpf].
 [CR] A leak is noted from inside the crawl space below the toilet.

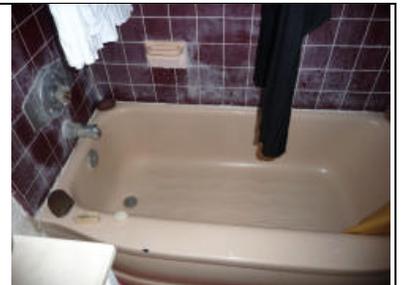
**13.24 TUB:**

[CR] Chips noted in enamel.

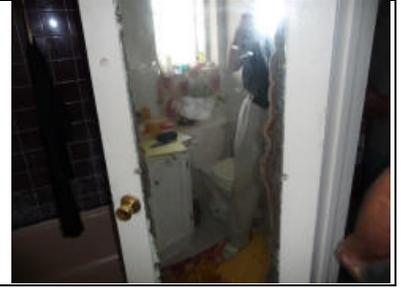
13.25 MIRRORS:

[CR] The mirror on the door needs to be removed or replaced. [CR] The mirror was de-silvering around the edges or in spots in the central area. This is not unusual, gets worse with age, and if it bothers you, the mirror will need to be replaced.

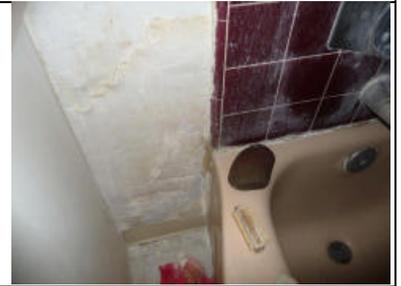
**13.26 WALLS/CEILING:**

[CR] [FE] There is water damage to the wall outside the edge of the tub or shower. This is a common problem and will often reappear after it is patched if the source of the leaking is not corrected. As with any evidence of leaking into a wall cavity, there is always the potential of mold growth inside the wall and a hole should be cut into the wall to inspect for possible mold and/or rot damage inside the wall. See the Mold Statement at the beginning of the report.

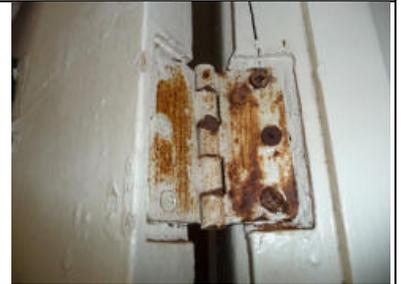
**13.27 DOORS:**

[CR] The hinge was loose and rusted and needs to be replaced.

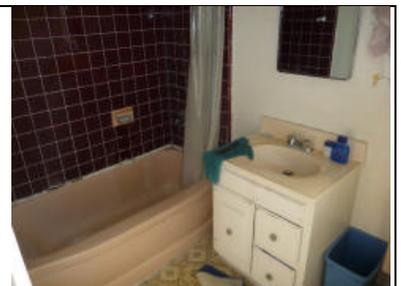
[CR] The caulk is poorly done and should be removed and replaced.

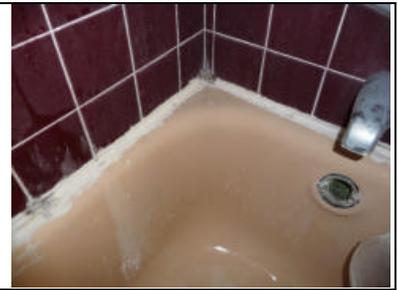
[CR] The over flow cover plate is missing and this increases the potential for water leaking around the gasket and repair is needed.

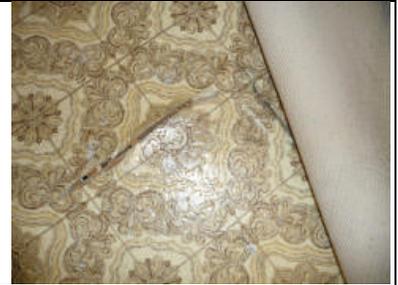
[CR] the flooring is old, damaged.

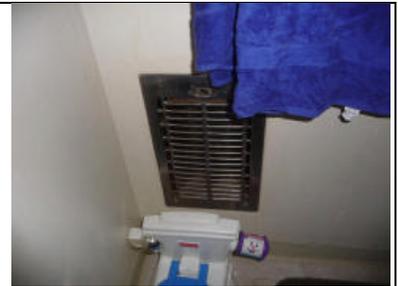
[SC] Electric wall heaters get very hot and pose a safety hazard. I recommend extreme caution be used with these heating systems. Never set anything in front of the heater and never install a towel bar above one of these heaters. These would be substantial fire risks
[SC] A towel bar was mounted above the wall heater, this condition is a safety hazard that could cause a fire. The towel bar must be removed but it would be better to remove the electric heater.

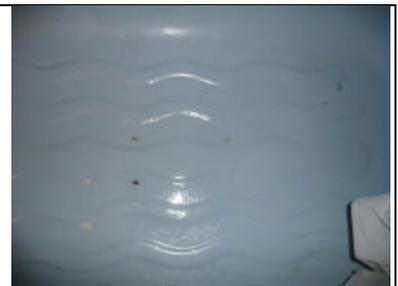
[CR] [FE] [FE] The tub drained very slow. Whenever the drain lines are older cast iron, there is always a possibility that this can be an indication of serious problems which can be expensive to repair. See the note about cast iron in the Plumbing section. This is a ground floor bathroom on a slab and these can be difficult/expensive to correct. I don't know how this can be fixed without removing the tub and the shower walls above the tub. This will also require cutting and patching the concrete slab and replacing the flooring. At this point it will probably make better sense to replace all of the drain line under this bathroom and completely refurbish the entire bathroom. **I strongly recommend further evaluation by a plumbing contractor and/or a**

contractor that specializes in bathroom remodeling before the end of your contingency period.

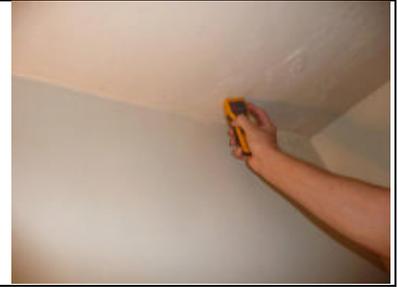
[CR] [FE] There is water damage noted to the ceiling above, I tested this with a moisture meter and the reading was very high. Further evaluation is needed. Most likely there is a leak in the drain line for the unit above. Meter reading - 65.

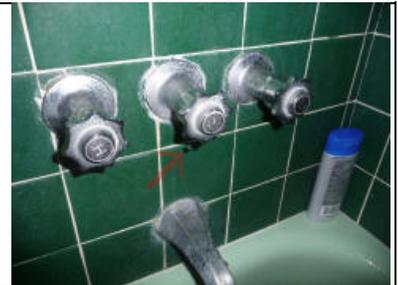
[CR] The faucet leaked out of the handles, stem, or base plate when operated, and needs to be repaired or replaced.

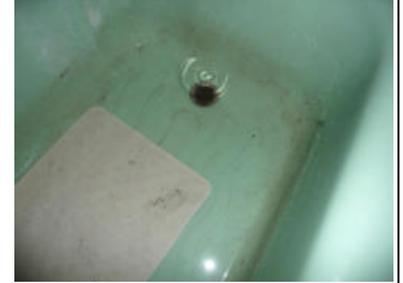
[CR] The tub drained very slow. The trap may need to be cleaned or there could be a blockage farther down the drain line. Request that it be clean and free flowing when you move in. Whenever the drain lines are older cast iron, there is always a possibility that this can be an indication of more serious problems which can be expensive to repair. See the note about cast iron in the Plumbing section.

[CR] The tenant was understandably concerned about the slow draining tub and said attempts to solve it have not been successful. Its a safe bet the drain line needs to be replaced.

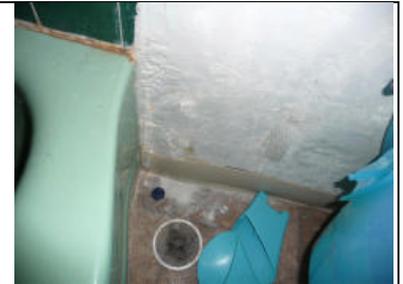
[CR] [FE] There is water damage to the wall outside the edge of the tub or shower. This is a common problem and will often reappear after it is patched if the source of the leaking is not corrected. As with any evidence of leaking into a wall cavity, there is always the potential of mold growth inside the wall and a hole should be cut into the wall to inspect for possible mold and/or rot damage inside the wall. See the Mold Statement at the beginning of the report.

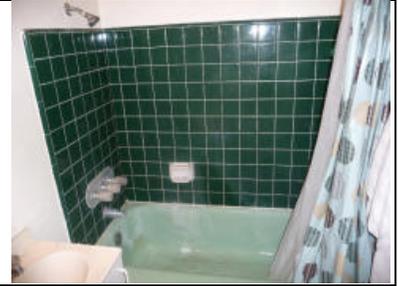
OK minor chips.

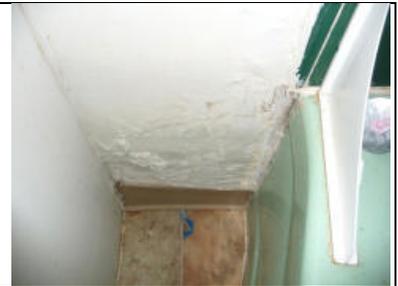
[CR] [FE] There is water damage to the wall outside the edge of the tub or shower. This is a common problem and will often reappear after it is patched if the source of the leaking is not corrected. As with any evidence of leaking into a wall cavity, there is always the potential of mold growth inside the wall and a hole should be cut into the wall to inspect for possible mold and/or rot damage inside the wall. See the Mold Statement at the beginning of the report.

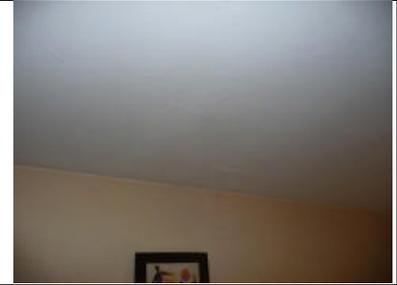
[NOTE] There is a crack across the ceiling and down the wall that clearly indicates there has been stress due to movement. This is probably the most likely place for movement in the entire complex because it is a corner unit that ties the two story section to the single story section with garages under it. Considering the age of the building however, this isn't a lot for 60 years.

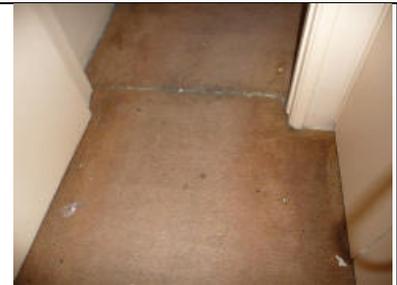
14.17 FLOOR:

[CR] The carpet was frayed or very worn - probably the worst of any unit.

The carpet is torn or frayed in several places.

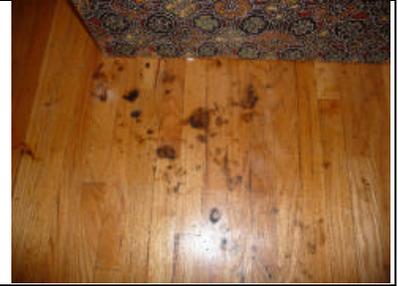
14.52 FLOOR:

Burn marks on the floor in front of the heater. These can be difficult or impossible to sand out of the floor.

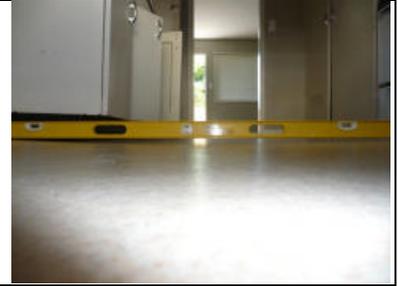
This shows how the cabinet leans away from the wall due to the slope in the floor.
