All Pro Home Inspections

STANDARD RESIDENTIAL INSPECTION AGREEMENT

Client Name: History Buff
Inspection Address: 1234 Old Street
Oldville, CA 92100

INSPECTION REPORT	9
STRUCTURE, FOUNDATION, CRAWL SPACE	12
EXTERIOR	19
ATTIC AREAS & ROOF FRAMING	28
ELECTRICAL SYSTEMS	29
PLUMBING	34
HEATING SYSTEMS	37
GARAGE - CARPORT	38
LAUNDRY	38
WATER HEATERS	39
BATHROOMS	42
INTERIOR ROOMS	49
KITCHEN	54

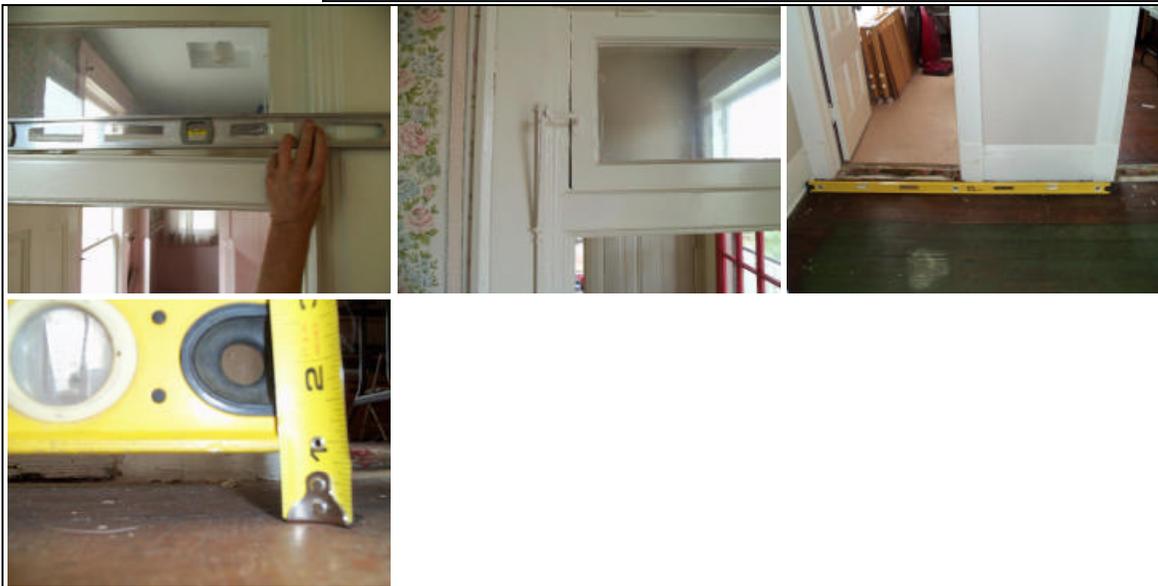
[FE] The area at the back of the house in the center section at the front walls of the bathrooms has settled substantially and needs further evaluation by an engineer. I was not able to determine the cause of this settlement. The center area of the floor has dropped in relation to the back wall. The doors both upstairs and down and the windows above the doors in this area are out of square due to the settlement. Repairs will be needed and you may want to level this area up somewhat. The floor slopes almost an inch in 6 feet.

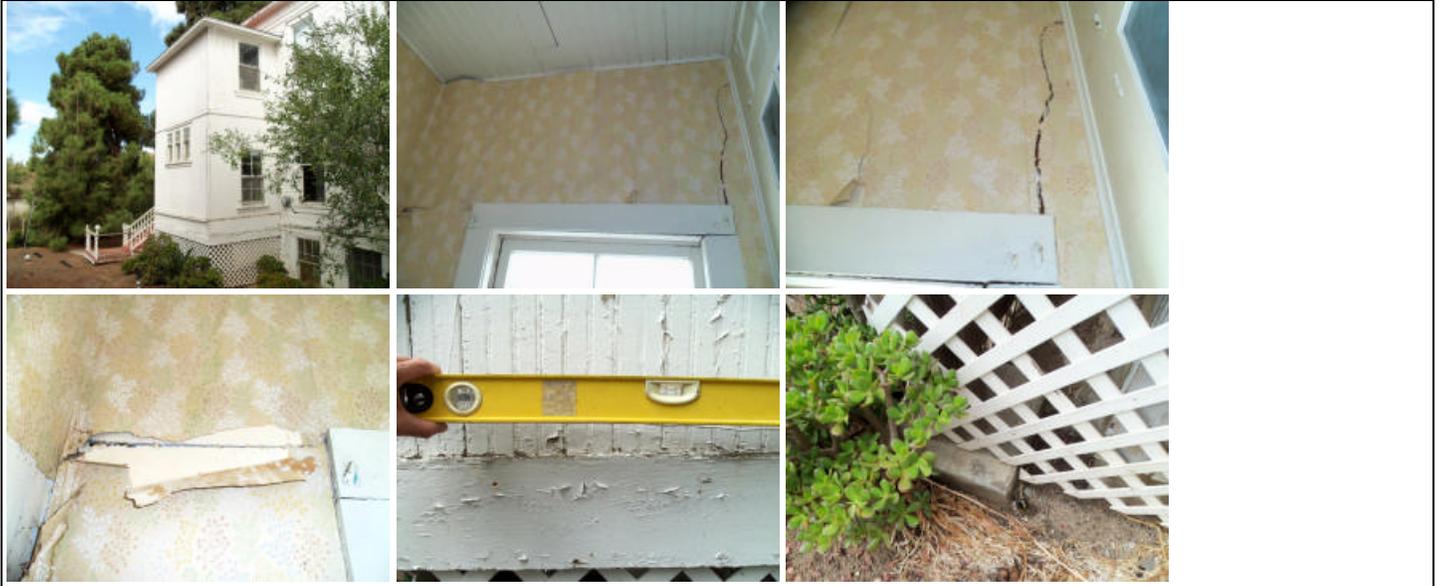
2.3 ADDITION

[FE] [Defect] [CR] A two story extension or addition was added to the left side of the original house. The west wall has clearly settled or sunk a couple of inches and the floors are off level a couple of inches in six feet. That's a lot of settlement and it has caused substantial cracking in the walls and the windows are substantially out of square and damaged. I suspect that new foundation piers were added and that most of this damage was caused before the piers were replaced, but I can't be sure. This section, like the rest of the house does not have a perimeter foundation. Consideration should be given to removing this extension entirely and then deciding if it is worth replacing it. Again this is going to be a very substantial expense. It could also be a consideration with the historical designation of the house since this isn't original.

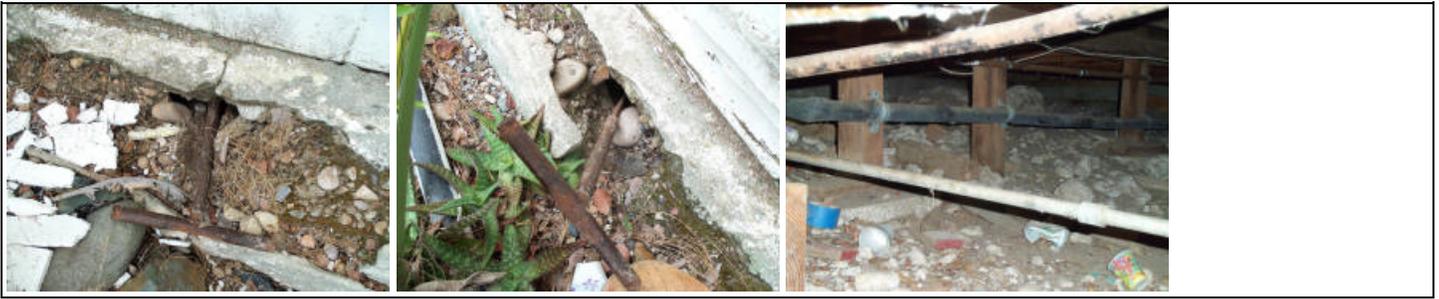
The house has no perimeter foundation. When the probe is pushed in past the deteriorated curb wall, it is just hollow under the exterior wall. Also, looking under the front crawl area, it is clear that the exterior wall is only supported on isolated piers. I suspect that after all these years, there is very little support for the exterior wall due to deterioration in the posts supporting the wall and any footing under the posts. The house is likely getting much more support from the basement walls that are about three feet in from the exterior walls along the sides of the house and 8 to 10 feet in at the front of the house. This offset is what is causing the slope in the living room floor noted below. The basement and exterior walls line up at the back and this back wall appears to have been more stable. In this area the outside wall is the high point, but the interior has settled substantially as noted in the note above.

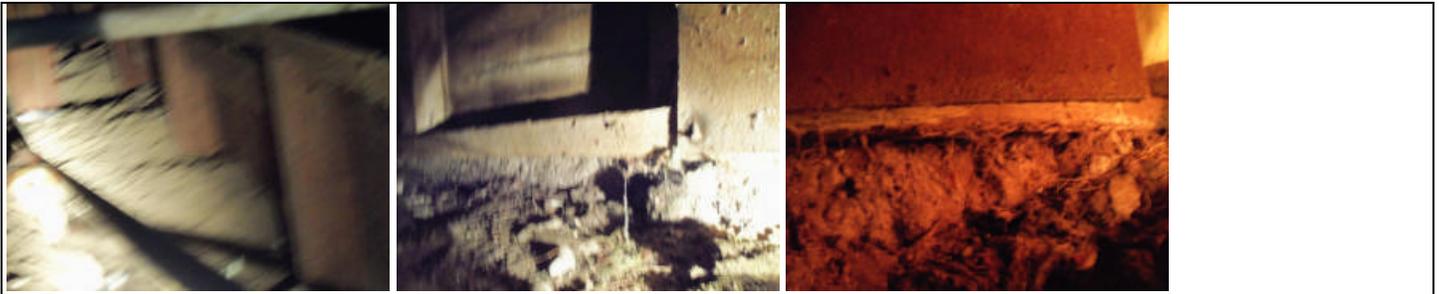
[CR] Soil is up against the base of many of the posts in the crawl area at the front of the house. Also, the wood sill along the edges is in contact with the soil. I am very surprised that the wood was in as good a condition as it was in the areas that I could access and took these pictures. However, it may not be is such good condition in other areas.

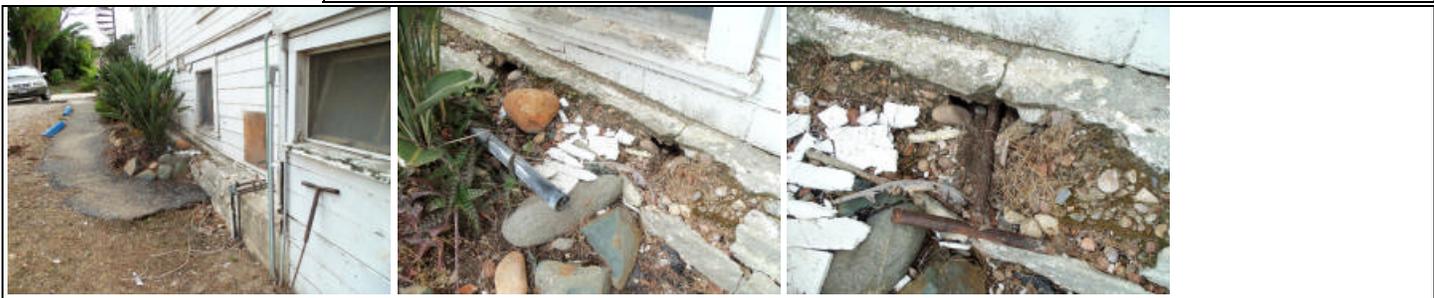
[CR] [CR] [CR] The concrete curb that was added to separate the soil from the structure of the house is a disaster and needs to be removed. The only recommendation that I have is to remove the concrete curb, and install a new foundation. This will require removing the front porch structure as well as some other additions to the side of the house and replacing them after the work is completed. This can be a substantial task. To do anything less requires accepting an very substantial risk of rot, mold, and termite activity inside the base of the wall as well as a risk of water getting onto the basement level of the house. The excavation work will be needed done to make replace the foundation and both of these substantial tasks will need to be done at the same time. See foundation notes also.

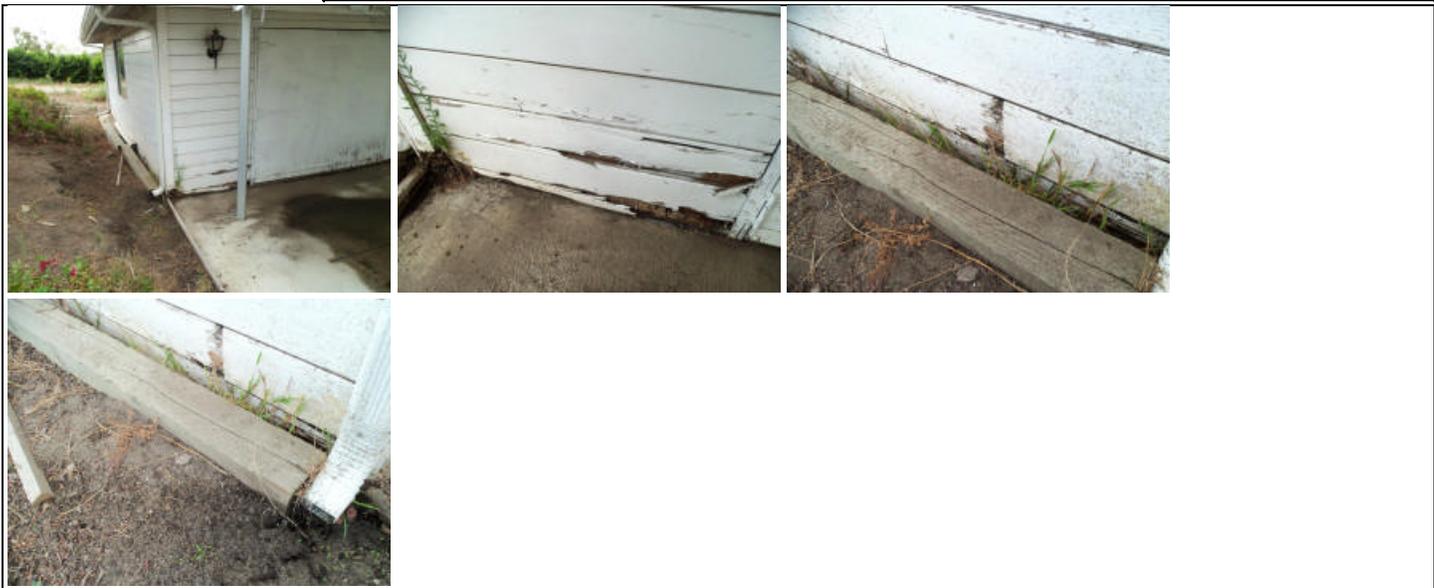
3.2 GARAGE

[CR] Another place where the soil is too high is all along the right side of the garage. There is clearly damage to the wood at the base of the wall. Someone added a concrete curb. This curb needs to be removed and the soil level lowered to the proper level and adequate drainage provided without raising the soil level too high.

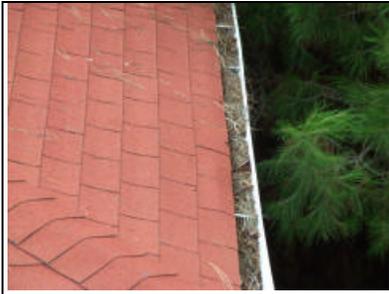
[CR] Some or all of the rain gutters need to be cleaned.

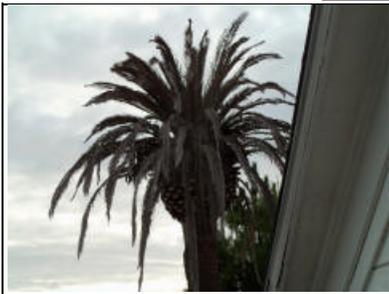
[NOTE] The Canary Island palms are susceptible to crown rot. It appears that a couple of the palms have a lot of damage and are probably going to die. Consult a tree specialist about possibly saving them and the risk of this spreading to the other palms.

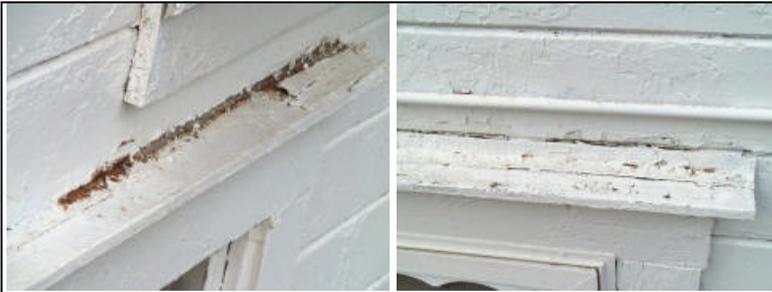
[CR] The metal flashings installed at the top of the door or window trim were rusted out and in bad condition. This condition is conducive to moisture intrusion into the wall and the flashings need to be replaced.

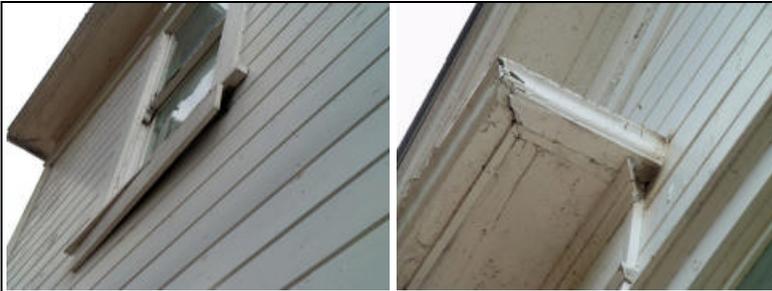
[CR] Considering the age of the house, the exterior siding on the original house is in surprisingly good condition, however repairs will be needed.

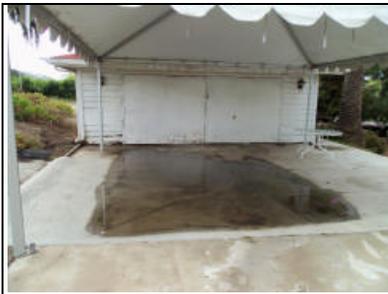
[Defect] Water ponds over a large area of the driveway in front of the garage. The best way to correct this is to break out the concrete and repour it.

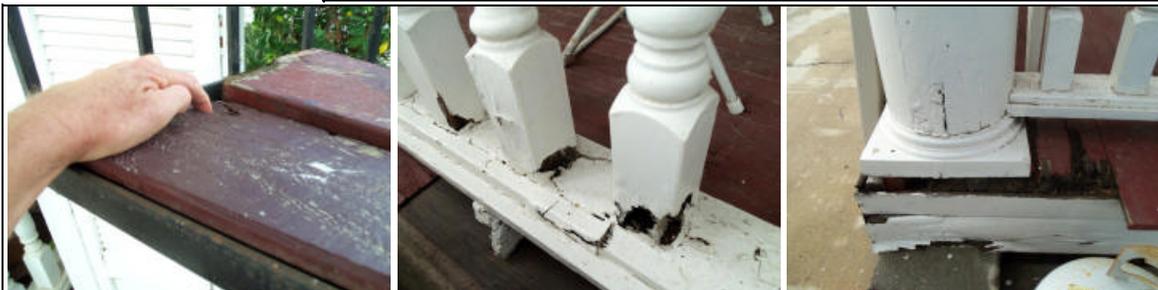
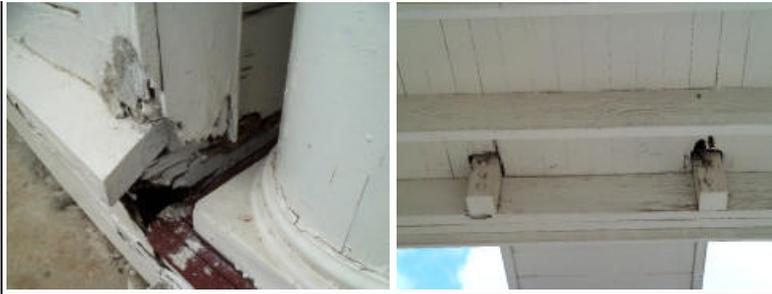
[CR] [CR] [FE] [CR] There is so much rot and deterioration to the front and back porch decks and the upper deck that it is probably best to just tear them down and start over again. I strongly recommend that you have a general contractor or deck specialty contractor come out now and evaluate the decks and give you recommendations and a price to replace all of these. I expect this to be a substantial cost recommend that you determine this cost before the end of your contingency period. It may be necessary to remove these decks anyway to install the new foundation.

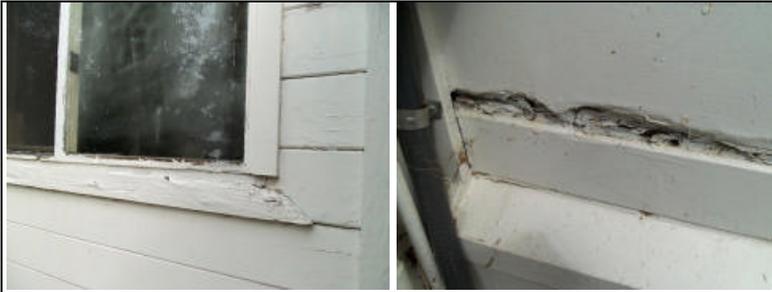
4.6

[CR] There is a lot of deterioration to the wood siding on the extension to the kitchen that was extended onto part of this front porch. There is also problems with the roof above and a window. None of this is original and probably doesn't make the historical people happy. I wonder if the city would let you rebuild this if it was removed since it isn't original.

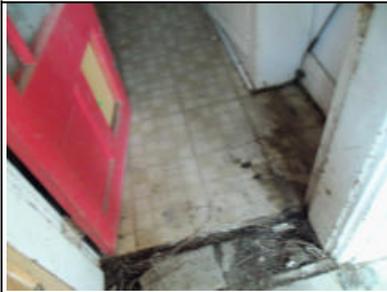
[Defect] The finish height of the patio at the back of the house is too high in relation to the interior floor level. Standards specify that the finish elevation of any flatwork on the outside needs to be two inches below the level inside to minimize the risks of moisture intrusion.
 [CR] [CR] Water actually runs into the basement level through the doors and the sidewalk/patio needs to be busted out and lowered. Also, the soil level and grading needs to be corrected to slope away from the house. See grading and drainage notes.

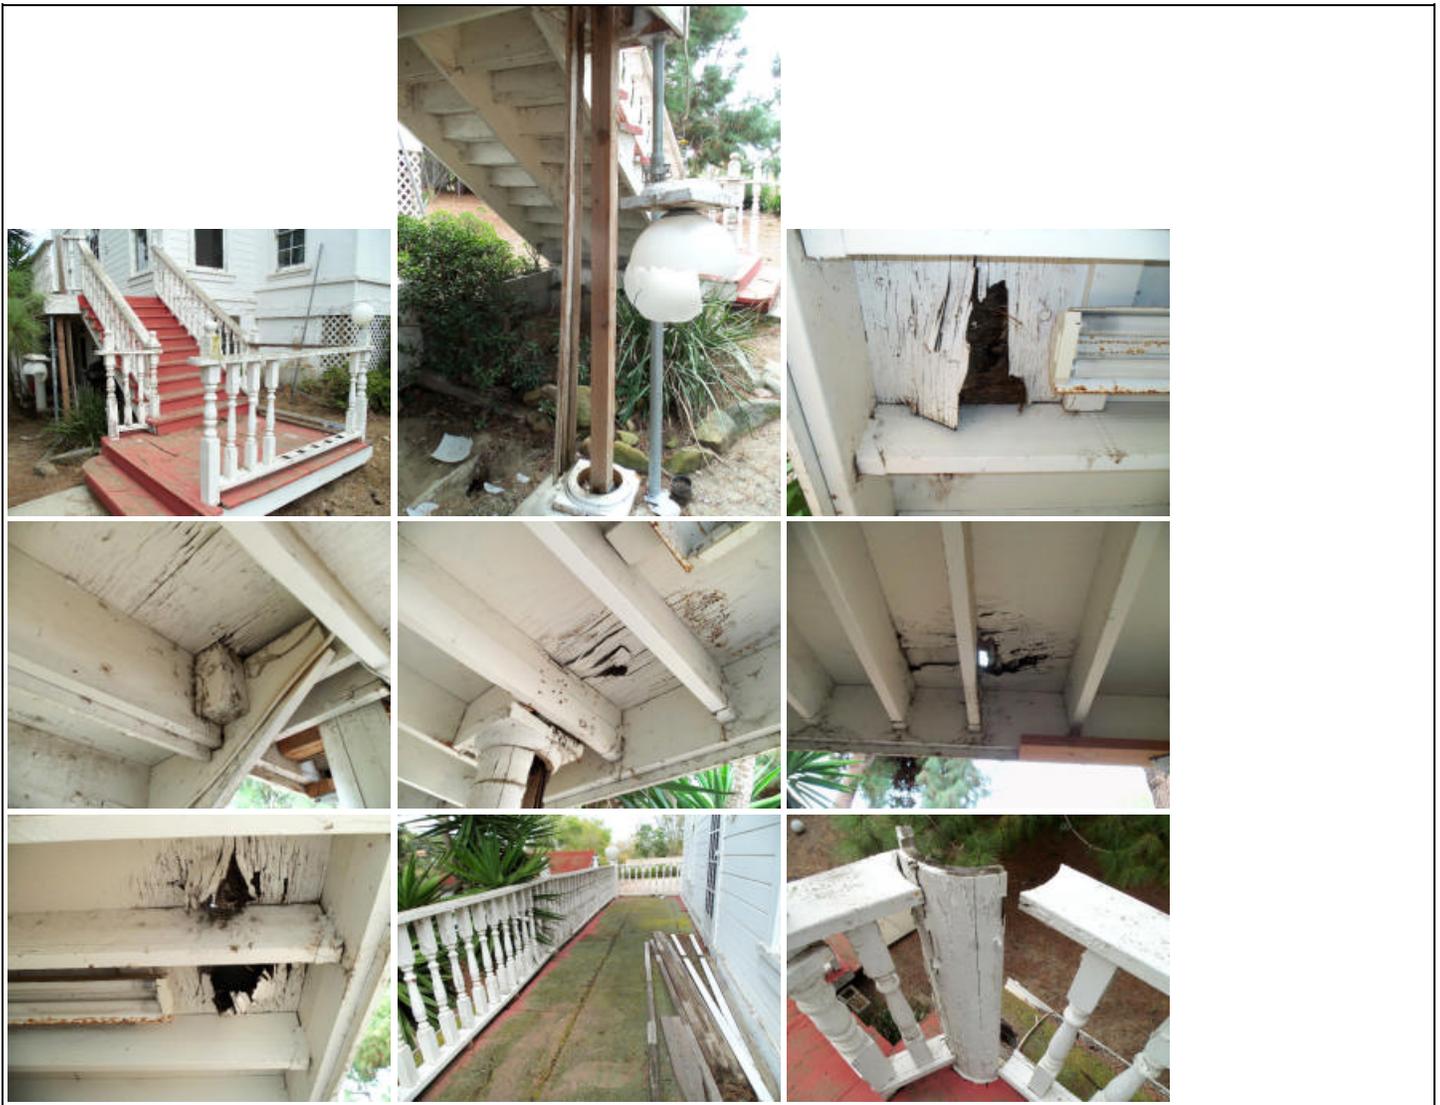
[FE] [CR] [CR] The back wood deck and stairs is so badly deteriorated that I don't think there is any alternative but to tear it all down and start over. Again, this will be a substantial expense and you should get a price before the end of your contingency period.

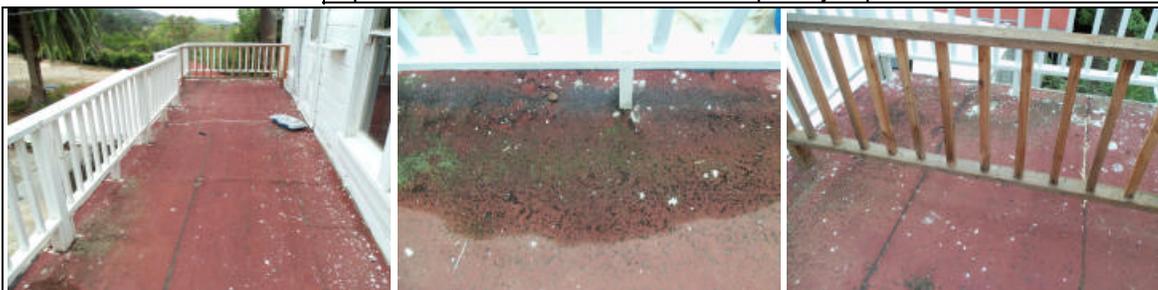
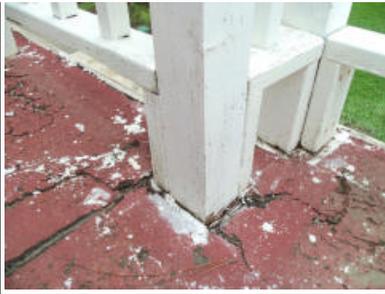
[CR] [CR] The balcony decking is in terrible condition and would need to be stripped and replaced even if the deck is not completely replaced.

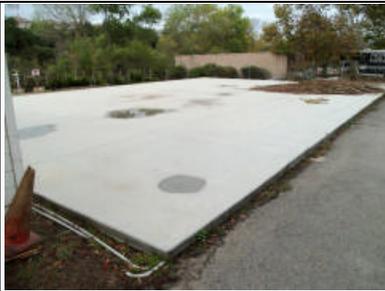
[FE] There is a large slab on the far side of the exterior bathrooms that I understand was put on top of an abandoned pool. I did not evaluate this in any way and it is outside the scope of this inspection. I will tell you that there are rules for abandoning a pool and I doubt that these have been folowed here.

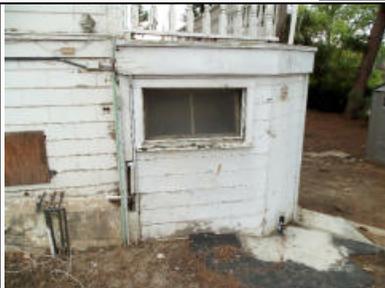
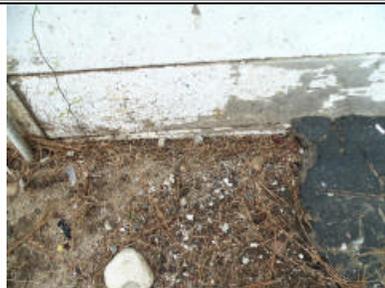
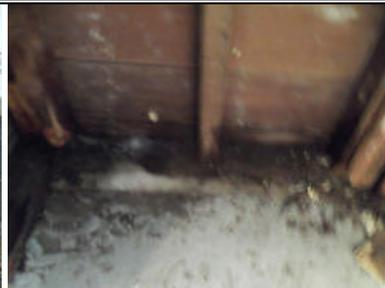
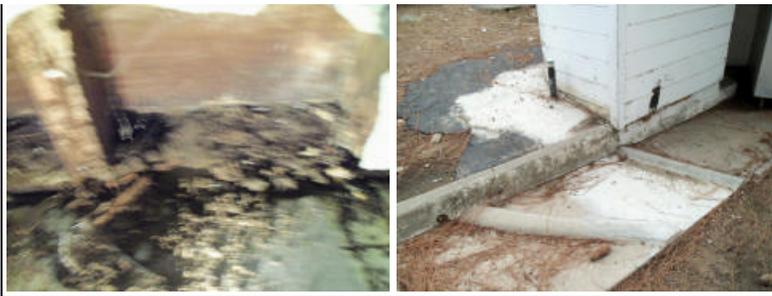
4.12 ABANDONED BATH AT BACK

[CR] [CR] There is a small abandoned bathroom at the back of the house that has so many problems that it clearly just needs to be removed. The interesting thing to note is the amount of rot and damage to the wood at the base of the wall. This is what happens when the soil is too high and the wood get wet for prolonged periods. The real question is how much rot and damage is there along the side of the house where we can't see the wood below the soil line but know that water is magrating onto the wood. The soil level is of course too high and the drainage is bad and runs against the house.

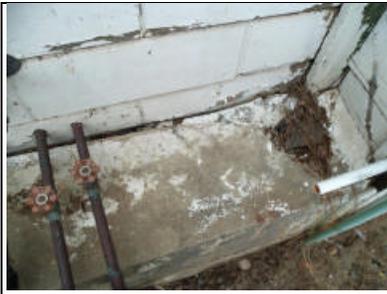
4.13 SIDING BELOW CURB

[FE] Wherever the house siding is below the curb wall, the risk of rot will be high.

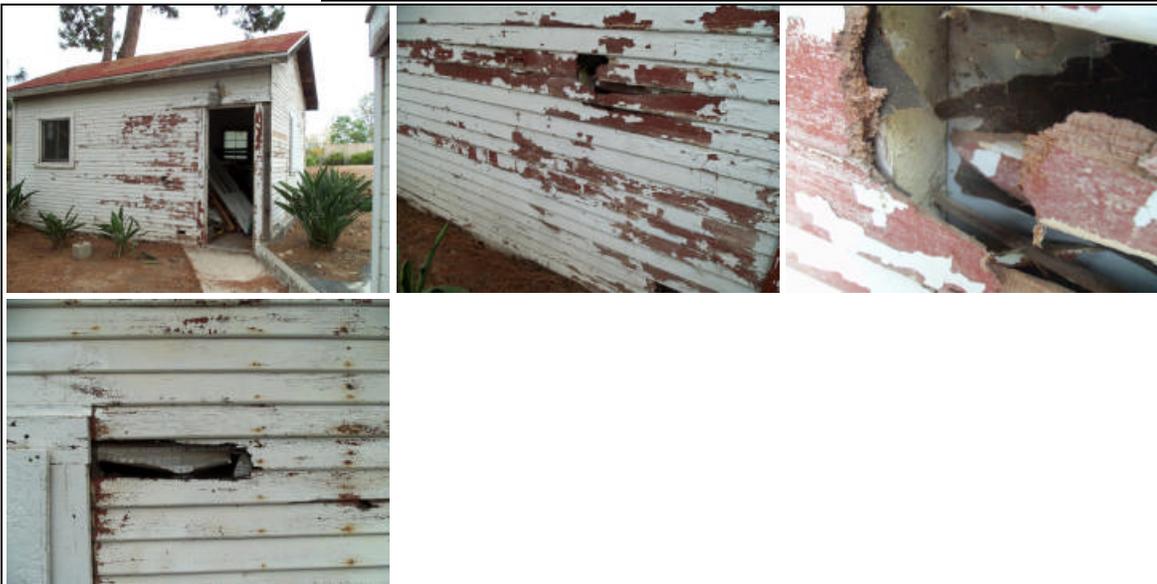
4.14 BACK SHED

[CR] [CR] [FE] The exterior siding of the back shed with the laundry and water heater has substantial damage and water is leaking into the wall. The siding and the moisture barrier behind the siding both need to be replaced. I would expect that you will have to have this siding specially milled to match. A lot of water is leaking into the wall cavity and the drywall is saturated in several areas. Any drywall that gets wet is at risk of growing mold and staining is noted that could be mold. I don't do any mold testing. The drywall needs to be removed and replaced at minimum. See the Mold Statement in the Introductory Notes section at the beginning of this report for additional important information.

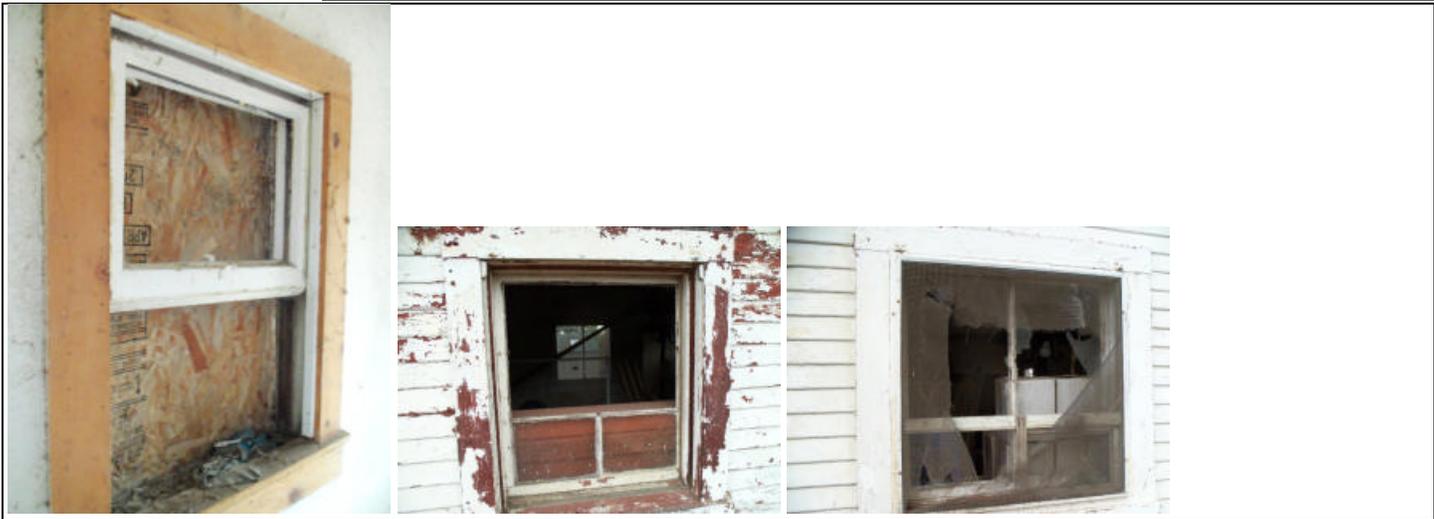
4.15 SHED WINDOWS

[CR] The glass is broken out on 4 of the windows.
[CR] One window frame is completely missing.

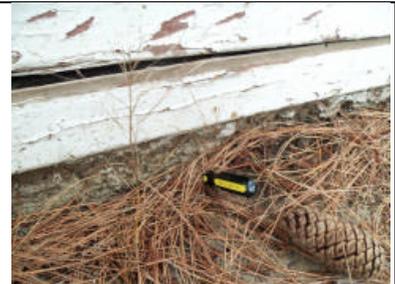
4.16 SHED FOUNDATION

[Defect] There is no perimeter foundation around the shed. It just sits on a slab. This increases the potential for cracking settlement and movement. The shed was full of storage so I couldn't see much of the floor. This isn't unusual for sheds and old garages of this era.

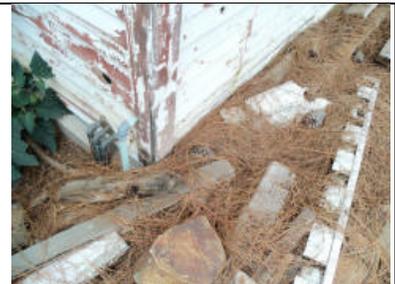
4.17

[CR] The soil level is too high around the shed in areas and needs to be lowered. See grading and drainage notes. This increases the potential for rot or other damage to the wood.

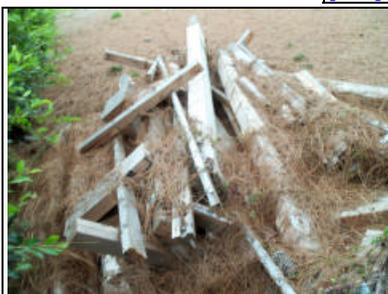
[CR] There is a pile of trash behind the shed that needs to be removed.

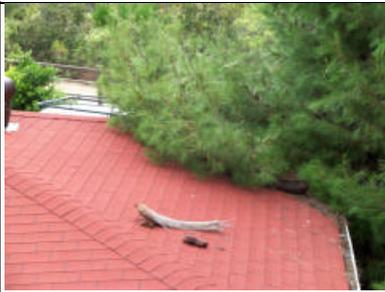
* The overall appearance of the roof is good except as noted. * The roof material appears to be in the early to mid part of its expected life.
 [CR] Trees or other plants need to be cut away from the roof as part of regular maintenance because they will often cause damage to the roof. This is a problem at the side of the garage.

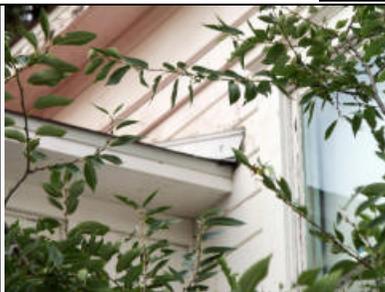
[FE] I am not comfortable with flashing details in some areas of the roof. They do not meet current standards and this increases the potential for leaks.

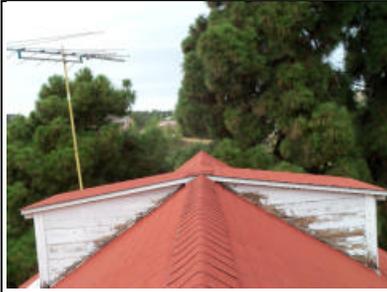
[FE] [CR] Code and the manufacturer's specifications limit composition shingles to roofs with slopes of at least 2 inches in 12 inches, and the small section where the attic was popped out have a slope that is flatter. Composition shingles are not waterproof and require a slope to shed the water. The less slope the greater potential for leak particularly around the edge and whenever there is a wind when it is raining. Composition shingles on too low a slope will generally have a much shorter life because all these risks increase as the shingles age and deteriorate. These sections should have a different material installed that is intended for flatter roofs. These dormers were added and are the areas the historical society is concerned about.

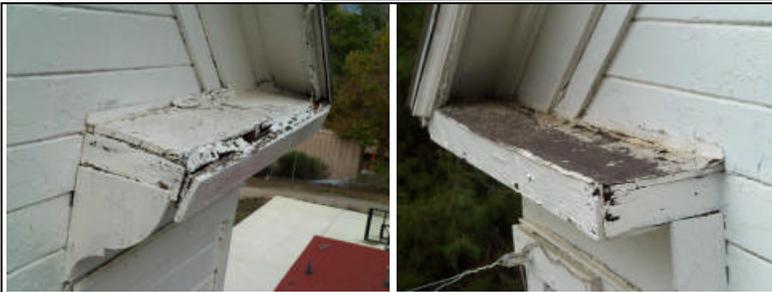
5.6 ROOF RETURNS

[CR] [CR] There are decorative returns on the roofs at each corner of the house. These have not been maintained and are in terrible condition. They need to be flashed and protected like any roof section. Wood repairs will be needed and then the tops need to be flashed and covered. The two in the pictures are at the front of the house and there are two more at the back not shown that are similar.

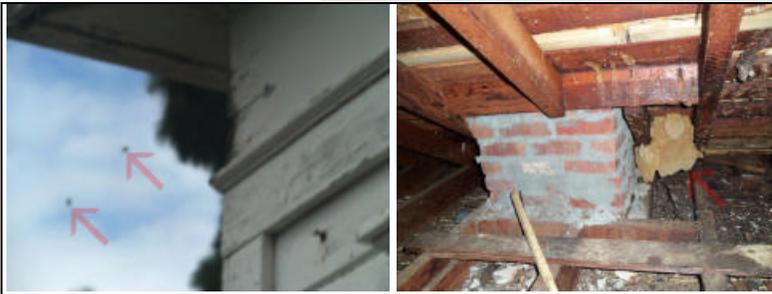
[FE] At least six different bee hives have been removed from this house. One section in the attic still has substantial cone structure left. I have been told that it is important to remove all of the hive material or a new bee colony will be attracted back to the old hive. I don't have confidence that everything has been removed adequately. At the two back corners at the eave of the roof, there were bees swarming in and out and I am concerned that there could still be an active bee infestation. This should be checked by a person who specializes in bee control. Note the bees in the picture that were flying in and out of the eave. There appears to be a fresh honeycomb in the attic in the second picture.

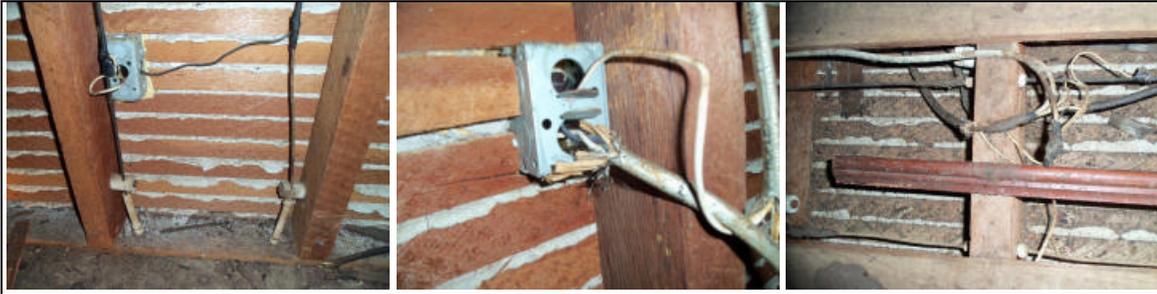
[SC] [SC] Serious consideration should be given to replacing much if not all of the wiring throughout the house.

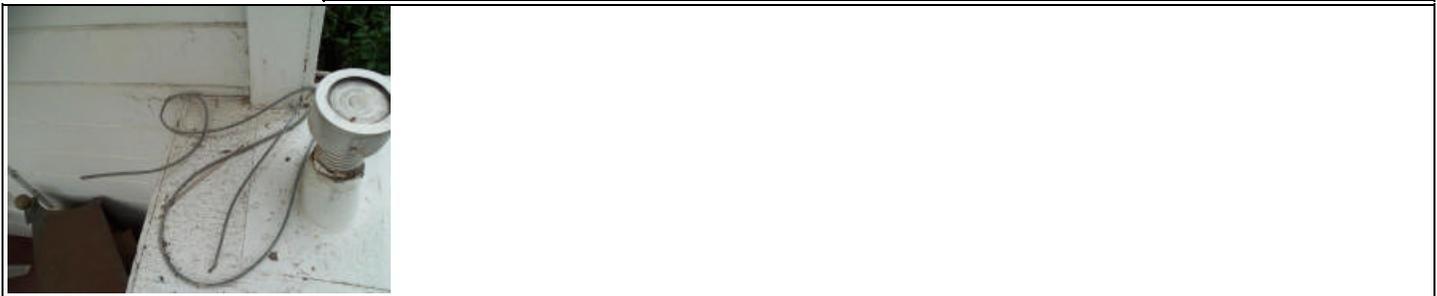
[SC] [FE] The wire used for the ground or bond wire was smaller than it should be and needs to be replaced by an electrician. Also, the ground doesn't follow the other wires back to the main panel and I am very concerned that it has been cut because I can see some of this same wire cut and sitting on top of the water heater. An electrical contractor will need to evaluate this further and I suspect a new ground wire will need to be installed. There is also no bushing on the ground at the end of the armored cable.

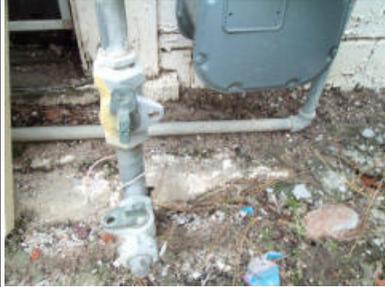
[CR] The gas line is required to have 6 inches clearance to the soil to minimize the risk of rust. The gas line does not have the proper clearance and correction is needed by a plumbing contractor. The location(s) for this problem are at the edge of the house at the right side from the gas meter towards the front of the house.

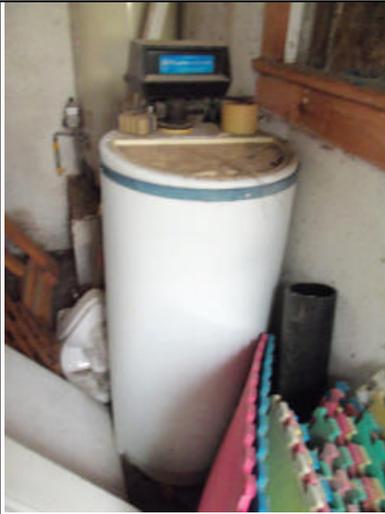
[FE] The water softener did not appear to be in operation at the time of the inspection. You need to ask the seller about the operation of the water softener, and whether it will convey with the house. It looks like it hasn't been serviced in a long time and I was not able to open the lid to check inside.

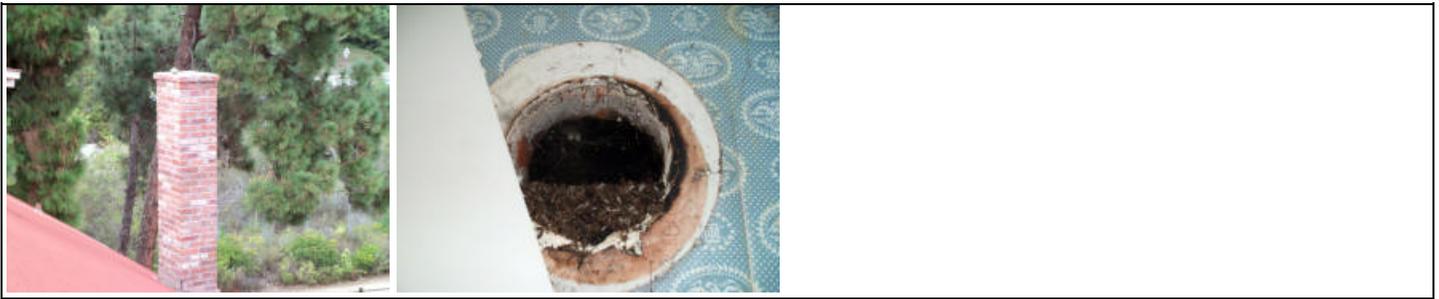
[NOTE] [SC] There is an old abandoned brick chimney vent that was most likely for wood stoves that likely heated the house originally. This brick vent can not be safely used for anything at this time. The top of the chimney above the roof line was rebuilt and appears to be in good condition. The top appears to be capped to keep out water. However, the brick most likely does not have any steel reinforcing and could be at substantial risk of failure and collapse in an earthquake. The section that could collapse would be the section above the roof. The safety concern is that it could fall and damage someone or something below. Un-reinforced chimneys are one of the first things to fail in an earthquake. The second picture shows a hole in the brick chimney where a stove vent was likely attached.

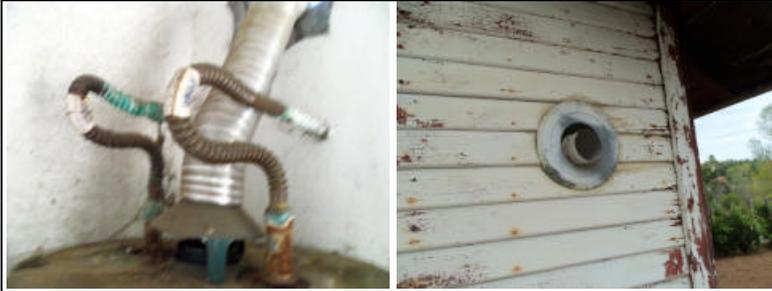
[SC] The vent needs to be replaced to improve safety. This can be done by a heating or plumbing contractor. The vent must go above the roof. See notes on first water heater.

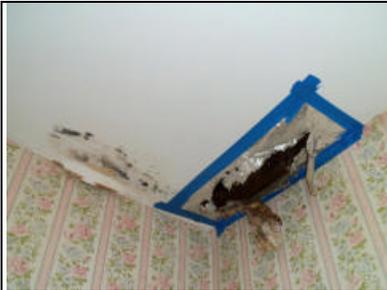
[CR] [FE] There is a large hole in the ceiling from a leak at the tub above. See the Mold Statement in the Introductory Notes section at the beginning of this report for additional important information.

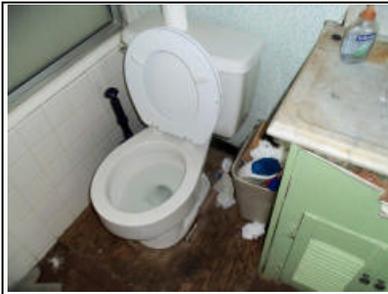
This toilet is most likely designed to use 3.5 gallon per flush [gpf] and you should seriously consider replacing it to conserve water.

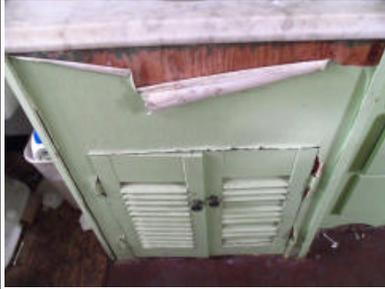
[CR] The cabinet under the sink is old and damaged and needs to be replaced.

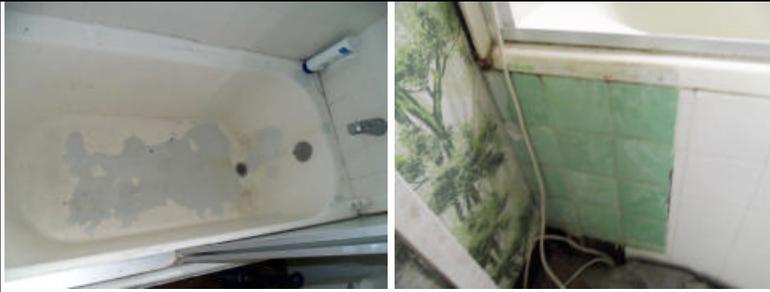
[CR] I strongly recommend that you replace the tub rather than refinish it.

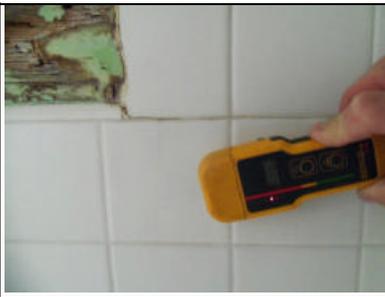
[CR] I recommend that the tile walls be completely removed and replaced. You need to anticipate that there will be some damage inside the wall that will need repair.

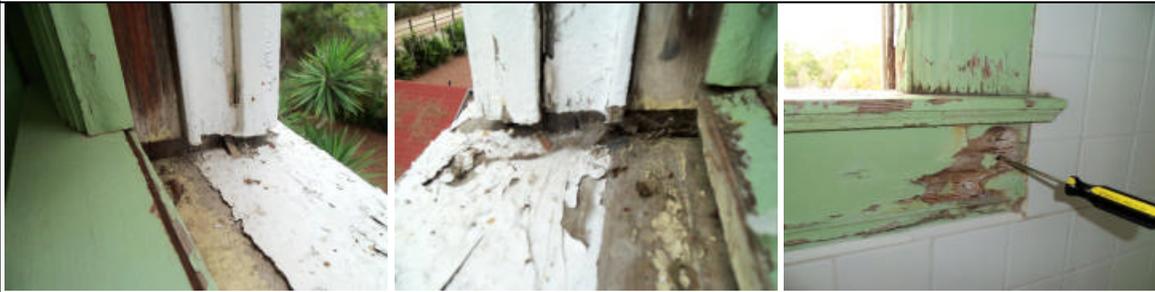
[CR] The sill on the larger window has dropped over half an inch. This window needs substantial repair.
The window in the shower has substantial deterioration.

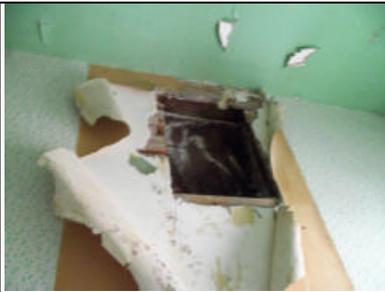
[CR] There are large holes in the wall where a bee hive was removed. I recommend completely removing the walls and stripping them down to the studs. Replace with drywall.

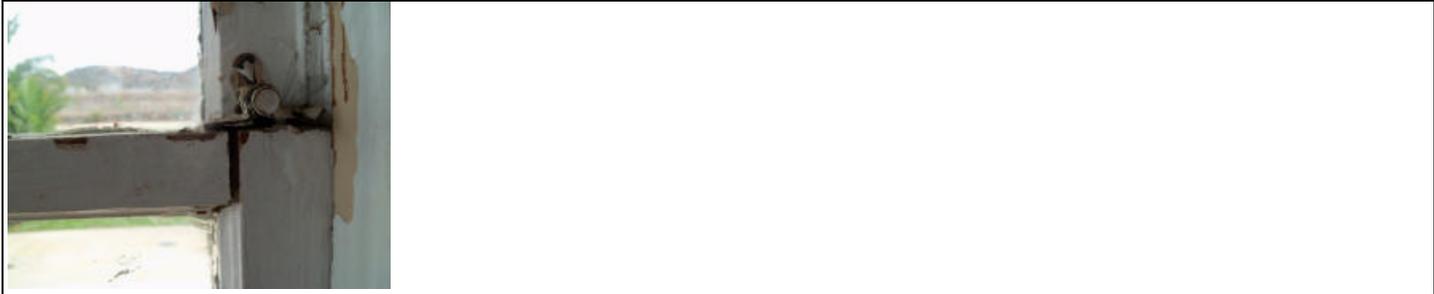
[CR] There are 6 windows but only two of them open. The counterbalances are weak on both. There are no screens. 2 panes of glass are broken. The frame of one window is coming apart. (picture) Broken glass is also noted in the bedroom behind this room.

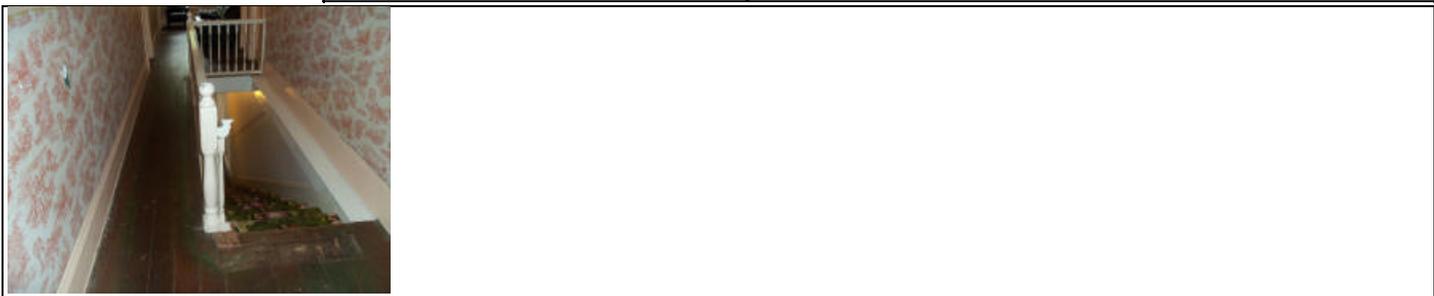
[NOTE] The upstairs hallway is only 26-1/2 inches wide which is very narrow considering out 36 inch minimum standard today.

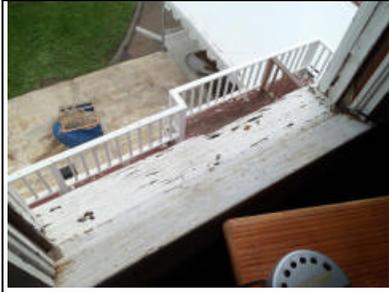
[CR] This room has 6 windows. None of them have screens. Two wouldn't open at all. There is moderate to substantial frame damage on a couple of the windows.

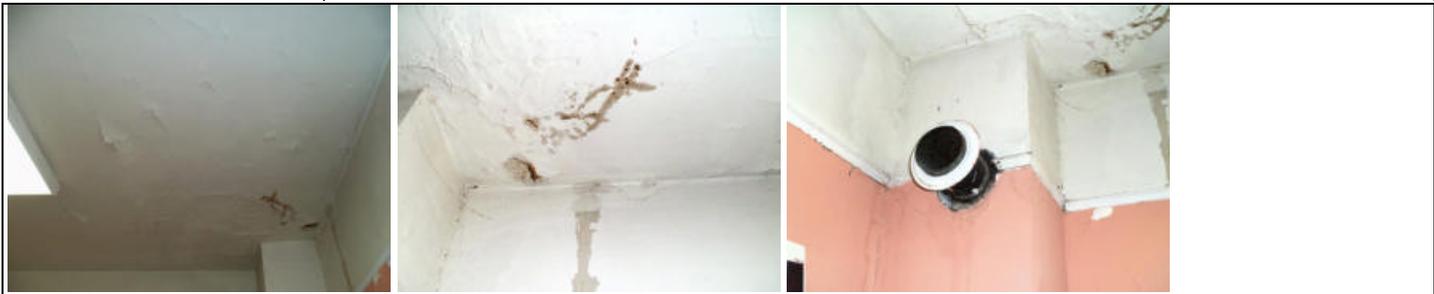
[CR] Pictures show some typical damage to the ceiling. The stain is from wax dripping down from the bee hives that were in the attic above. The old stove vent is sticking out of the brick flue.

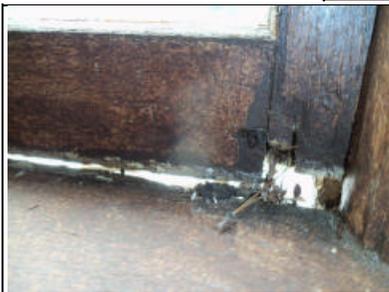
[CR] The frames on the side windows are badly deteriorated and will be difficult to salvage. The front window in this office was replaced with a newer vinyl window. This will likely be a problem with historical review.

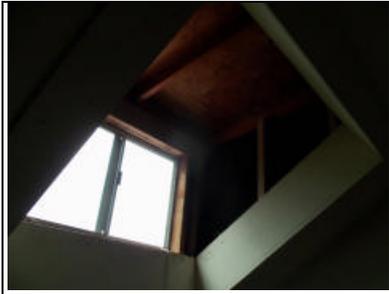
[FE] These are the illegal dormers that were added to the house without a permit and violate historical review. See roofing note about problem with the roof above.
