All Pro Home Inspections

STANDARD RESIDENTIAL INSPECTION AGREEMENT

Client Name: Mark & Amy Dream
Inspection Address: 1234 Dreamer Street
Dreamville, CA 92100

Date: August 9, 2011
Time: 8:00 AM

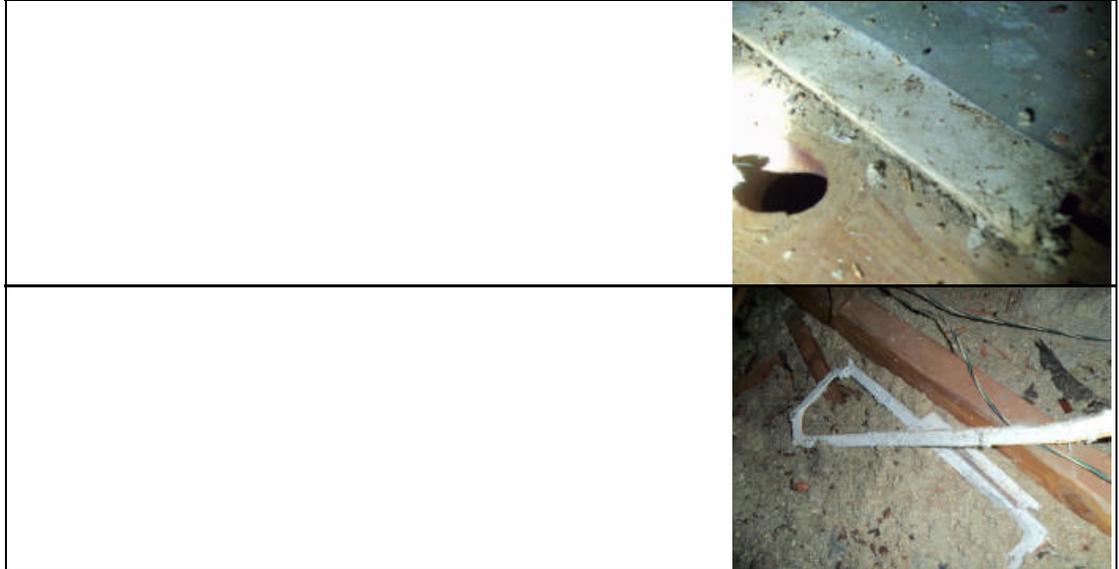
The thin grayish material on the sheet metal register casings most likely is asbestos. The asbestos material generally does not, and should not, come in contact with the air flow and when left alone should not cause problems. First picture. All the others are similar.

The material in the third picture is likely discarded pieces of asbestos insulation board.

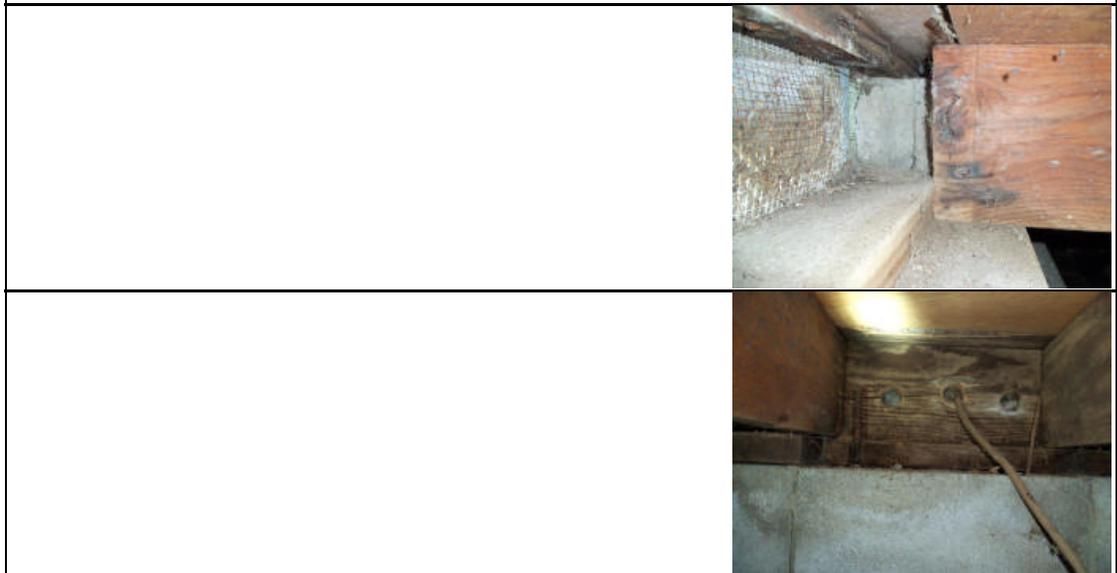
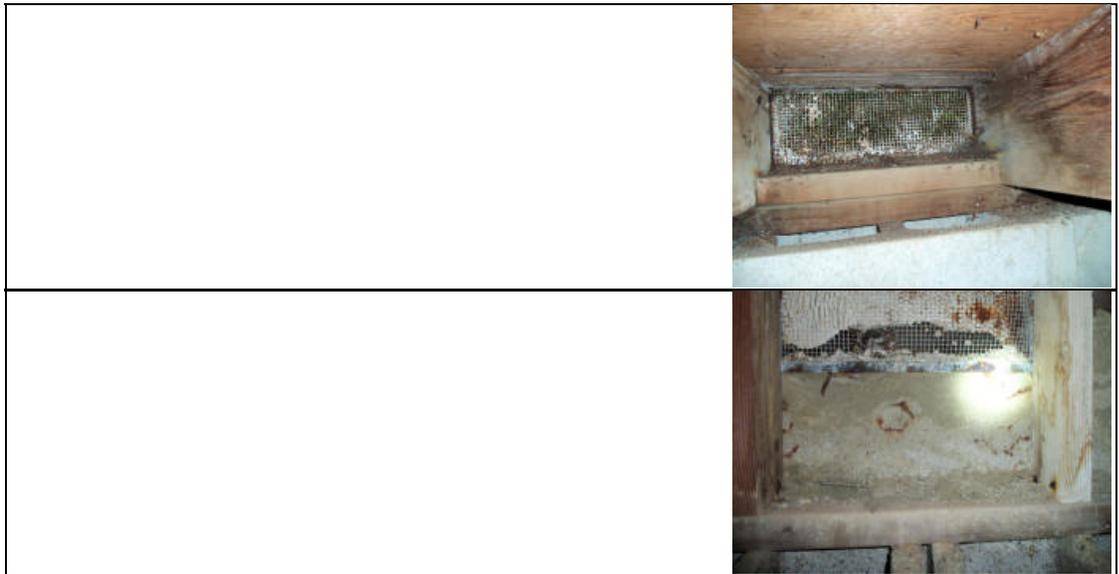
[FE] There is risk of rot to any of the wood that gets wet but I was surprised generally at how well most of the wood has held up and how little damage I could find. Determining the risk of future damage is very difficult. Clearly the less water that migrates through the less risk and reducing the water intrusion is definitely recommended. **It may not be cost effective to completely eliminate the moisture intrusion and judgment will be needed to balance the risk of future damage against the expense of reducing that risk.** Areas with damage to the framing lumber are discussed in later sections.

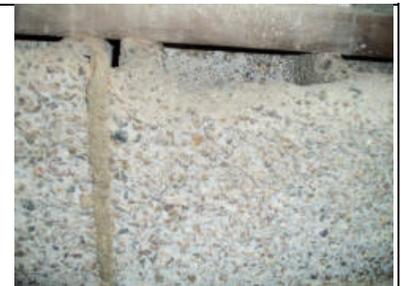
2.3 DETERIORATION:

Minor to moderate spalling or surface deterioration is noted to the face of the foundation block. This deterioration is caused by water migrating through the porous concrete block and leaving behind salt deposits that brake down the mortar over the years. A serious effort is recommended to minimize water saturation next to the foundation to slow further deterioration, but no effort is recommended to repair the foundation because of this spalling. This type of deterioration to the mortar also makes it difficult to see cracks because the flaking of the mortar will fill the cracks and make the entire surface rough and hide cracking.

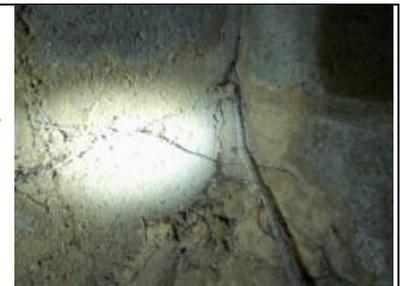
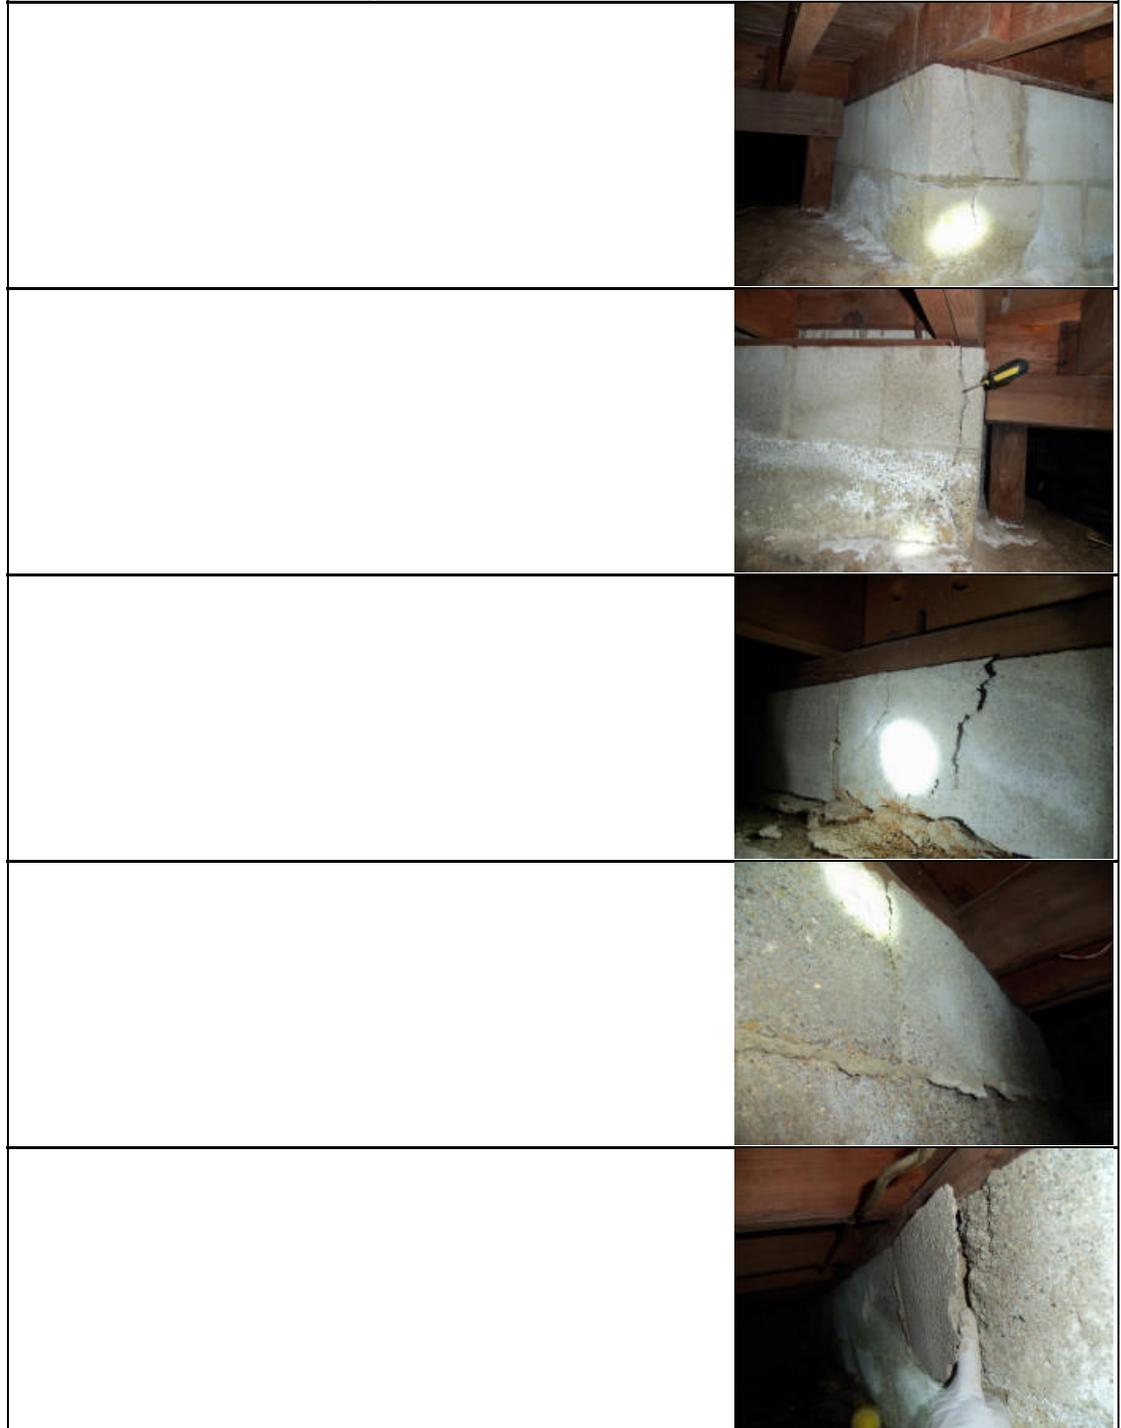
2.4 CRACKS:

[FE] The foundation generally looked good with no more than small cracks except where the steel reinforcing is rusting and expanding with enough force to break out the side of the foundation wall. The more moisture that migrates through the foundation, the more vulnerable the reinforcing will be to rust. The water causes the steel to rust and expand or exfoliate which breaks the side of the foundation next to the steel. This was noted in about half a dozen places around the perimeter foundation. The broken sections can be removed and the steel cleaned and epoxy sealed and then patched. How important this repair will be is open to debate. The more important recommendation is to minimize further deterioration.

The first picture shows a root growing through the

foundation searching for the plentiful supply of water in the crawl space. This is at front of house on bedroom side of the entry courtyard. The second and third are at the front corners of the kitchen and are some of the largest cracks. The fourth is at the middle of the right side. The fifth is at the back wall. The sixth is on the wall by the pool equipment. The pictures are not just examples. These are all the cracks noted in this range.

To minimize the potential for further cracks and deterioration from developing, I recommend you to take any recommendations in the 'Grading and Drainage' section seriously and read the hand out 'Recommendations for Lot Grading and Drainage' available on my web site at AllProHI.com . Controlling water saturation into the soil around the foundation, and water intrusion into the crawl space, is highly recommended for any home with a crawl space. Proper drainage control could save many homes from ever needing foundation repair expenses.

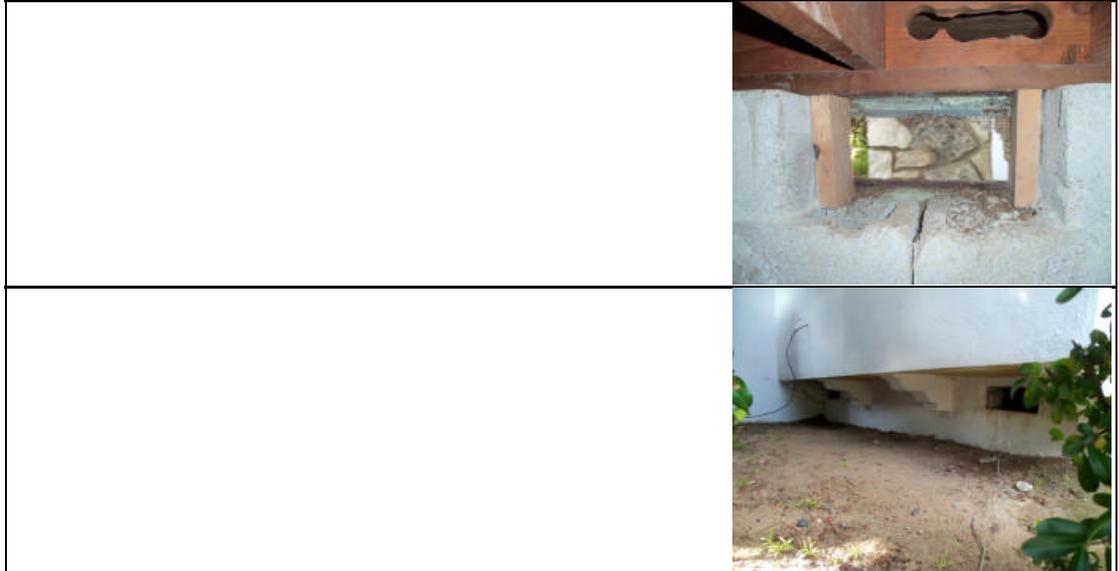
house. The second picture is at the front where there are two screens under the overhanging section that are completely missing and may be missed unless someone checks under the section that projects past the foundation to the right of the entry door.

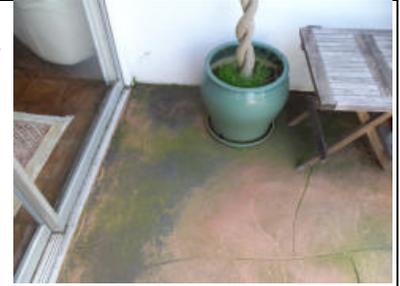
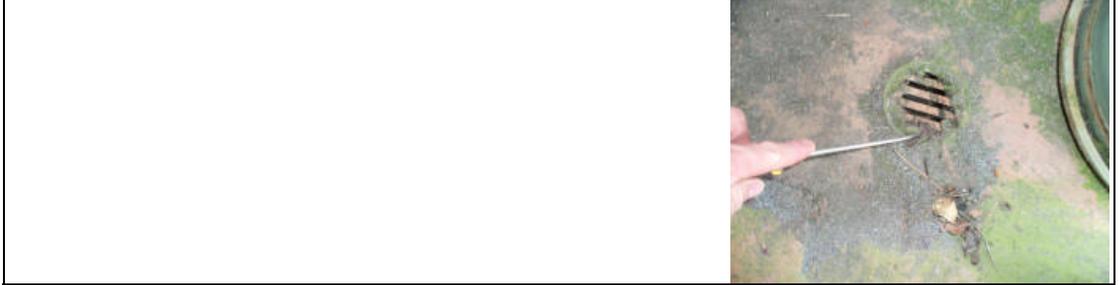
[DEFECT] There is a drain in the patio at the inside corner area. The patio and this drain were poorly installed because water flows toward the house, the patio level is too high in relation to the floor level and the drain inlet is too small and easily clogged. Water can and has leaked in around the sliding glass door frame due to this combination of defects. Consideration should be given to correcting these defects. At minimum you will need to keep a very close eye on this drain inlet to make sure it stays clear. It was clogged until I cleared it off to find the drain and that is why it looks like water ponds in this area.

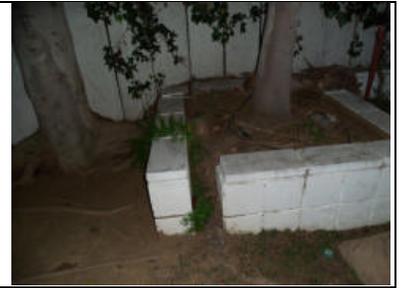
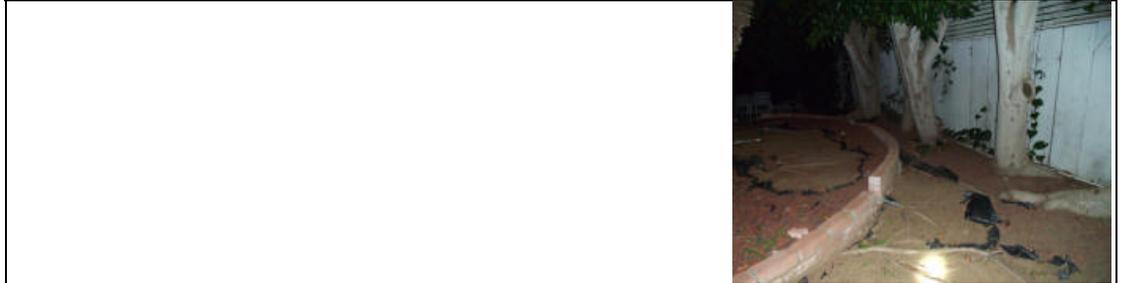
[CR] The planter walls have large cracks and movement.

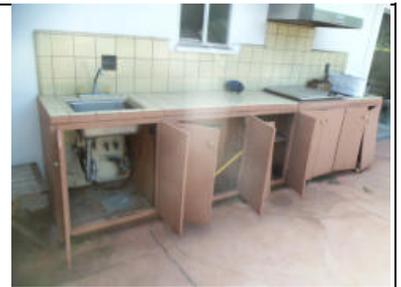
**4.6 BBQ/EQUIPMENT:**

[CR] The cabinets with the barbecue is in really bad condition and all needs to be replaced.

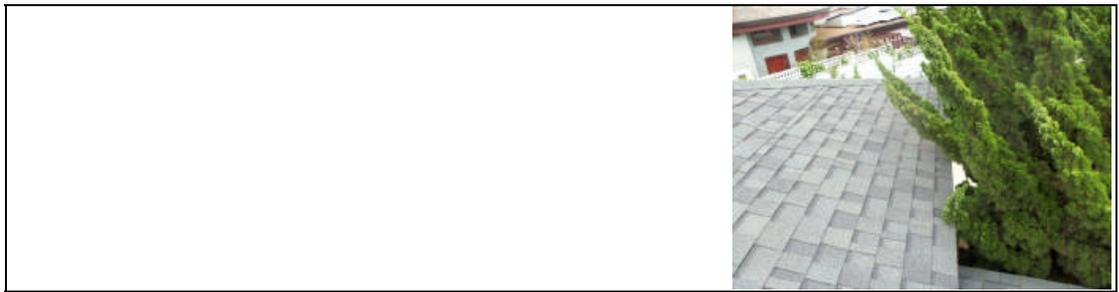
[CR] Trees or other plants need to be cut away from the roof as part of regular maintenance because they will often cause damage to the roof.

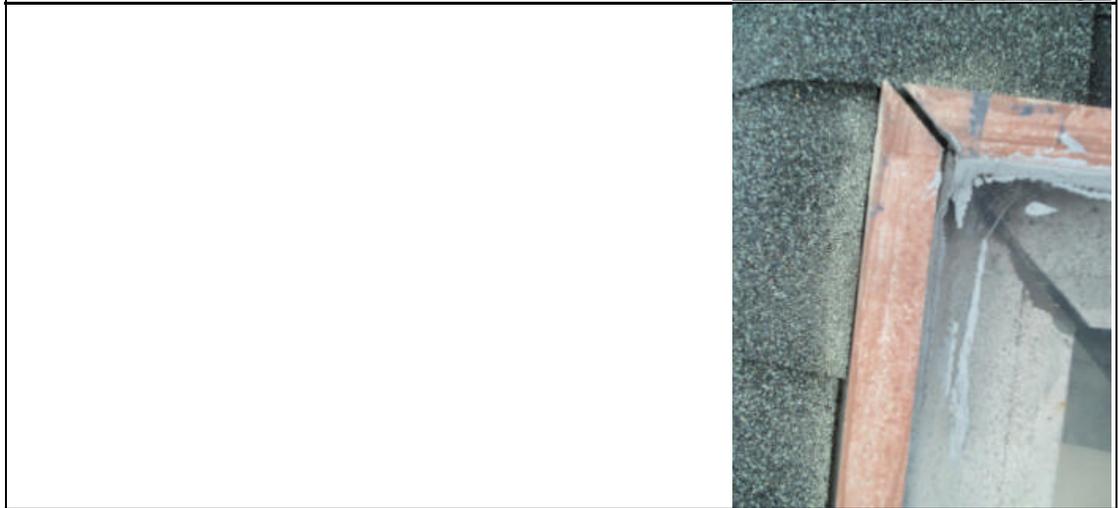
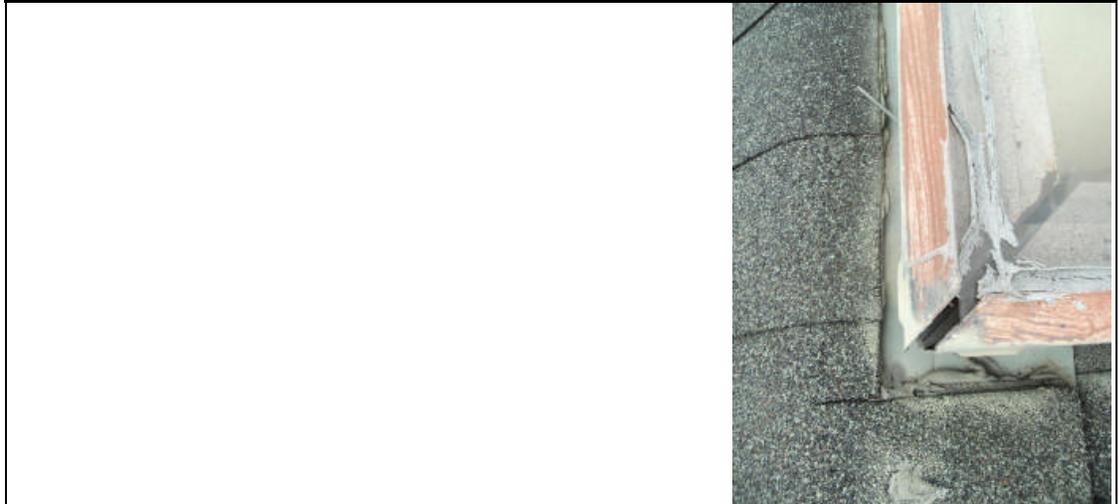
5.4 SKYLIGHTS:

[CR] The skylight over the master bedroom is coming apart at both upper corners and needs service and repair. If the corners can't be sealed and repaired, it may be necessary to replace the skylight. Also, the skylight is just sitting on the curb and not secured.

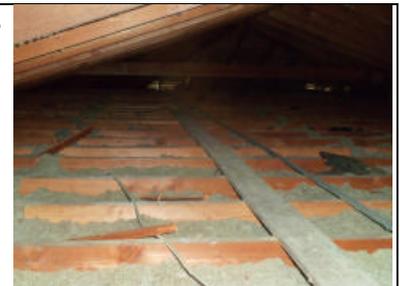
[RU] Recommended Upgrade: The insulation is much thinner or even bare in some areas and you should seriously consider adding insulation to improve energy efficiency and comfort.

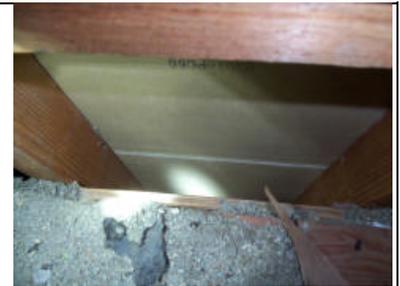
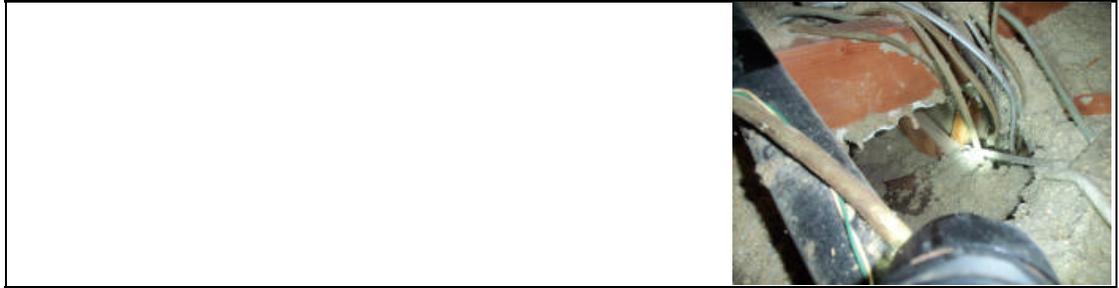
[SC] There are draft stops or fire stops missing in the attic. Their purpose is to slow down and hopefully stop the spread of fire from below from using this space as a chimney to spread a fire up into the attic. They are required at each floor or ceiling level so that a fire from below can not rush up into the attic. You should never be able to look down from the attic into a vertical cavity. A contractor who understands the requirements needs to inspect the attic and install the proper draft or fire stops. The space can be blocked off by a wood block, piece of sheet metal or even drywall.

I only noted one other place besides the fireplace and this is at the dropped ceiling area in front of the family room fireplace. It is fairly easy to block this off.

A second place is where the drywall has a large hole in it above the middle secondary bedroom above the electrical sub panel next to the closet.

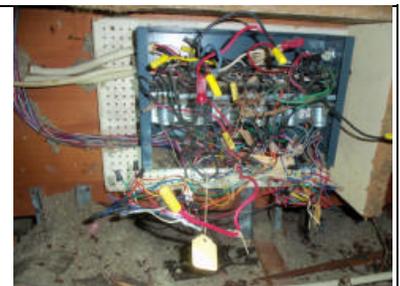
[FE] I recommend that the electrical contractor check this

panel to see if it is still being used.

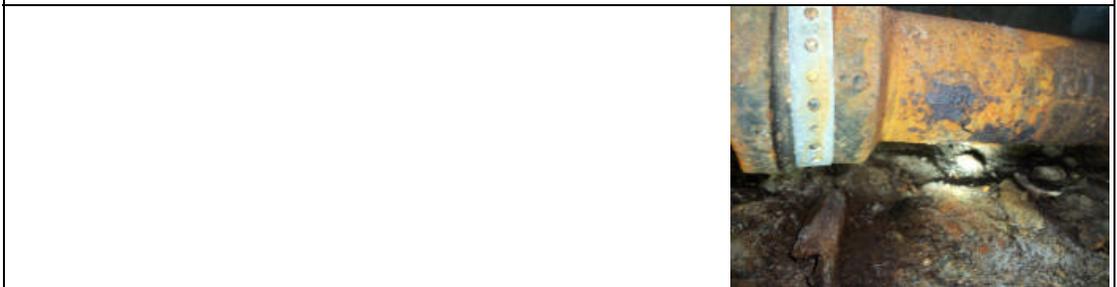
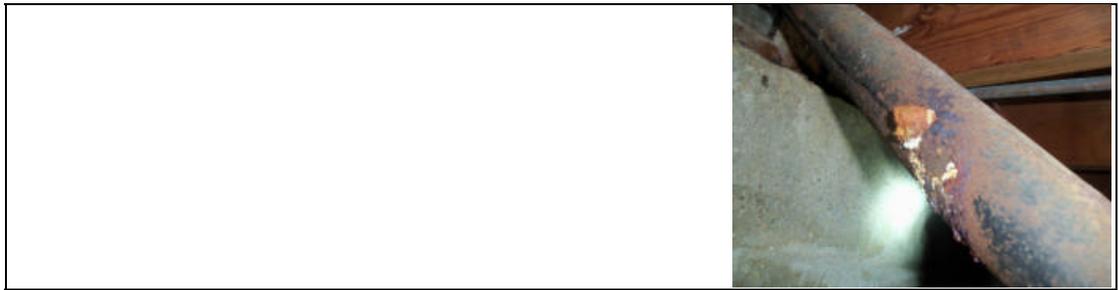
These pictures are representative of the general condition of the cast iron drain lines. Much of it is under the plastic and hidden and I couldn't inspect it. Where I pulled the plastic back, there was generally more rust and the plastic must trap the moisture and increase the rust.

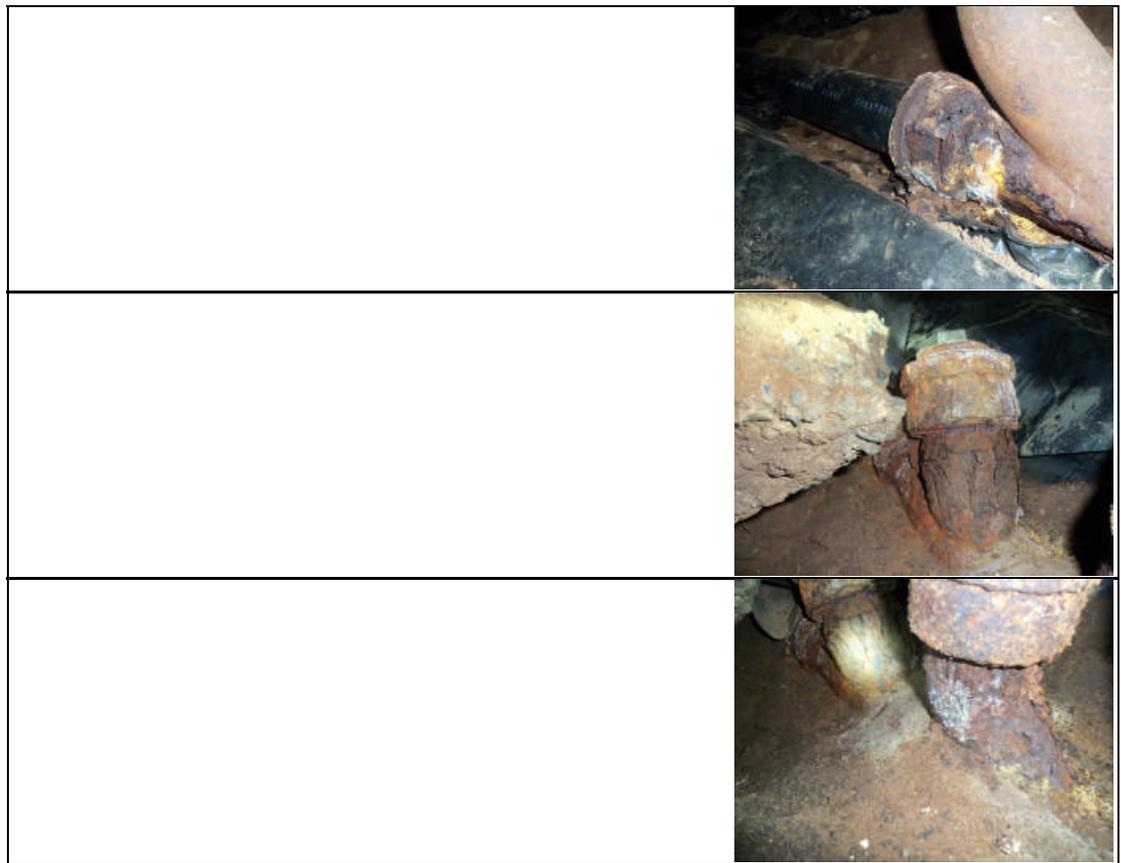
Note the water below this drain that leaked out of this rusted area.

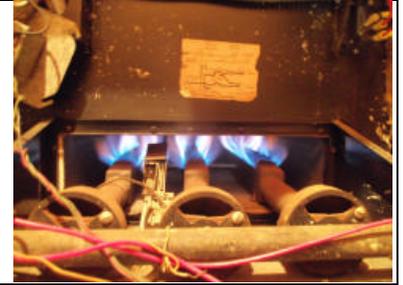
[SC] The panel over the burner assemble had been removed before I arrived. I did not remove it or put it back. This is just one sign that this heater has needed service in the past.

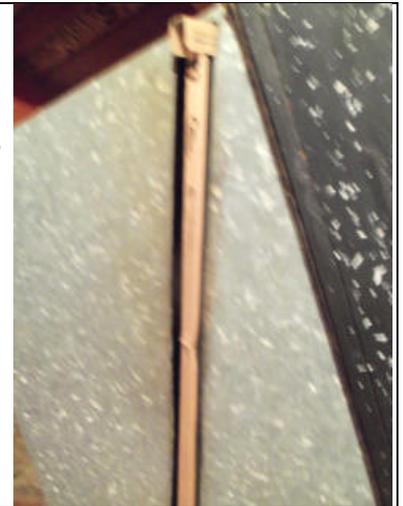
9.8 FILTER:

[CR] The filter is installed in the side of the return air plenum next to the heater. Where the filter slides into the plenum, there is a large slot that needs to be sealed to keep unconditioned air from being sucked into the heating system. It is not sealed. Generally there is a metal cap, but this is missing. Also, this can be a safety concern when the filter is close to the burner chamber because combustion gas (and possibly carbon monoxide) could be drawn into the air flow that circulates through the house.

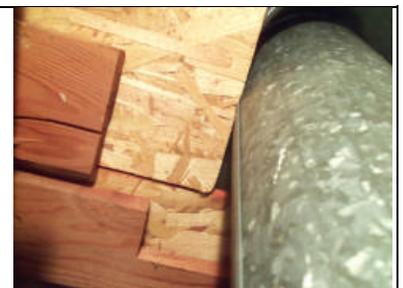
9.9 VENT:

[SC] The vent was too close to or in contact with combustibile materials, and this condition can be a fire hazard that needs to be corrected. The vent is too close at roof line. One inch clearance is required by code between the dual-wall vent and any wood or other flammable material. The vent is very close or even touching the wood and heat transfer is a clear risk.

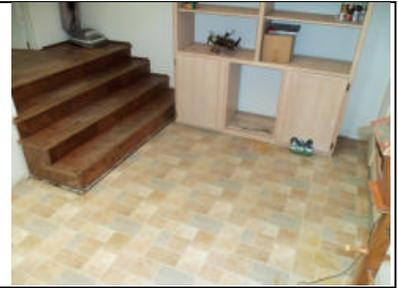
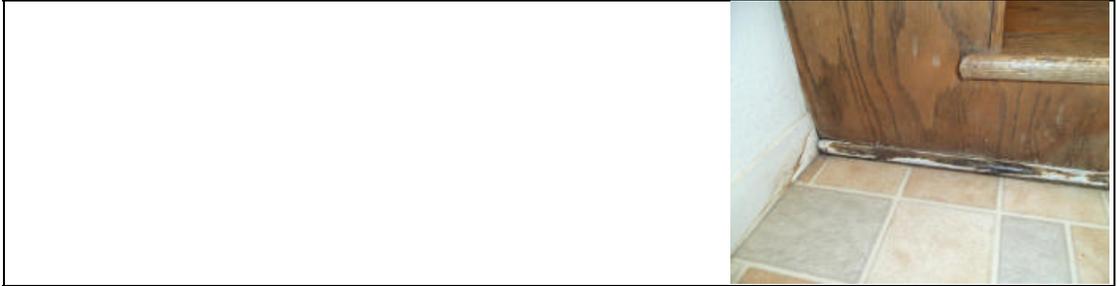
Water is also migrating in at the base of the stairs that go up into the house. I think the most likely source of this moisture is from the water that runs into the crawl space down to the low area directly opposite the steps and then migrates through capillary action through the porous block foundation. This is another reason to control the water in the crawl space.

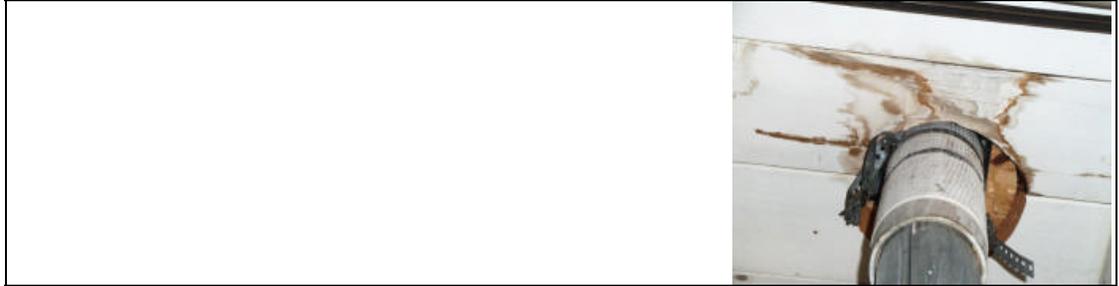
hazard that needs to be corrected. One inch clearance is required by code between the dual-wall vent and any wood or other flammable material. The vent is too close at roof line. The vent is very close or even touching the wood and heat transfer is a clear risk.

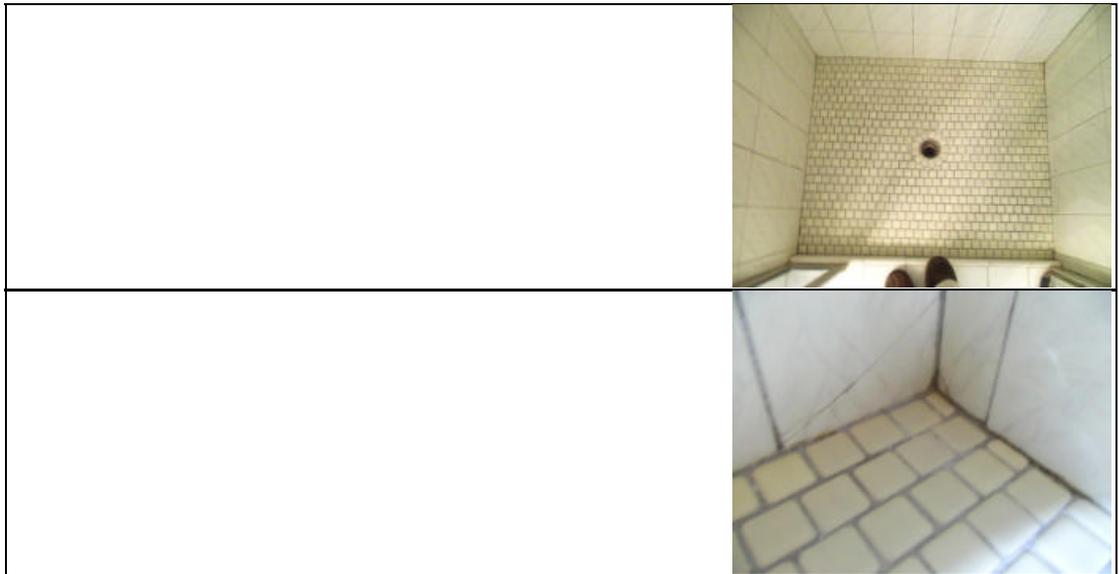
[CR] The drain grate was loose. The threads for the screws appear to be messed up and this could make correction difficult.

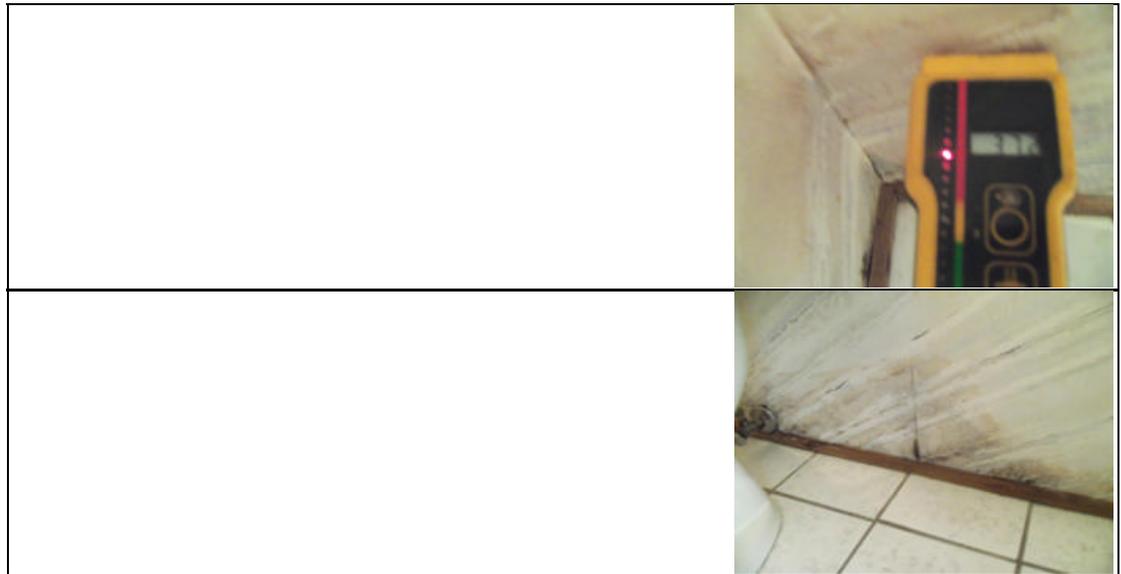
[FE] [CR] There is staining and discoloration on the wall around the toilet. With my moisture meter, I can confirm that there is excess moisture in the wall material. The wall material will need to be removed to allow the interior wall to dry and evaluate the source of the leak. The leak will need to be repaired. See the Mold Statement in the Introductory Notes section at the beginning of this report for additional important information.

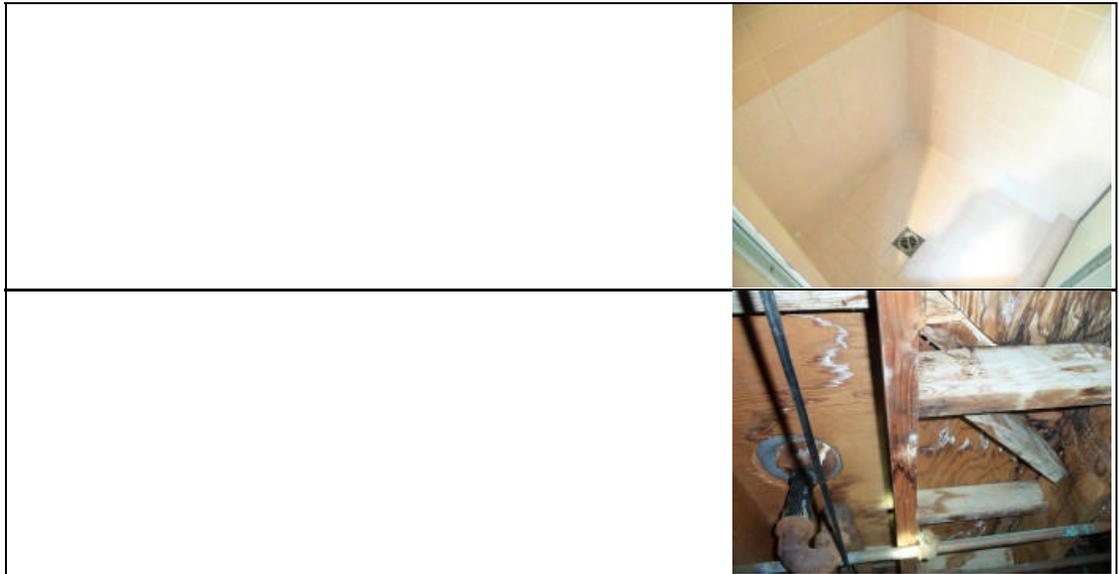
The shower pan was replaced once already but I can tell the new one leaks because there are water stains on the new plywood that was installed at the same time as the shower pan. The leaking appears to be small but unfortunately replacing the shower pan is the only solution that I am aware of. The leaking is visible from the crawl space below the shower.

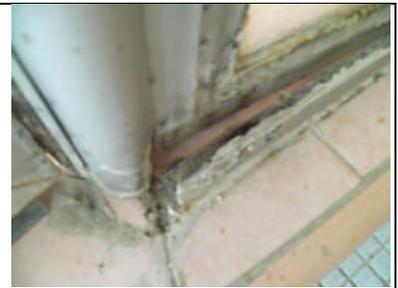
13.47 SHOWER DOOR:

[CR] The shower door frame is very corroded and coming apart at the bottom and will need to be replaced.

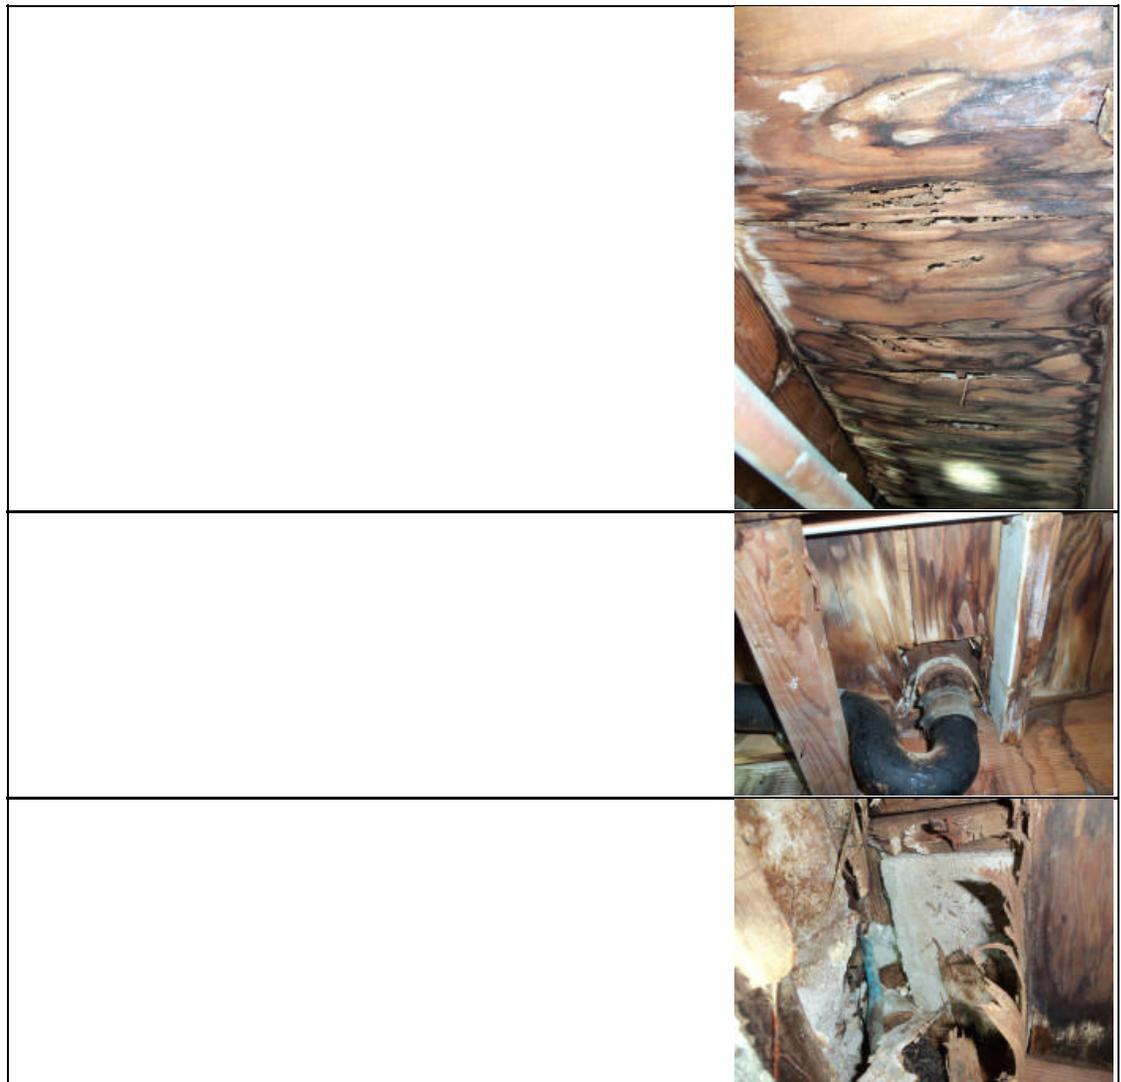
These pictures are under the shower. It looks like the shower was installed without a shower pan or any waterproof lining at all. Make sure the contractor confirms these pictures are for this bath before busting it out. This is a huge crawl space and it very unlikely but not impossible that this could be for a different shower.

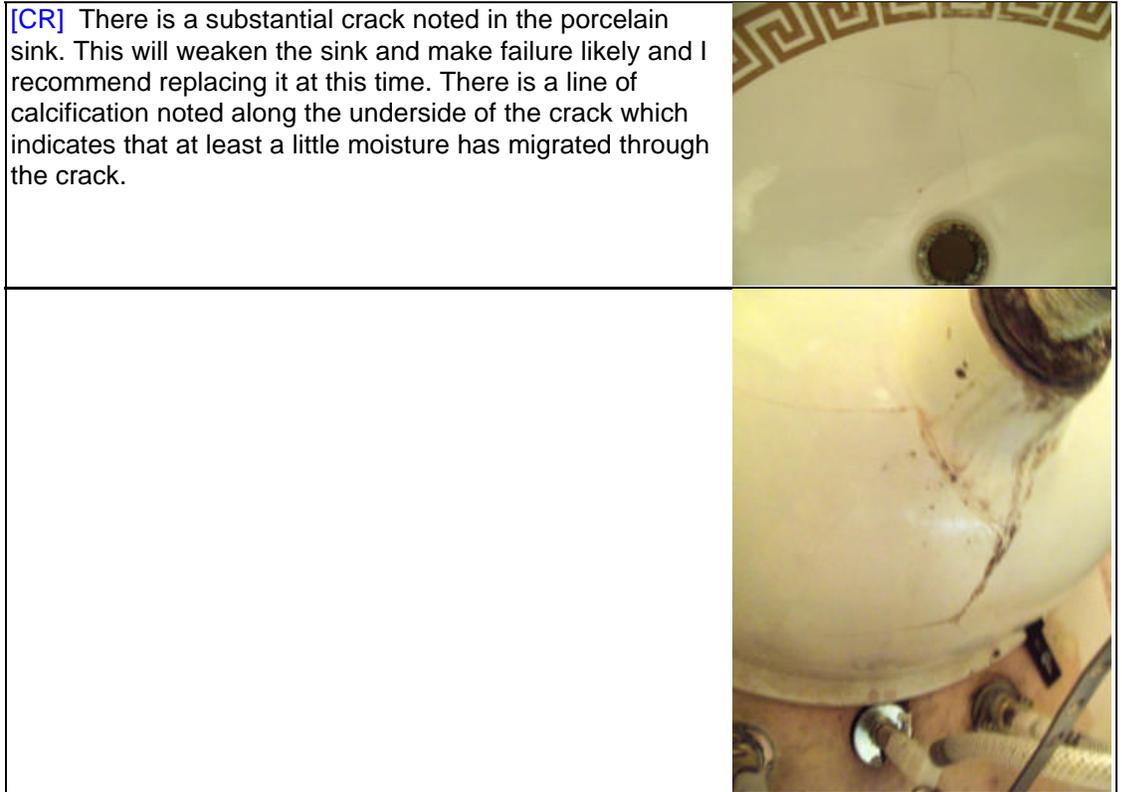
[CR] There is a substantial crack noted in the porcelain sink. This will weaken the sink and make failure likely and I recommend replacing it at this time. There is a line of calcification noted along the underside of the crack which indicates that at least a little moisture has migrated through the crack.

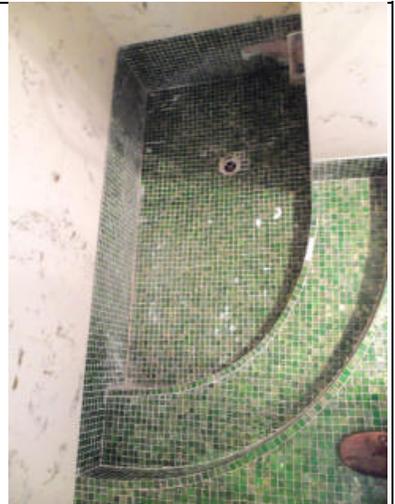
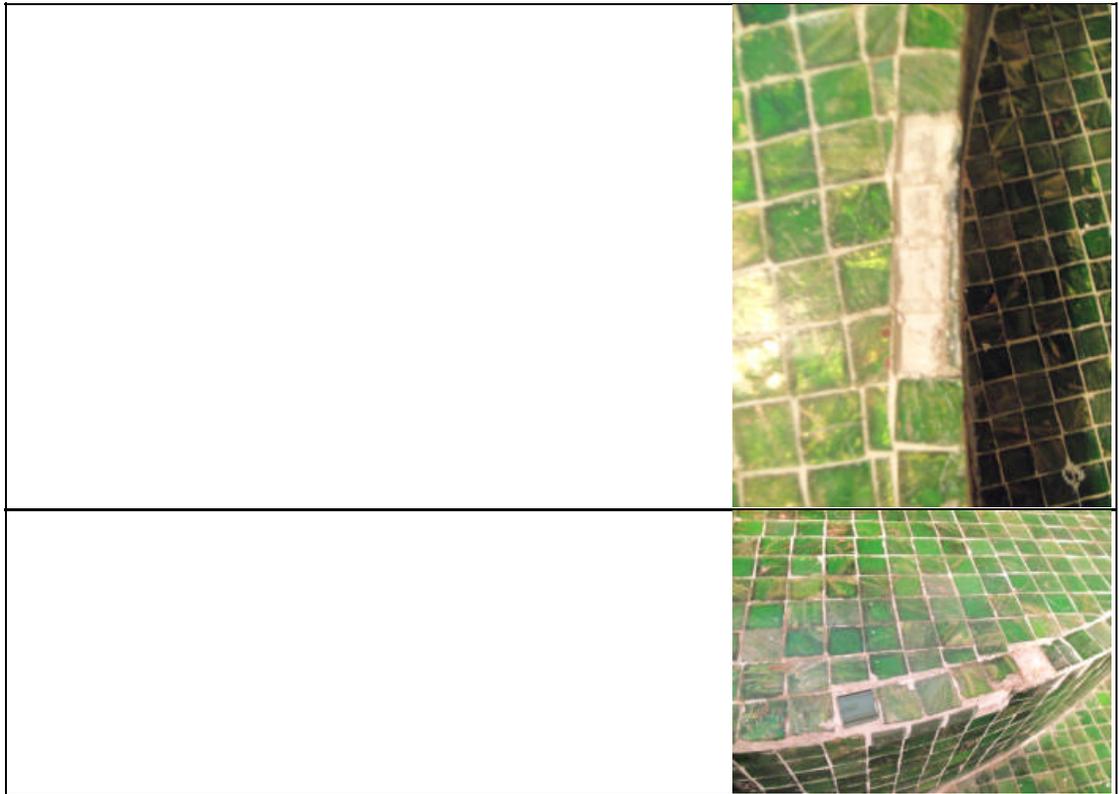
The shower has a tile floor and walls. It is outside the scope of this inspection to water test the shower pan or determine the integrity of the shower pan or lining below the tile. The tile grout is porous and this shower pan is what waterproofs the shower floor. Unfortunately, it is not visible for inspection, and leaks can go undetected. There is no crawl space under this shower.
 [CR] The drain grate was missing and needs to be repaired or replaced. There used to be a tub stopper for this drain so that this shower could be filled to be tub.
 [CR] A few of the tiles have come loose.

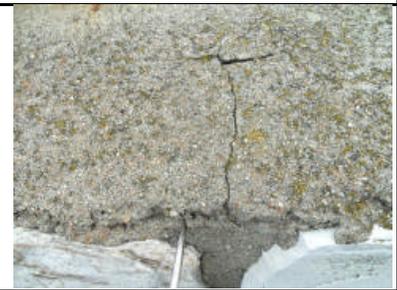
[CR] The mortar cap on top of the chimney was cracked or deteriorated and minor repair or maintenance is needed. Any cracks need to be sealed including any gap between the mortar cap and the stone face, and the mortar repaired or replaced to slope to the outside edge to prevent water intrusion into the brick structure below. Moisture leaking in through from the top can wet the steel reinforcing, causing the steel to rust and expand which is the leading cause of cracks around the top of the chimney. After the cracks are sealed and mortar repaired, you should consider sealing the entire top surface. There are products designed specifically for this such as Crown Seal. Ask your fireplace contractor or chimney sweep. The earlier repairs are done, the less chance of serious and more costly repairs later on. The third picture shows a crack on the sidewall above the roof.

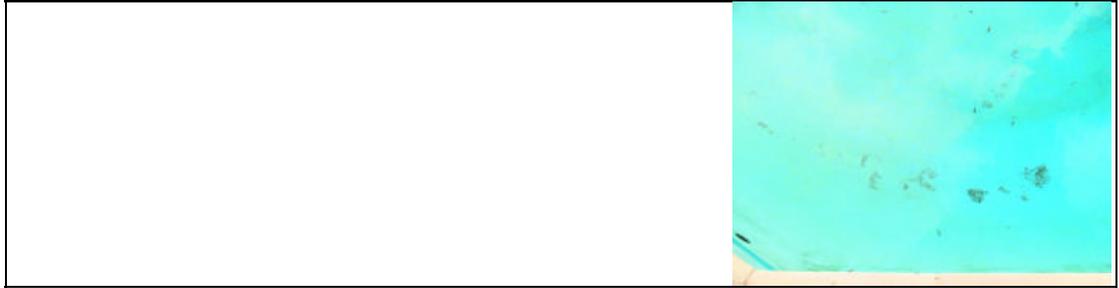
waterproof the pool. When water migrates through the concrete it can cause rust to the reinforcing steel. It looks like there could be a couple of rust spots on the bottom of the pool.

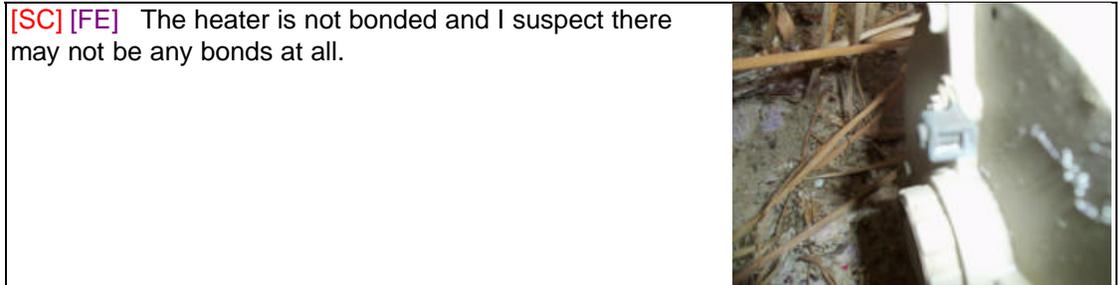
[SC] [FE] The heater is not bonded and I suspect there may not be any bonds at all.

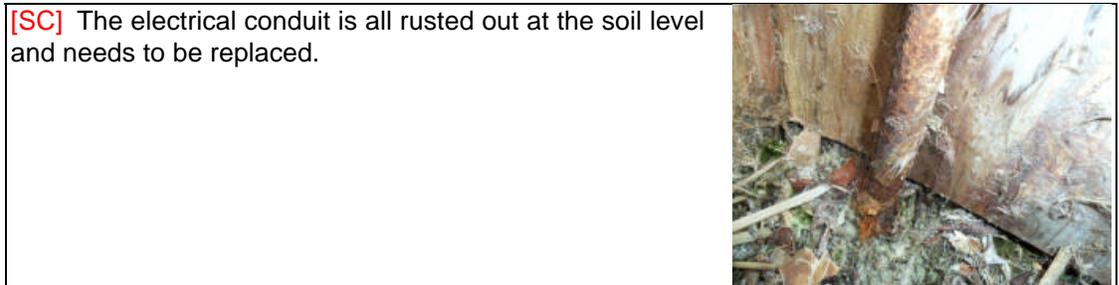
17.19 ELECTRICAL:

[SC] The electrical conduit is all rusted out at the soil level and needs to be replaced.
