All Pro Home Inspections

STANDARD RESIDENTIAL INSPECTION AGREEMENT

Client Name: Pool Lover
Inspection Address: 1234 Pool Street
Bonita, CA 91902

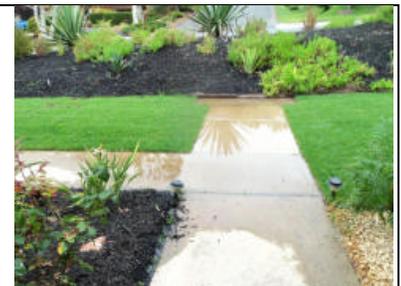
[CR] The slope and drainage around the house are generally poor and need to be improved to minimize water saturation, provide better drainage of water away from the foundation, and provide a way for the water to more easily escape from the yard and make its way to the street or other appropriate drainage. See the note above and read hand out "Recommendations for lot Grading" which is available on my web site at AllProHI.com I strongly recommend that you take these recommendations seriously. Consult a grading or landscape contractor. The swale or drainage channel is not adequate to meet the minimum requirements and needs to be improved to carry the water around the house usually from the back or side yards to the street. A minimum slope of 1/8 inch per foot would need to drop about 6 inches in each 50 feet, and it is much better to drop one foot in each 50 feet to adequately allow excess rain water to escape to the street. Neither of these standards are met around this property and excessive amounts of rain water could saturate into the soil before it has an opportunity to drain away. Yard drains are recommended as an alternative to a swale in order to collect and remove the excess water. Slope the soil into the yard drains and provide as many drain inlets as needed to catch all the low spots in the yard. One of the best ways to capture and remove a lot of excess rain water is to install rain gutters and then tie the down spouts directly into a drainage system.

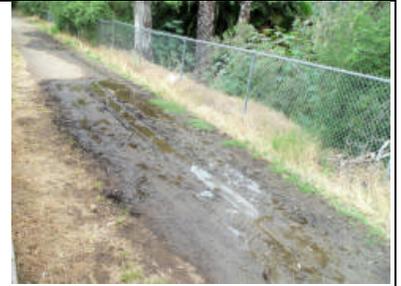
[FE] [CR] There is mud all the way around the pool house with standing water in several areas and water flowing out onto the trail behind the back fence. This needs immediate attention to determine the source of all this water and correct the situation. There are many possible sources and these are the ones that come first to my mind but not all the possibilities. The slope and grading is terrible and all the water from the back yard drains towards the pool house. The yard is being greatly over watered and the excess water runs and pools around the pool house. The sprinklers are leaking. There appears to be a sump pump which is likely for the sewer drain for the pool house that has failed and is full of water. Someone overfilled the pool and the excess water leaked out. There could also be a leak in a water line.

[FE] I was walking around the back of the pool house and the ground had a lot of soft spots that I figured were due to gofer tunnels, then I stepped in one spot and sunk about a foot.

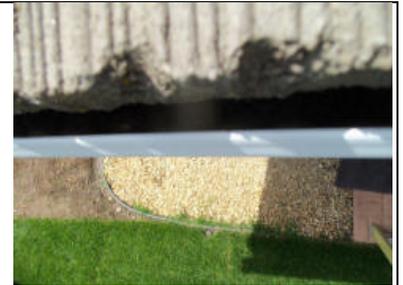
[CR] The rain gutters do not project far enough from the roof, and water will overshoot the rain gutter in a heavy rain when they are most needed. The gutters will need to be re-installed and set properly. The rain gutters are plastic. These tend to be weaker and more problematic and I never recommended them. They sag and the joints leak. Consideration should be given to replacing them with seamless aluminum.

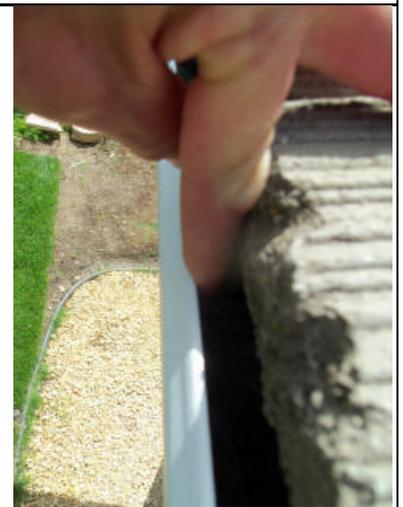
[CR] I strongly recommend rain gutters on the front of the house, particularly to keep the rain from the sopped roof from running onto the flat roof. This section used to have rain gutters but they were removed. The down spout is still installed.

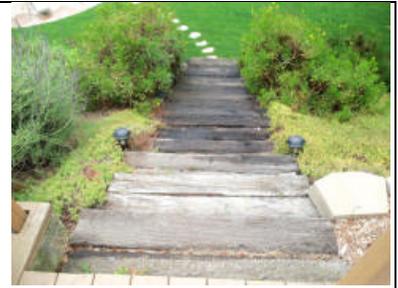
[SC] All stairs and steps need to meet minimum standards for safety or they can be a trip and fall hazard. Trip and fall hazards from stairs are the number one cause of injuries and emergency room visits in and around homes and need to be taken seriously. The back steps down to the pool do not meet the minimum requirements in several ways and are clearly a trip and fall hazard. There is no handrail and the steps are uneven and irregular. [SC] There are steps over 8 inches high, which is the maximum acceptable by code. This could be a trip hazard. [SC] The spacing between the steps or stairs was inconsistent and this can be a trip hazard. The code states that the variation in the height or depth of any stairs should be no greater than 3/8's of an inch.

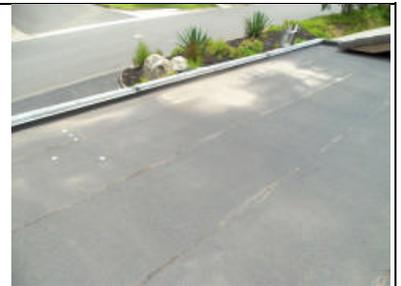
[CR] There are spots or areas with cracking or other deterioration due to aging, and maintenance or repair is recommended at this time. The entire roof over the garage should be inspected and repaired as needed by a roofing contractor that has experience with this material and willing to certify the roof after the repairs are made. Any sealant used needs to be specifically designed to be compatible with the modified bitumen. Common roofing mastic is not compatible with this material, but is too often used when repairs are not done by a specialist. The roofing contractor should check the entire roof with special attention to the edges or any transition areas and make any needed repairs or maintenance. This is often called a roof 'tune up' and is a necessary part of maintenance to extend the life of the roof.

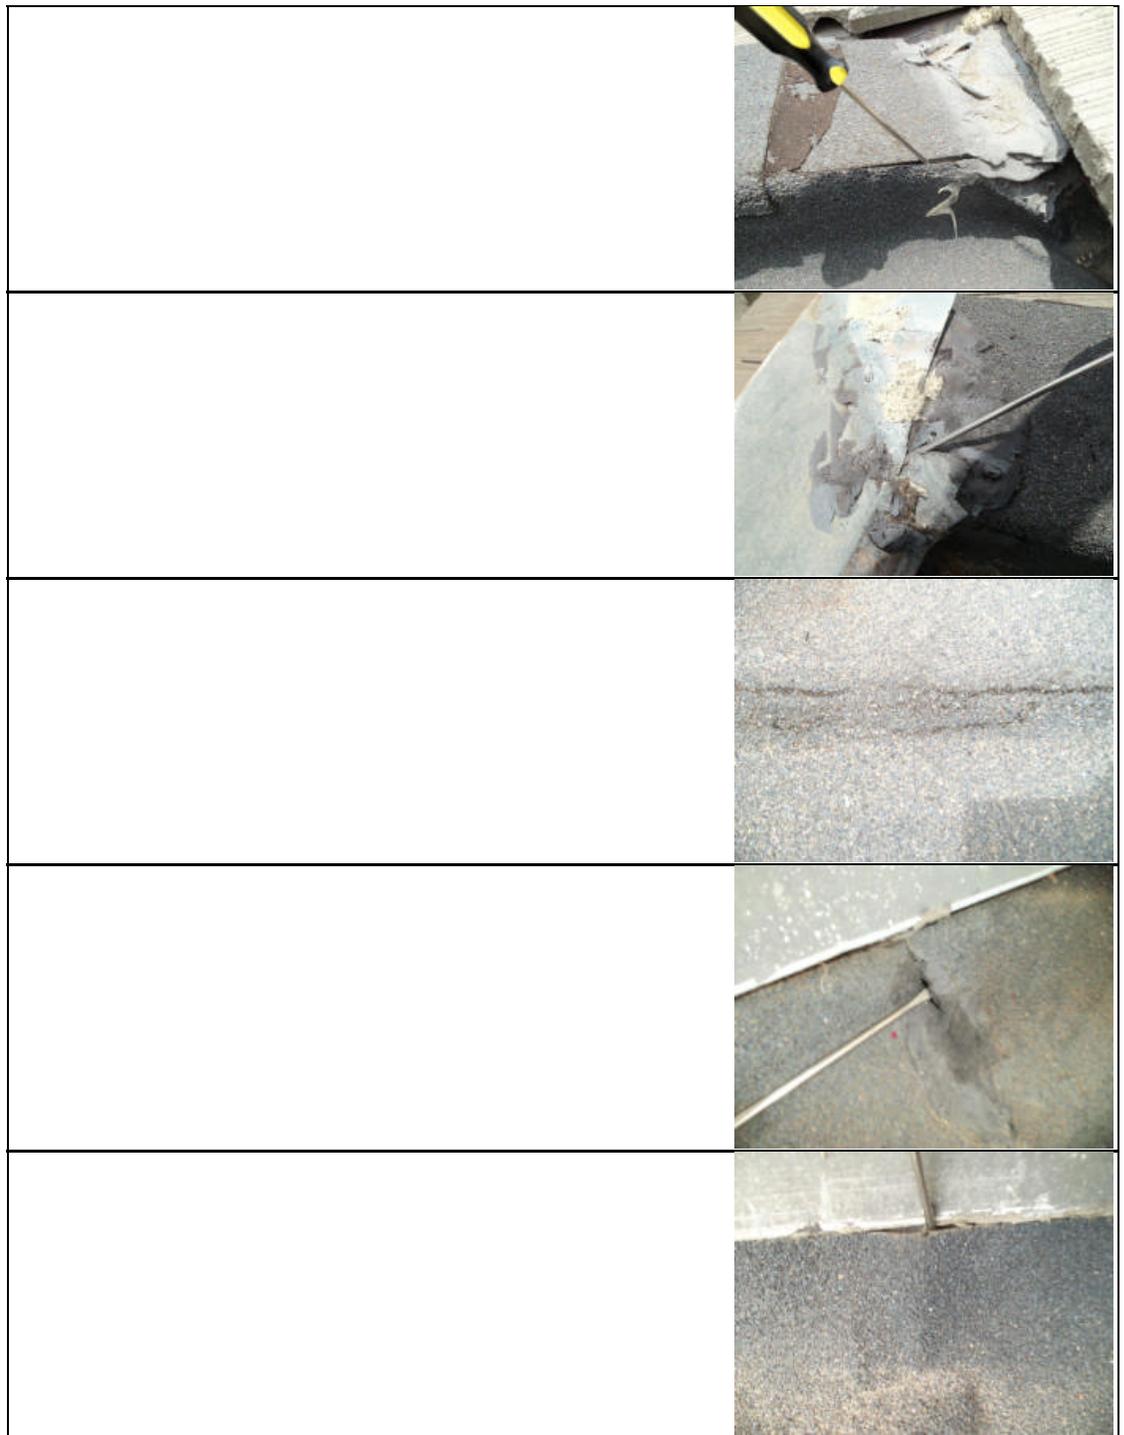
[FE] Repairs are needed at this time and there is overall deterioration from age that needs further evaluation by a roofing contractor. Have a roofing contractor examine the roof, estimate the cost of repairs, and help you determine if it is more economical to make repairs, or wiser to re-roof this section of the roof. If repairs are made, the roofing contractor should also give you an estimate of the remaining life so that you can budget ahead for replacing it.

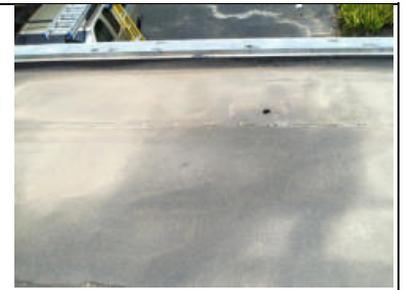
[Defect] The flat roof has areas that will pond or hold at least a little water. The code and manufacturers specifications for a flat roof requires a slope of 1/4 inch per foot to ensure that water will not pond. Any areas that pond will be much more prone to damage, particularly as a roof gets older, because any water that sits on the roof can continue to seep through even a small leak until all the water evaporates. If a roof has the proper slope, the only time it can leak is when it is actually raining and a minor leak will be far less likely to cause damage. Whenever a roof is replaced, I feel very strongly that any ponding, even if it is minor, needs to be eliminated before the new roof is installed. The ponding will shorten the expected life of the roof, cause more rapid deterioration to the roofing material in any areas that pond, and cause more damage to materials below the roof when it leaks. Any ponding on this roof is probably shallow.

The areas in the picture with the light silt deposits pond water.

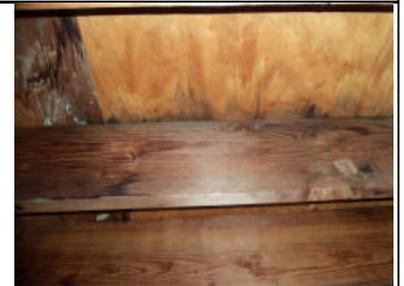
[FE] There is lots of staining under this roof but most likely that most of this is from a previous roof. However, one section of plywood was replaced and this new section has a stain that I am more suspicious is from the current roof.

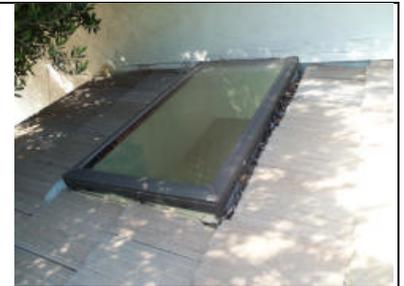
[FE] There is water damage to the texture, paint or finish below the skylight in the master bath and the roofing contractor needs to investigate the possibility that there is a leak around the skylight. I strongly suspect it is leaking.

[FE] The flashing details for the skylights are weak and I recommend that they all have further evaluation. It appears that all the water that runs around the skylights will run under the tile to the edge of the roof.

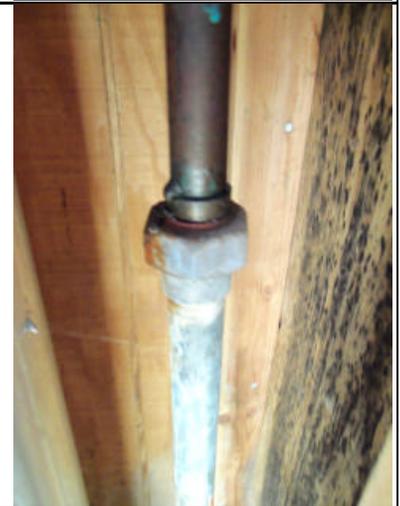
[CR] There is also a section of galvanized pipe being used on the pool house and this is inside the water heater closet and runs to a hose bib. This also has high failure rates and should be replaced. The dielectric coupler in this picture is rusting and failing.

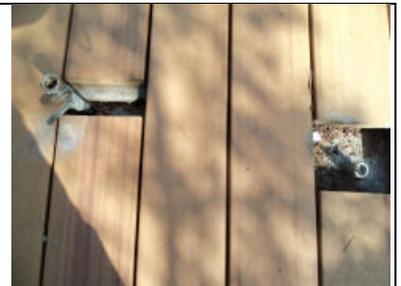
[SC] Any gas line that is not being used, needs to be capped. Having a valve that is turned off does not meet this requirement because a valve is much more likely to leak than a cap. Have the valve replaced with a cap. This is for the line that sticks up in the back patio where there used to be a barbecue. It would be best to cap this at the edge of the house and eliminate the rest of the line. The gas line sticking up is a trip hazard.

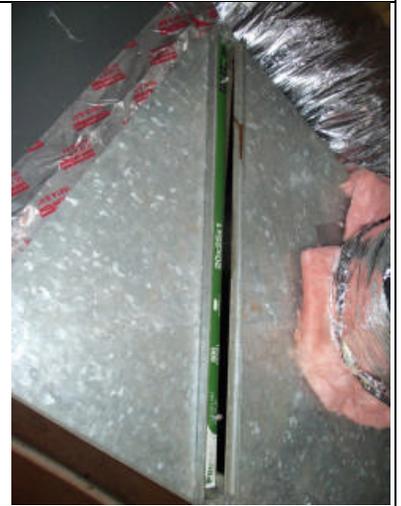
[CR] The filter is installed in the furnace located in the attic, and this makes it very inconvenient to change. I recommend relocating the filter to the return air grill where it will be much easier to change. Return air grills that hold a filter are available and usually easy to install.

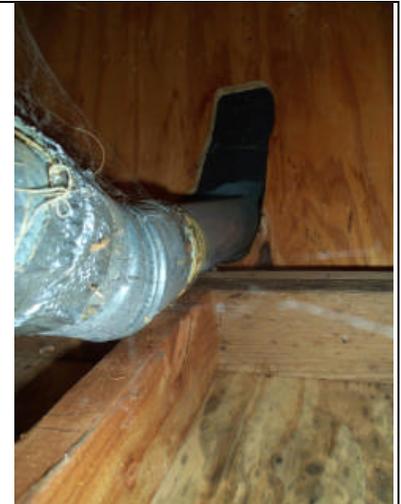
[SC] Single wall vent is not allowed to run through any ceiling, or any partition, or inside any concealed space, or in the open air on the outside of the building. It is only permitted for the section from the water heater to where the vent exits the room or enclosure. All other sections need dual-wall vent installed to replace any single wall sections.

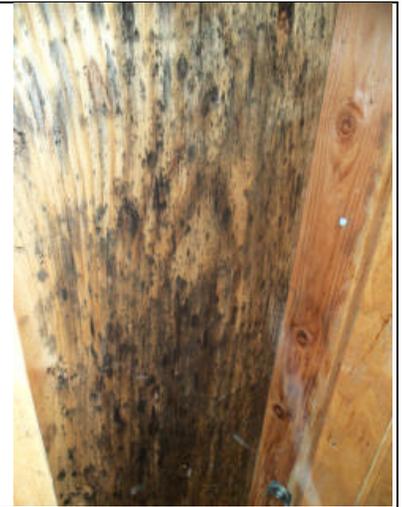
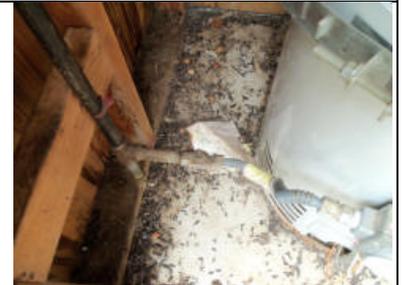
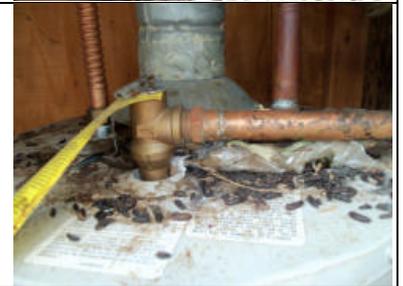
[FE] The plywood on the inside of the closet is covered with black staining. Further evaluation is needed to determine the cause of the staining and make corrections. See the Mold Statement in the Introductory Notes section at the beginning of this report for additional important information.
[CR] Also, there are a lot of rodent droppings that need to be cleaned out and the closet sealed to keep them out.

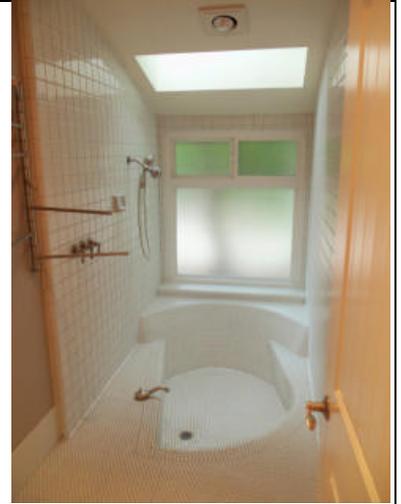
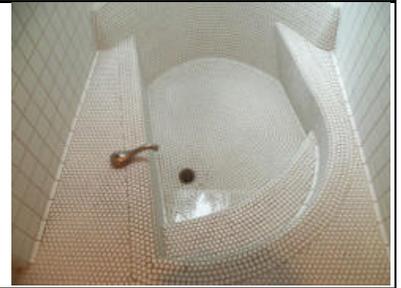
[CR] The tub drained slow. The trap may need to be cleaned or there could be a blockage farther down the drain line. Request that it be clean and free flowing when you move in.

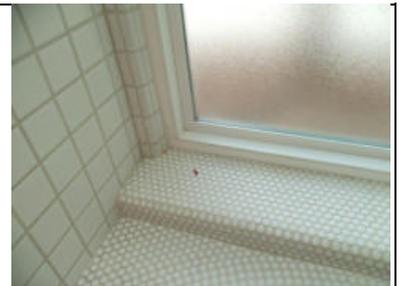
[CR] It will be difficult to maintain a seal between the window and the tile because of the way the tile was installed. There should be a gap between the two that is filled with a flexible sealant. This has little to no gap and is filled with ridged grout.

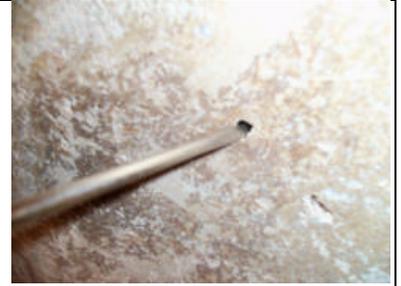
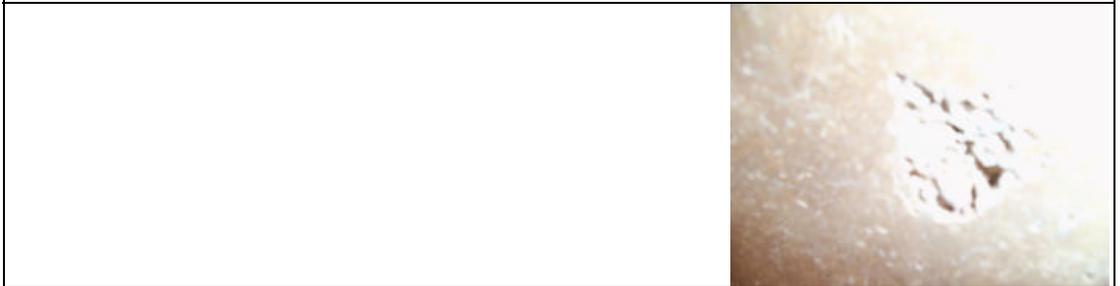
[FE] This shower appears to have natural stone tile. Some stone tiles are not appropriate for showers because they do not hold up to the spray of water and I have seen surface deterioration in previous inspections on stone tiles. Another problem with stone tiles is that they are porous or have rough surfaces that can be difficult to clean or are prone to the growth of mold or mildew. You should consult the tile manufacturer for this tile to see if it is approved for use in a shower. **The stone in this shower is so porous and deeply pitted that it will be very difficult to clean. I would also be concerned about the amount of water migrating through the stone and challenging whatever water barrier is behind the tile.** Unless the walls behind the tile was waterproofed, which is not likely, there is risk of water migrating into the wall. Only non-porous tiles should be used in a shower.

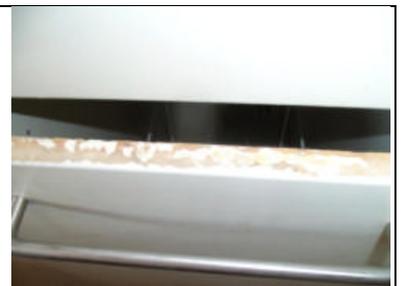
The cabinets have a vinyl or melamine skin over a fiberboard core. A weakness with this material is that the skin can come loose and curl at the edges and unfortunately this is not unusual as the cabinets age. The risk is greatest wherever there is heat or moisture such as below the sink, above a stove or where someone places a coffee maker or toaster. Unfortunately this is not easy to repair and the effected panels usually need to be replaced. The edges of several of the lower and upper cabinets have deteriorated.

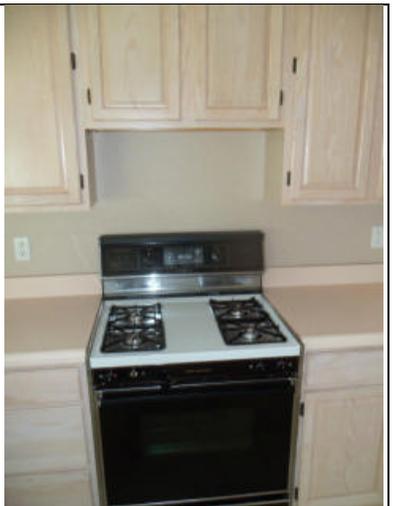
<p>Type: Gas with electric igniter The cooktop/range burners functioned. There were common signs of aging and wear. [CR] One of the control knobs or dials was missing and need to be replaced.</p>

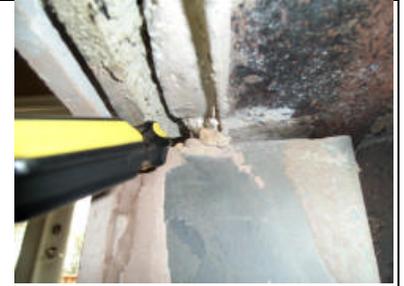
[SC] There is a gap, crack, or separation between the front edge of the firebox and the facing material covering the wall in front of the fireplace. This separation is located around the front edge of the fireplace opening. The fireplace requires a tight seal at this location to prevent the passage of heat and smoke into the wood framing inside the wall surrounding the fireplace opening. Further evaluation is needed by a fireplace contractor or certified chimney sweep to inspect, service, and repair the firebox and it should not be used until then. Any sealant needs to be rated for a fireplace and installed professionally. There are several gaps that need to be sealed and the pictures are just examples. The contractor should also fill any gaps in the transition between the firebox and the flue.

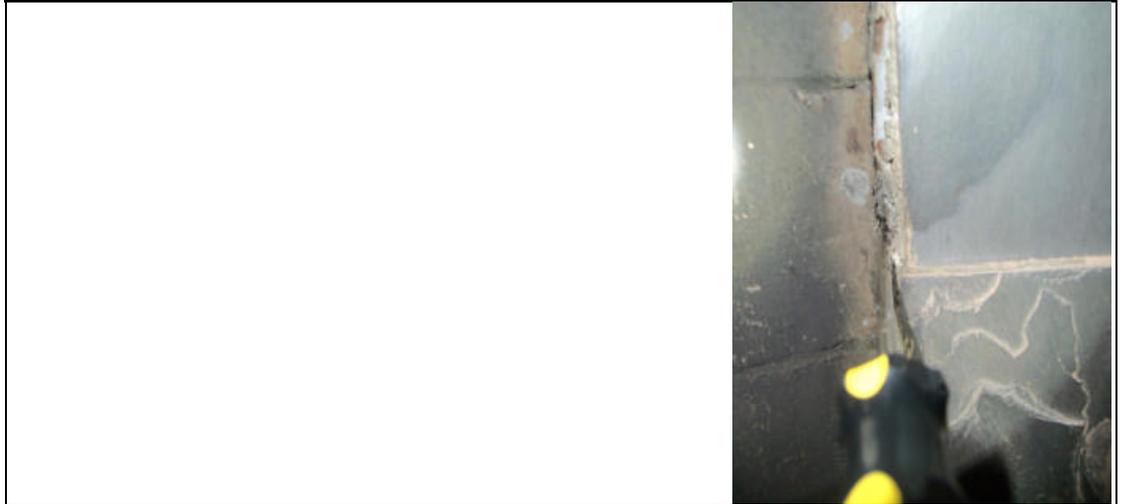
[FE] There are small cracks or gaps in the brick walls or through the grout lines inside the firebox that could be caused by overheating, poor installation, or some movement in the fireplace. The fireplace needs further evaluation by a fireplace contractor or certified chimney sweep who specializes in fireplace repair. The cracks may just need to be sealed or patched with special heat-resistant mortar or caulk, but they could be a symptom of a larger problem. (If patching is all that is needed, you should ask the contractor about the advantages of installing a heat shield to minimize risk of further damage.)

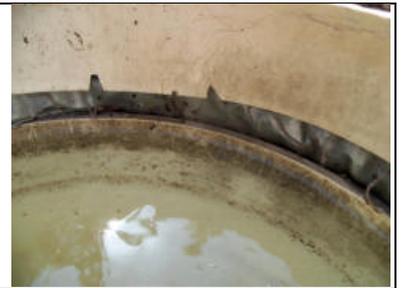
[CR] The water level is too high in the pool. This picture is inside skimmer casing and any water above the plastic housing will leak over the top and can then run under the concrete deck. The water level is at the top of the housing and the pool may have been filled even higher than it is and ran out. This is one possible explanation for all the water around the pool house.

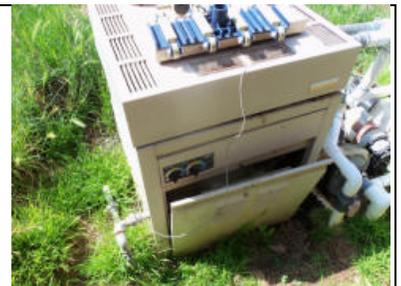
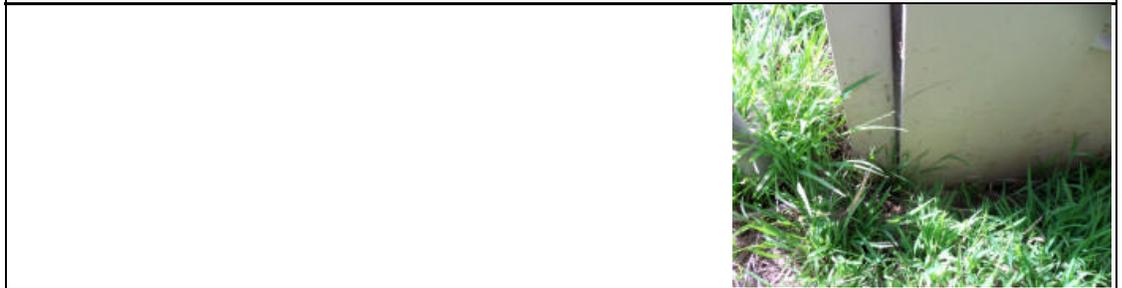
[FE] The heater failed to function and further evaluation is needed by a pool heating equipment contractor. This is an old heater with lots of rust and I suspect the entire unit may need to be replaced. You should have further evaluation at this time and before the close of escrow.

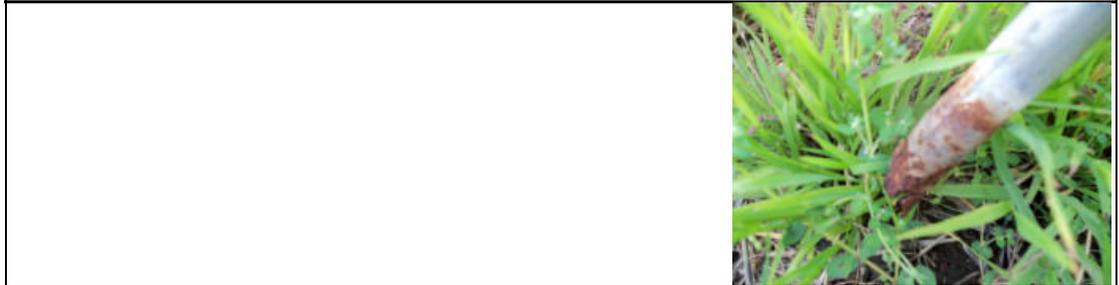
[SC] The support post for the electrical box has rusted through and needs to be replaced.

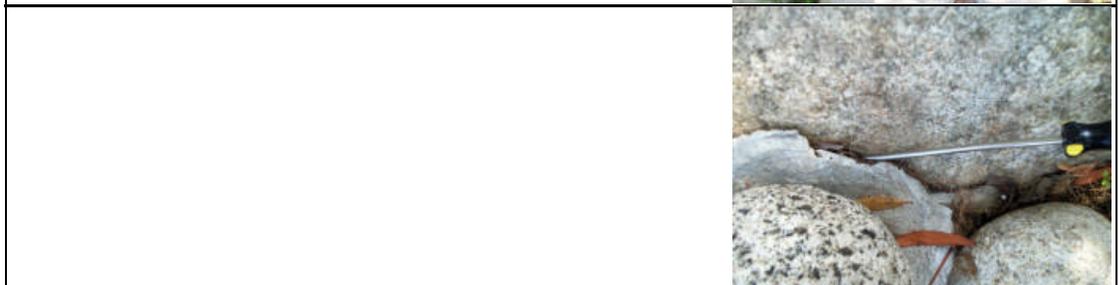
[FE] The pump motor failed to function and needs further evaluation and may need to be replaced. It is old.
 [FE] The waterfall itself needs further evaluation. I am concerned that a substantial amount of water will leak through the waterfall when it is on. There are cracks in the mortar and I do not know if there is any waterproof lining under it.
