All Pro Home Inspections

STANDARD RESIDENTIAL INSPECTION AGREEMENT

Client Name:
Inspection Address: 1234 Apartment Avenue
San Diego, CA 92101

Date: April 8, 2011
Time: 8:00 AM

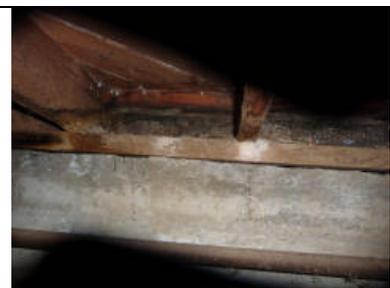
[CR] There is a series of vents that should be approximately under the unit C front windows that have been covered up. The soil level needs to be lowered below the level of the vents. From inside the crawl space, I can see just a little bit of light and most of these vents are covered with soil or debris. Also in the crawl space, I can see that water runs from this back area towards the lower areas and I suspect that the water comes in through these

vents.

This picture looks at the vents from inside the crawl space.

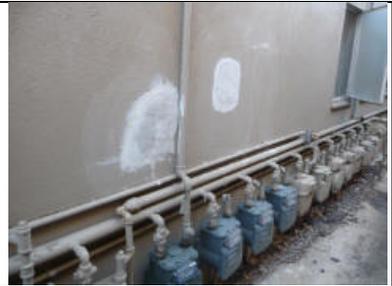
4.1 STUCCO:

[NOTE] There is patching to the stucco around the buildings in quite a few places. Generally this patching is rough and doesn't match the rest of the wall. You should consider having a good patch person evaluate and give you a price for redoing the patches. The location of individual patches will not be identified. Whenever patches are poorly done, I always have concern that the integrity of the building paper was not maintained.

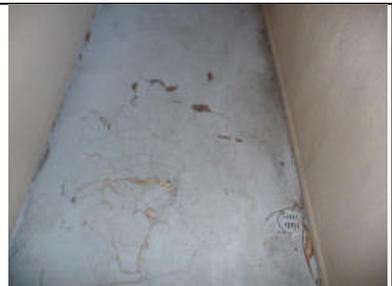
4.2 BALCONIES:

[FE] [FE] [CR] [CR] [CR] The balconies, upstairs walkways and the stairs all have a waterproofing that has failed. I strongly recommend that you have a deck specialty contractor evaluate all of these further and give you a price for replacing all of them. This includes the small deck outside of Unit D. There is evidence of leaking throughout and the material looks very deteriorated. I doubt that any of it can be repaired and expect that it will all need to be stripped down to the wood framing and replaced. This can be a substantial expense and you need to get a price for this work during your contingency period.
 A could have put in a lot of similar picture to this of damage to the decks.

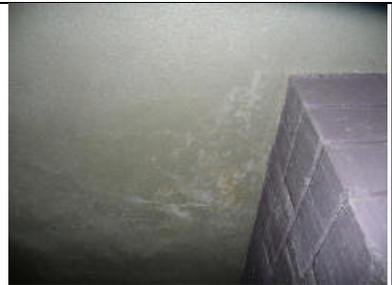
4.3

I could have added another 10 pictures showing places where there are water stains or damage under the decks and also under the stairs.

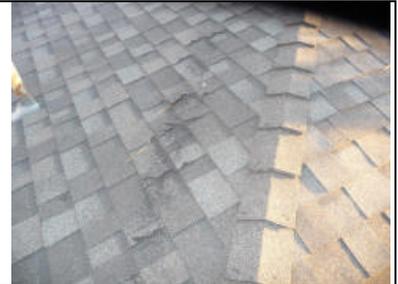
5.3 GENERAL CONDITION:

* The overall appearance of the roof is good except as noted. * The roof material appears to be in the early part of its expected life.
 [CR] Trees or other plants need to be cut away from the roof as part of regular maintenance because they will often cause damage to the roof. This section of roof at the front of the left wing shows damage from a palm frond.

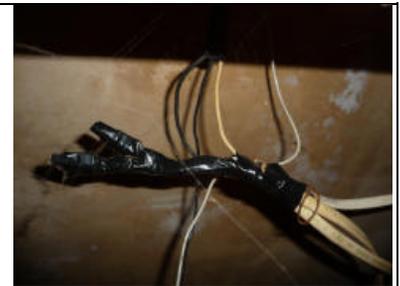
[SC] All splices in electrical wiring (with a few exceptions) are required to be made inside of an enclosed junction box in order to contain any arc or spark, and to protect the splice from damage or contact with anything flammable. Whenever electrical wiring splices are exposed and not contained in a junction box, it is an indication of sub-standard workmanship, and I feel that an electrical contractor should check all the wiring alterations that were made for additional shortcuts or poor workmanship. The potential for serious damage, and loss of life, from fires due to faulty wiring is too great to take the chance with a lower standard. Also, all splices must be accessible so the junction box must be set so that it is accessible before the ceiling is patched in. Also, wiring is being used unsheathed and the grounds are not connected. **It scares me to see electrical work that has such a total disregard for minimum standards of care and makes me concerned about any wiring alterations that may have been covered and not visible for inspection.**

This is in the ceiling of the garage that is connected to unit E.

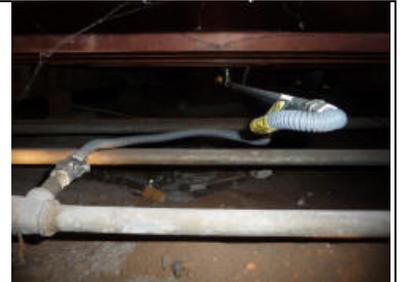
8.6

[SC] Using this type of connector in the crawl space is not allowed. This is to the new heater below unit A. The shut off valve and the flexible connector are required to be above the floor directly under the heater.

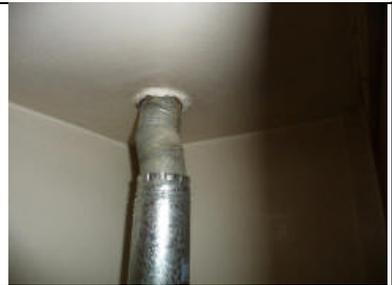
12.16 VENT:

[SC] The flue vent pipe sections were out of alignment, weak, or not properly connected, and this needs to be corrected.

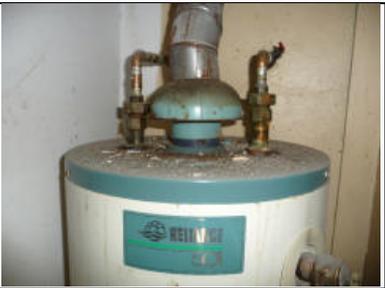
12.18 AGE:

<p>17 years old based on the date of manufacture. The average life of a water heater is 13 years, but I sometimes see them over 20.</p> <p>[CR] The water heater should be considered in the latter part of its life and any remaining life may be limited. You should budget for replacing it. Corrosion is noted to the tank which can be expected to start leaking at some point.</p>

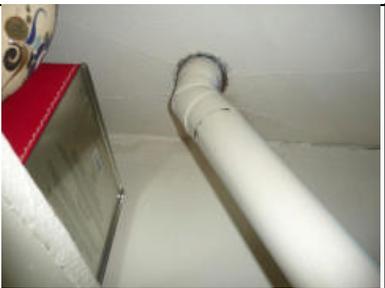
UNIT # E.**12.20 VENT:**

<p>[SC] The vent was too close to or in contact with combustible materials, and this condition can be a fire hazard that needs to be corrected. Six inches of clearance is required between a single-wall vent connector and any wood or other flammable material.</p> <p>There is a serious potential hazard whenever there is a shelf or storage next to, or close to, the vent that someone could place a flammable item on that could touch the vent. This is a fire risk. A shield or guard needs to be installed to make sure that nothing on the storage shelf could come in contact with the vent. Sheet metal is generally recommended for the shield.</p> <p>[SC] This same arrangement is noted in Units E through I. I didn't see any need to repeat the note for each one. Adding a sheet metal end cap on the upper shelf for each of these units should take care of this issue.</p>

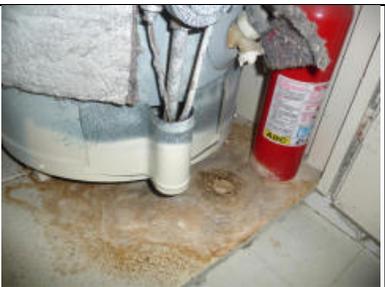
12.21 TANK:

<p>There was rust or corrosion noted on or inside the water heater tank that gives me the impression it is relatively old, but no leaking is noted. You should budget for replacing the water heater.</p> <p>[CR] The drain valve leaks or drops and needs to be replaced. Considering the age of the water heater, you may want to consider replacing it completely.</p>

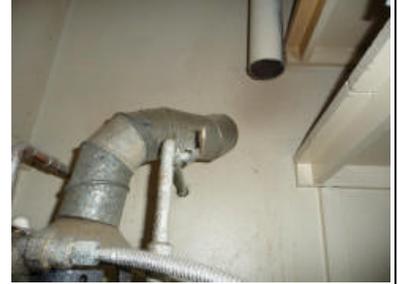
[SC] This vent should be ran vertically up as much as possible before the diagonal section is used.

[SC] All the vents need to be securred and strapped better so that they do not come apart. This can be a very serious issue and needs to be taken seriously.

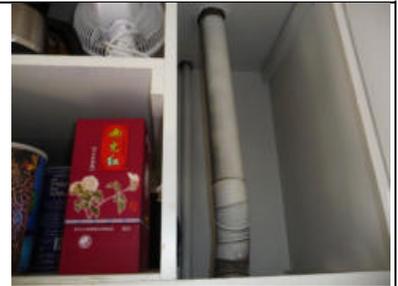
12.51 VENT:

[SC] The flue vent pipe sections were weak, or not properly connected, and this needs to be corrected.

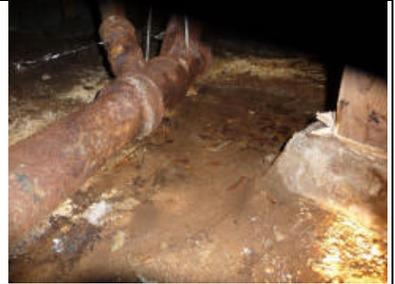
13.3

The soil is saturated under this entire area and for quite a ways out.

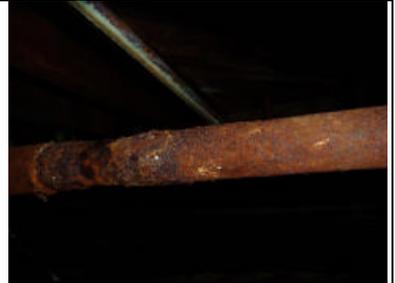
[SC] There is a gas line under this area that is badly rusted and needs further evaluation by a plumbing contractor. This gas line is a couple feet from the toilet so I am not sure how it got rusted. Possibly from leaking below the water heater.

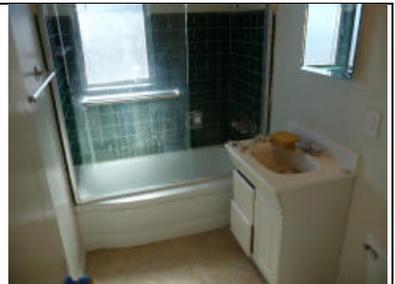
13.8 TUB:

The tub is steel with a porcelain finish.
[CR] There are chips noted in the porcelain finish that need to be professionally patched to prevent rust. I see so many failures in patches in steel tubs that I highly recommend that they be done by a professional who will guarantee the work and can match the color.
[NOTE] A caution you against being talked into refinishing these tubs with a white finish. New finishes seem to inevitable fail and peel at some point and then the original colors will come through. You are luck to get 5 good years from a tub refinish.

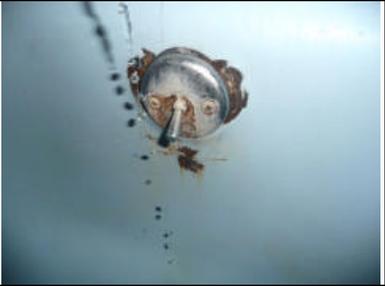
13.44 TUB:

[CR] Chips and rust are noted around the drain.

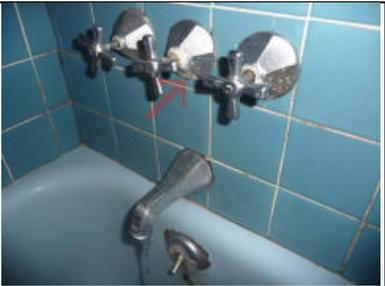
13.45 TUB/SHOWER FIXTURES:

[CR] The faucet is in poor condition and I recommend that it be replaced.

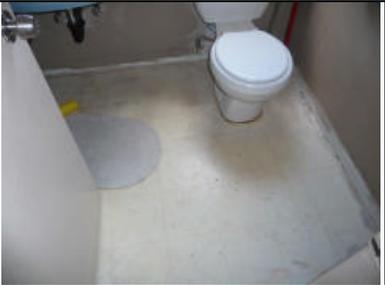
13.47 FLOOR:

[CR] Flooring needs to be replaced. Staining around the toilet could indicate a leak around the toilet.

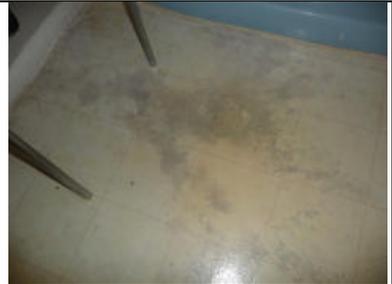
13.52 FLOOR:

[CR] [FE] The vinyl flooring was stained on the underside close to the tub. This is often caused by water being trapped below the vinyl surface, and could be caused by water leaking under the vinyl at the edge of the tub. Unfortunately it is just as likely that it could be due to a leak in the plumbing below this slab. See note in plumbing section. I recommend that a plumbing contractor that specializes in leak detection do further evaluation. I strongly suspect a leak under the slab.

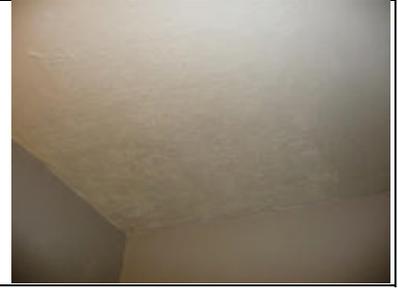
13.53 WALLS/CEILING:

The ceiling has been patched above this tub.

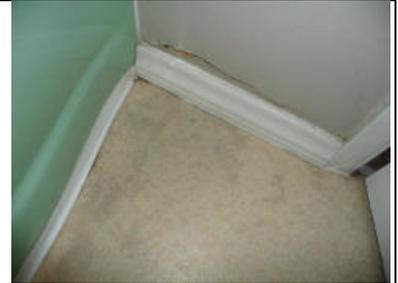
The baseboard outside the tub is saturated and the floor is stained. Most likely this is due to water getting around the curtain.

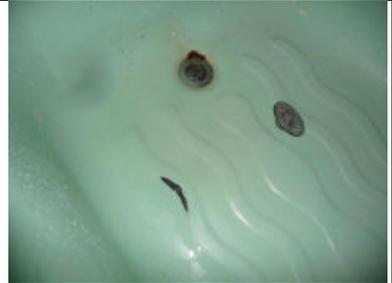
13.72 TUB:

[CR] Rust is noted at one or more chips and it will be critical that the rust be removed before it is patched. The patch will fail if the rust is covered.

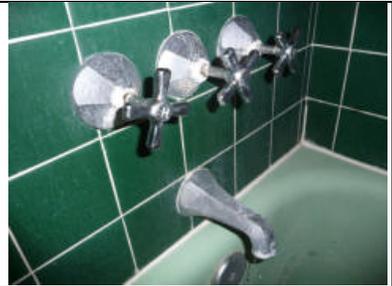
13.73 TUB/SHOWER FIXTURES:

[CR] The faucet leaked out of the handles, stem, or base plate when operated, and needs to be repaired or replaced.

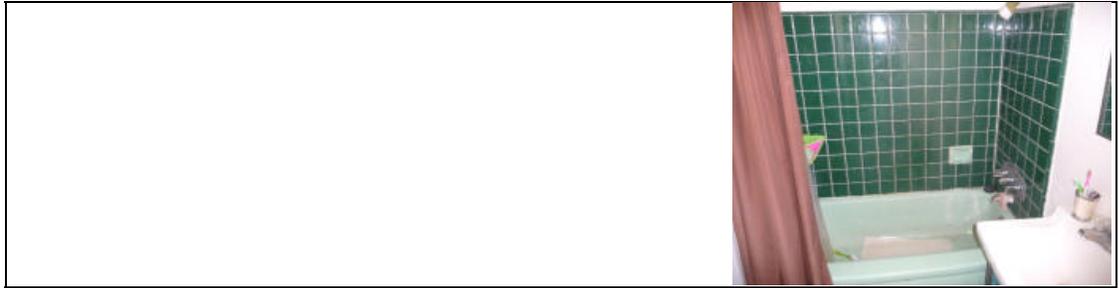
13.79 TUB:

[CR] The tub drained very slow. The trap may need to be cleaned or there could be a blockage farther down the drain line. Request that it be clean and free flowing when you move in. Whenever the drain lines are older cast iron, there is always a possibility that this can be an indication of more serious problems which can be expensive to repair. See the note about cast iron in the Plumbing section.

[CR] The tenant was understandably concerned about the slow draining tub and said attempts to solve it have not been successful. Its a safe bet the drain line needs to be replaced.

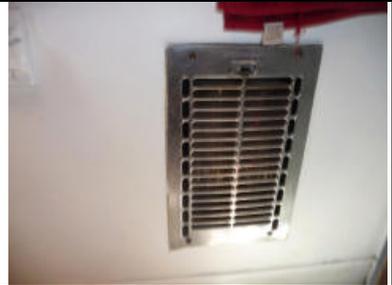
13.98 HEAT:

[SC] Electric wall heaters get very hot and pose a safety hazard. I recommend extreme caution be used with these heating systems. Never set anything in front of the heater and never install a towel bar above one of these heaters. These would be substantial fire risks. [SC] A towel bar was mounted above the wall heater, this condition is a safety hazard that could cause a fire. The towel bar must be removed.

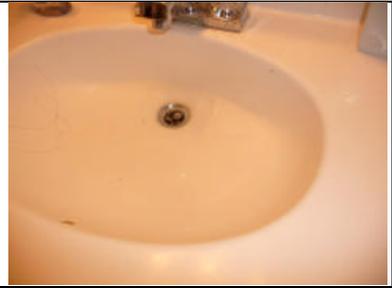
13.100 SINK:

[CR] The sink drain was slow and needs to be cleaned. You should request that the sellers clean it so you can recheck the drainage. Occasionally just cleaning will not be enough. This can be a sign that older cast iron drain lines are approaching the end of there life.

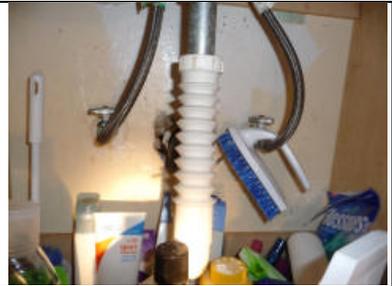
13.101 UNDER SINK:

[CR] Corrugated plastic is being used as drain piping, this material is considered weak and is not approved for this application even though it is readily available at supply stores.

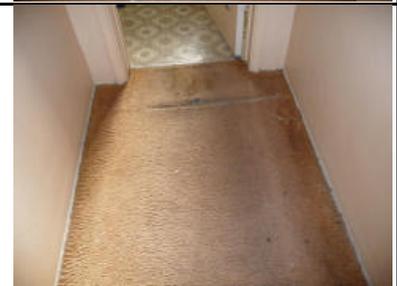
14.17 FLOOR:

[CR] The carpet was frayed or very worn - probably the worst of any unit.

The carpet is torn or frayed in several places.

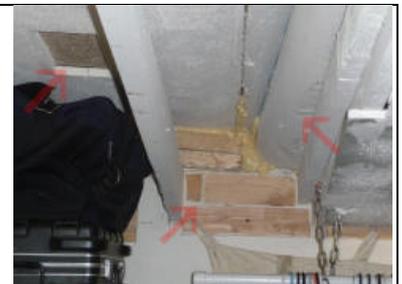
14.47 COMMENTS:

[FE] [CR] The outside patio appears to have been incorporated into this unit. The workmanship is very poor. I am sure it is not permitted. This room will get very hot and was hot on this day that was mild outside. I suspect that much of the heat is coming out of the attic vents that are now inside this room. An attic can get over 120 degrees on a hot day and this heat will come down into the room. Also, the attic needs this ventilation and these vents need to be on the outside of the building. There could be other reasons that the room was so warm such as the lack of a wall or ceiling cavity in areas around the edge. Also there is no ventilation for the joist spaces above the ceiling. The left arrow shows the attic vents. The middle arrow shows the crude blocking used to seal the room from the outside. The right arrow shows where there is only a single layer of roofing material separating the inside from the outside.

This space does not meet the requirements for interior living space and should be discounted or not included in the total square footage.

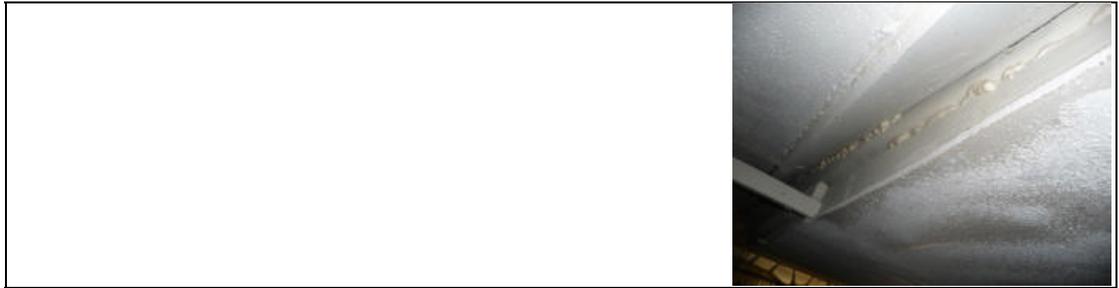
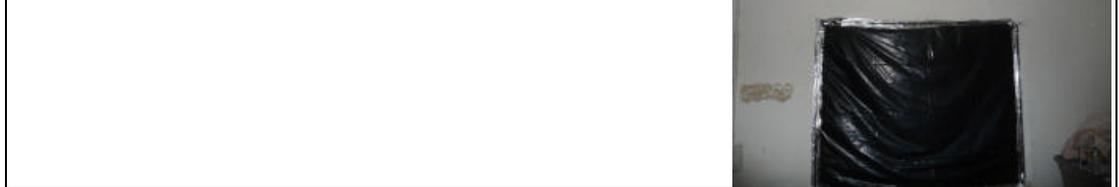
14.48

The windows between this room and the rest of the unit have been sealed off. This used to be the outside wall. See not in bathroom about lack of ventilation.

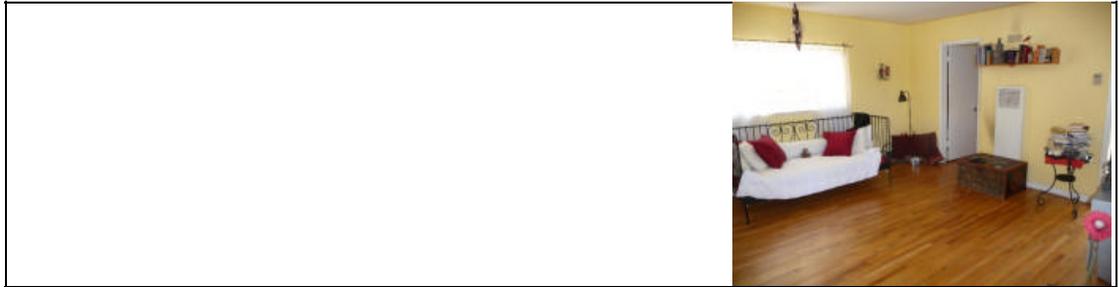
[CR] Repairs are needed. One back window opened but then wouldn't close.

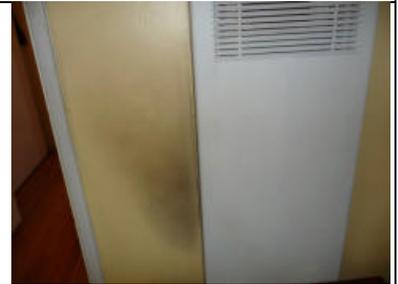
Burn marks on the floor in front of the heater. These can be difficult or impossible to sand out of the floor.

[FE] [SC] Apparently there has been a fire in front of this heater. A tenant told us that a piece of furniture caught on fire. Make sure the tenants understand that nothing can be placed in front of a wall heater. There are smoke stains on the wall to the side and above this heater and further evaluation is needed. The tenant believed there was a problem with the heater that caused the fire.

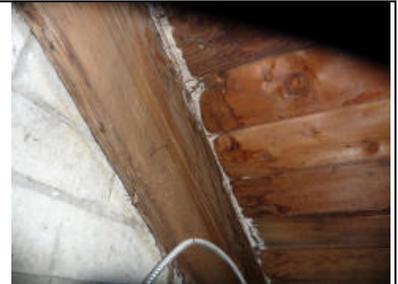
[SC] The area under the stairs had exposed wood framing where it has been accessed to create a closet or storage area. The stairwell is the primary fire escape from the second story, and when the area under any stairs is used for storage the walls and underside of the stairs requires 5/8 Type X drywall to slow down the spread of fire to the stairs to allow more time for escape. This needs to be corrected by sealing this space off or installing the drywall to meet the code.

[CR] [CR] Clearly both of the stairs leak and repairs are needed before this can be drywalled. See the deck notes.

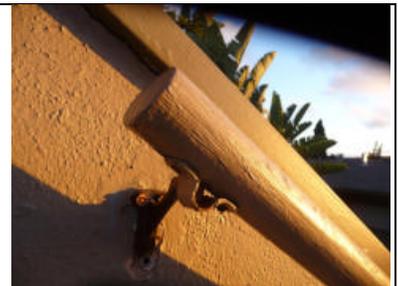
14.56 HANDRAILS:

[SC] The handrail is coming loose at the top bracket on the front stairs.

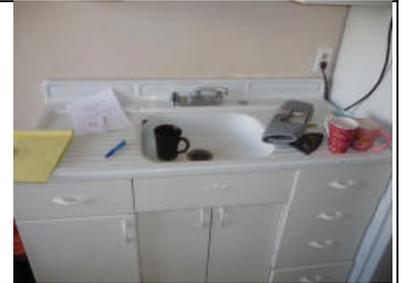
15.16 SINK:

Original steel sink, counter and cabinets. There are chip(s) in the sink enamel. The picture shows the original steel sink units that are still in most of the units. Except for the chip noted, this one is in good condition. Most of these units were in amazingly good condition for their age. They all had some chips in the enamel but for the most part the drawers worked and the units are functional.

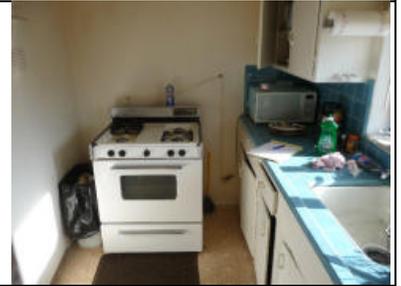
This is one of the older stoves.

[CR] One or more of the burners had a problem that needs maintenance, service, or repair. Back right burner,

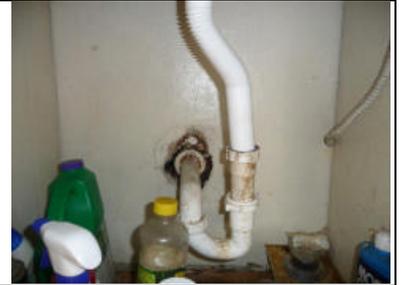
15.26 UNDER SINK:

[CR] Corrugated plastic is being used as drain piping, this material is considered weak and is not approved for this application even though it is readily available at supply stores.

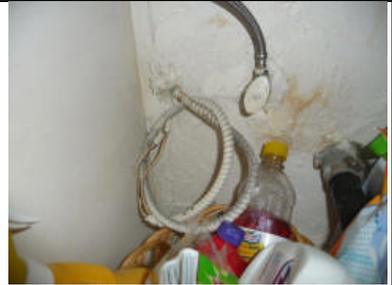
15.34 UNDER SINK:

[SC] Remove old wiring.

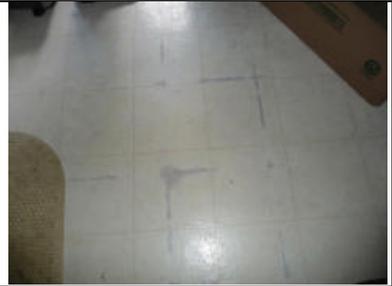
15.35 FLOOR:

[FE] [FE] There is staining on the kitchen floor that makes me suspicious that there is a leak under the slab. See the note in the plumbing section. The reason the staining is in this pattern is that there are square vinyl tiles under this vinyl sheet and the moisture comes up between the gaps in the vinyl tiles below.

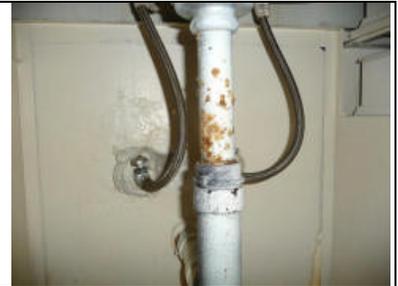
15.43 UNDER SINK:

There was some corrosion noted below the sink but no active leaking when I tested it. However, the corrosion will get worse and leaking can be expected at some point in the future. You should keep an eye on it and provide maintenance as needed.

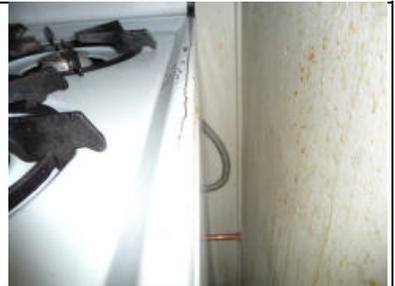
15.50 STOVE:

The cooktop/range burners functioned
This is an older stove with cracks in the sheet metal and damage to the finish.

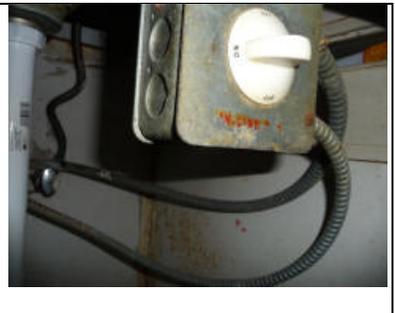
15.52 GARBAGE DISPOSAL:

[SC] Many of the units have electrical wiring under the sinks that would have been for garbage disposals that have been removed. I recommend that all of this wiring be inspected by an electrical contractor and removed as needed. The biggest risk is from the ends of wire that are very poorly protected. These loose wire ends have been removed in some of the units but not this one and several others. It would be best to remove the junction box with the switch entirely. It is old and should not be reused and is vulnerable to leaks.

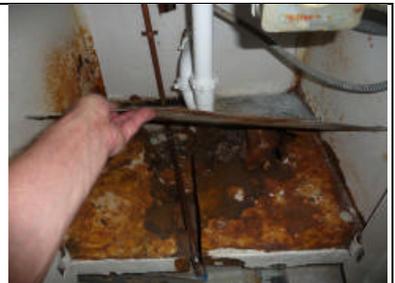
15.53 SINK:

Original steel sink, counter and cabinets.
[CR] There is a lot of rust and damage to the cabinet under the sink and chips to the sink and counter on top.
[NOTE] See plumbing section about water line that was replaced.

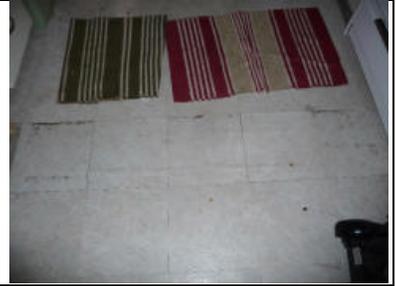
15.55 FLOOR:

[CR] The quality of the floor patch is poor and the concrete subfloor is very uneven. No flooring will go over this without problems. The high spots need to be ground off and the low areas need a leveling agent. See plumbing note about the quality of the plumbing installation.

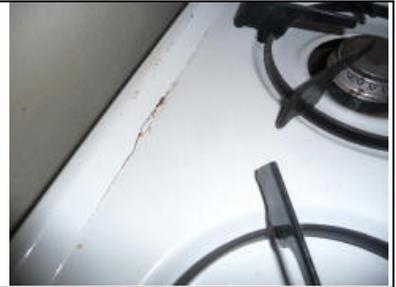
15.57 STOVE:

The cooktop/range burners functioned
[NOTE] The sheet metal is cracked.

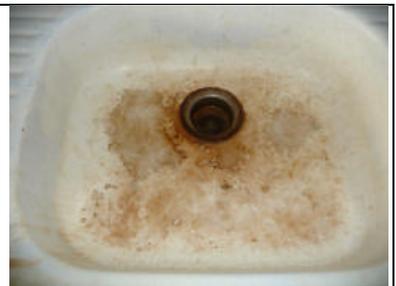
15.64 SINK:

Original steel sink, counter and cabinets.
The sink leans away from the wall due to the slope in the floor.
[CR] This sink is badly stained. It was refinished once but was not done professionally and is peeling.

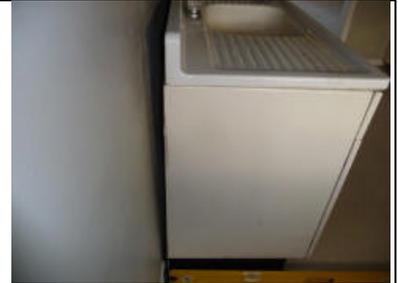
[FE] [FE] The floor in this kitchen slopes 3/4 of an inch in 3 feet. This was the most noticeable slope I saw in any of the units and further evaluation is recommended.

This shows how the cabinet leans away from the wall due to the slope in the floor.

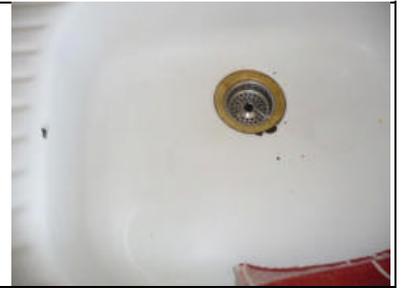
Original steel sink, counter and cabinets. There are chip(s) in the sink enamel.

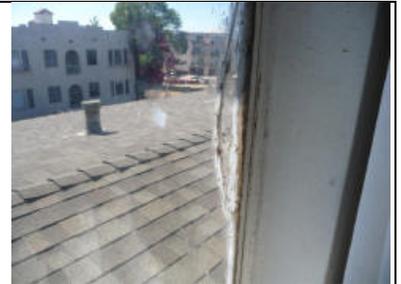
**15.83 WINDOWS:**

[CR] The glass is broken in one pane of glass and this window will not open. The other window has a one gap and wont close.
