All Pro Home Inspections

STANDARD RESIDENTIAL INSPECTION AGREEMENT

Client Name: History Buff
Inspection Address: 1234 Old Street
Oldville, CA 92100

INSPECTION REPORT	9
STRUCTURE, FOUNDATION, CRAWL SPACE	12
EXTERIOR	19
ATTIC AREAS & ROOF FRAMING	28
ELECTRICAL SYSTEMS	29
PLUMBING	34
HEATING SYSTEMS	37
GARAGE - CARPORT	38
LAUNDRY	38
WATER HEATERS	39
BATHROOMS	42
INTERIOR ROOMS	49
KITCHEN	54

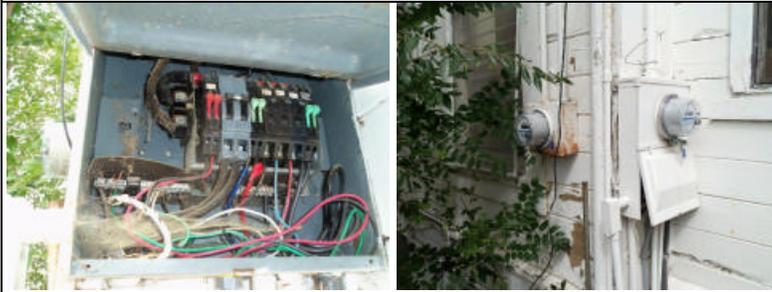
LOCATION:

Left side of the building, by the front corner.

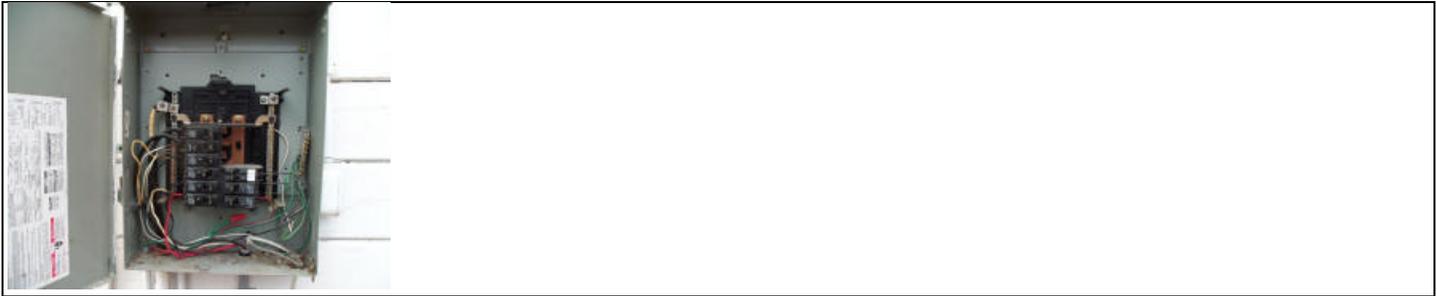
7.12 PANEL RATING:

80 Ampere; 120/240 volt system.

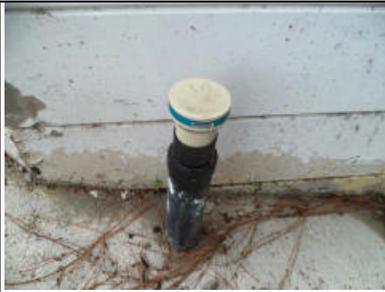
8.5 Plumbing Vents:

[CR] Someone stubbed out a plumbing vent behind the abandoned bath at the back of the house. The vent is required to go over the roof line. The cap is an air admittance valve and isn't ever approved for exterior use.

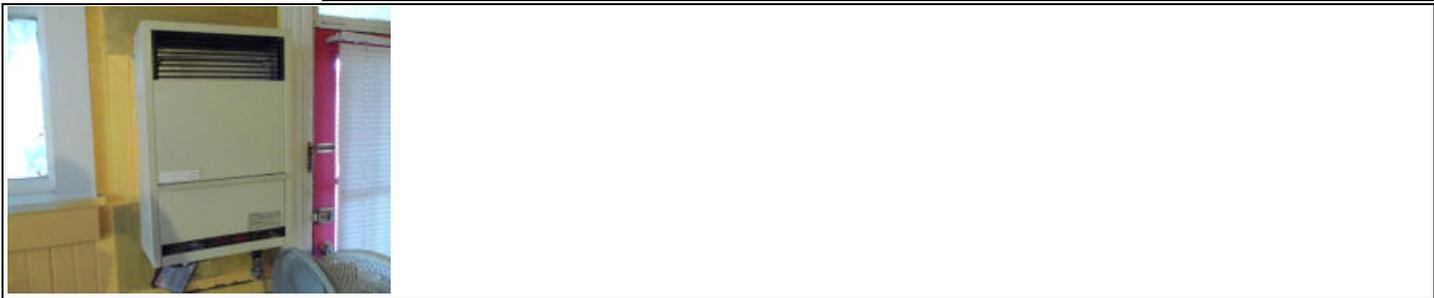
9.1 PICTURE

All the heaters are similar. This one is in the basement level.

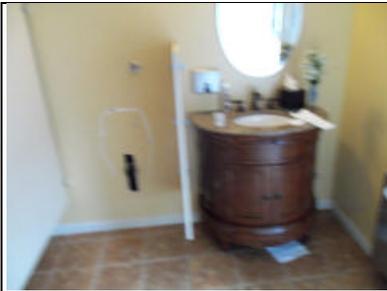
13.34 URINAL:

[CR] The urinal has been removed.

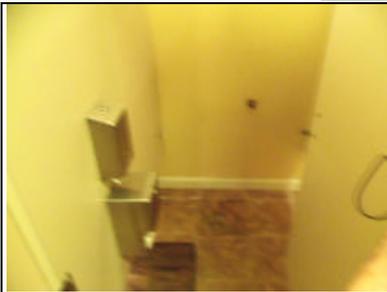
13.36

[ICR] One of the toilet stalls is empty and it looks like a toilet was removed.

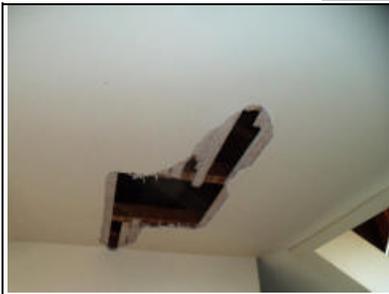
14.19 WALLS/CEILING:

[CR] Repair hole in ceiling. There are holes in the walls and ceilings throughout this house and added together will require substantial work to repair.

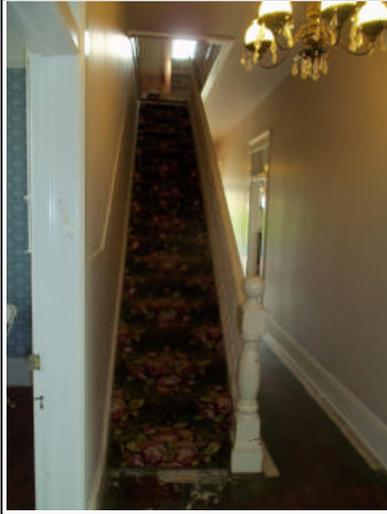
14.20 MAIN STAIRS PICTURE

The stairs are more narrow than we would have today but not unusual for a house of this age. The minimum width today is 36 inches and these are about 31 or 32. The stairs up to the top (attic) level are even narrower at between 27 to 28 inches.

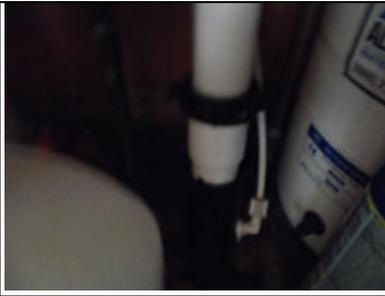
15.10 UNDER SINK:

[CR] There are fittings or parts below the sink that generally look old or corroded. Even when there is no actively leaking, they need to be considered close to the end of there life and should be checked and replaced if needed by a plumber. There is a broken, corroded, or loose mounting nut. The fittings generally are weak and there isn't a proper transition fitting between the PVC and the ABS drain at the base of the cabinet.

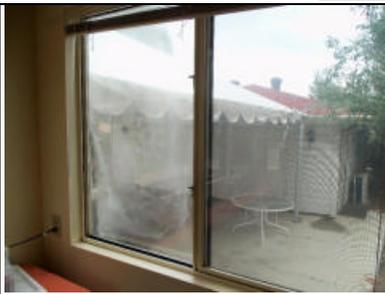
15.14 WINDOWS:

[CR] The window over the sink is painted in place and won't open.
[CR] The windows at the front are dual pane and one of the seals is bad and the window needs to be replaced. These can cost \$250 dollars or more to replace.
