All Pro Home Inspections

STANDARD RESIDENTIAL INSPECTION AGREEMENT

Client Name: Mark & Amy Dream
Inspection Address: 1234 Dreamer Street
Dreamville, CA 92100

Date: August 9, 2011
Time: 8:00 AM

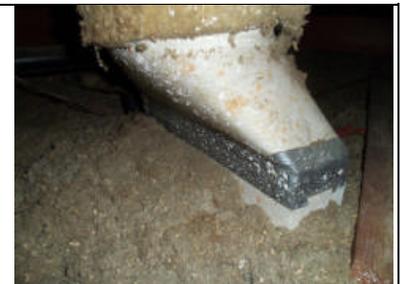
The thin grayish material on the sheet metal register casings most likely is asbestos. The asbestos material generally does not, and should not, come in contact with the air flow and when left alone should not cause problems. First picture. All the others are similar.

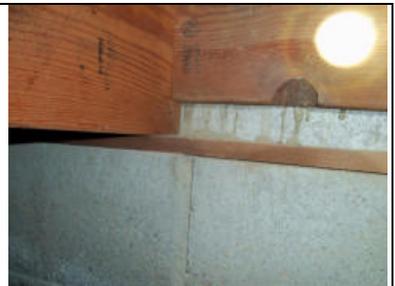
2.2 NOTICE:

[FE] One of the most unusual characteristics of this foundation is that the wood framing is below the soil level outside the foundation. A concrete block curb wall is used to separate the high soil level from the wood framing. I do not see any waterproofing on this curb wall and water is clearly leaking through it in some places. This goes against the basic principle that the soil level on the exterior should be 6 inches below the level of the wood framing. This is an issue from the right side of the house past the fireplace where the soil level rises up at the planter wall all the way around to the back side of the master bedroom to the back left corner of the master bedroom. On the good side, I was very surprised that there wasn't more damage to the wood. The area with the concrete patio all appears to be fine and water intrusion does not appear to be a problem. Much of the planter area outside the dining room to the living room has held up decently with the issues in this area detailed in the sections below starting with the one labeled Moisture. The same condition is noted in the entry courtyard in front of the kitchen which has generally done well with one exception also noted below. The section behind the master bedroom has had a lot of water getting onto the wood and this section has a lot of wood damage that will need to be repaired. See separate note on that section.

The first picture shows the basic structure where the floor joist sits on the block foundation with a smaller block at the joist level. In the first picture there is no evidence of water intrusion and much of the perimeter looks like this. The second picture shows the same structure from the side at a vent opening. The soil level on the outside is all the way up to the wood level at the top left of the picture and moisture intrusion is clearly visible. The wood is clearly getting wet but doesn't appear to be damaged. This condition is found in several large areas. The third picture shows the wood is getting wet and a root from a plant outside has come through. The fourth picture is fairly typical of moisture on the wood at the vents.

[FE] There is risk of rot to any of the wood that gets wet but I was surprised generally at how well most of the wood has held up and how little damage I could find. Determining the risk of future damage is very difficult. Clearly the less water that migrates through the less risk and reducing the water intrusion is definitely recommended. **It may not be cost effective to completely eliminate the moisture intrusion and judgment will be needed to balance the risk of future damage against the expense of reducing that risk.** Areas with damage to the framing lumber are discussed in later sections.

[FE] I recommend further evaluation of the system generally to see what can be done to minimize the risks of further water intrusion through the curb wall and onto the wood framing. This will take a combination of reducing

water saturation and improving drainage around these areas by lowering the soil level and grading away from the house towards a drain and using rain gutters and improving the waterproofing of the curb wall. The contractor I recommended should be able to evaluate all of these issues and he is welcome to call me if he would like to discuss them. See notes throughout the next sections of the report for further discussion.

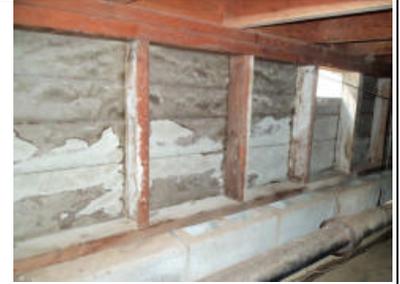
2.6 CRIPPLE WALLS:

The only section with a cripple wall is along the left wall of the house.

In this picture you can clearly see how deteriorated the building paper is. The purpose of the building paper is to keep water from migrating through the stucco onto the wood. The more moisture that gets onto the wood the more potential for rot or termite activity. The only places with damaged wood are noted a few sections latter in the report. Considering how deteriorated the building paper is, I was surprised how little deterioration there was to the wood. You can clearly see water staining on the wood but did not find any wood damage in any of this section.

This house has cripple walls, which are the short walls on top of the foundation that support the first floor. They lacked shear panel reinforcing. Shear panels are usually plywood panels specifically nailed to the cripple walls to resist lateral movement during seismic activity and are beneficial in helping to limit the amount of damage that may occur during an earthquake. Not having shear panel reinforcing was common for the age of construction on this house, but would be a serious weakness in the event of an earthquake. You should read "The Homeowners Guide To Earthquake Safety" provided by your agent or available at: http://www.seismic.ca.gov/pub/CSSC_2005-01_HOG.pdf for more information. Read the section "Weak Cripple Walls" starting on page 16 which describes the problem and provides a solution and additional resources. This is one of the more cost effective ways to improve your earthquake safety and you should consider adding shear panels as an upgrade for earthquake safety.

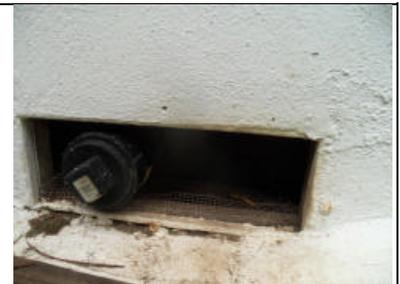
2.9 VENTILATION:

The first picture is at the back of the house and there are quite a few missing or damaged screens all around the

house. The second picture is at the front where there are two screens under the overhanging section that are completely missing and may be missed unless someone checks under the section that projects past the foundation to the right of the entry door.

[CR] Some of the ventilation screens around the exterior were torn, damaged, missing, or had a hole, and need to be repaired or replaced to keep out rodents or other animals. The screen material to use should be 1/4 inch galvanized steel. Someone needs to check closely for any holes into the crawl space all around the house, and repair holes as small as 1/2 inch either in the screens or any other locations. If you can put your finger through a hole, than a rodent can also squeeze through. If a rodent can find a way into the crawl space, they will find a way into the house.

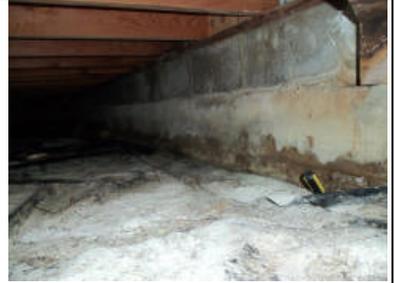
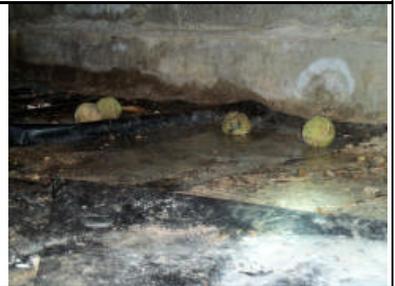
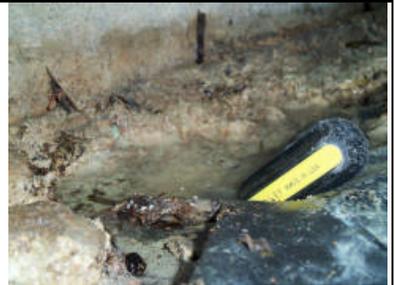
2.14 SHALLOW FOUNDATION

[NOTE] The foundation is very shallow. This will not only have an impact on the structural integrity of the foundation, but will allow water to migrate under the foundation and into the crawl space. I suspect that this is the primary weakness that is allowing a lot of water to enter the foundation. This is particularly a problem along the foundation close to the pool equipment. There is standing water in the crawl space all along this area and the foundation is very shallow. Note that the screwdriver in the pictures is pushed under the foundation where it is so shallow. Correcting these weaknesses in the foundation could be expensive. That is why improving the grading and drainage issues outside is so highly recommended.

[CR] The first picture is inside the crawl space next to the pool equipment. The white powder on the plastic in this picture is likely diatomaceous earth that is the medium inside the filter and is health hazard if it gets into the lungs and it needs to be cleaned up. Note in the picture that water is also running into the crawl space from the vent area in the picture.

The second picture shows the standing water currently sitting in this area.

The third picture shows how shallow the foundation is and how easy it is for water to percolate up under it from the exterior.

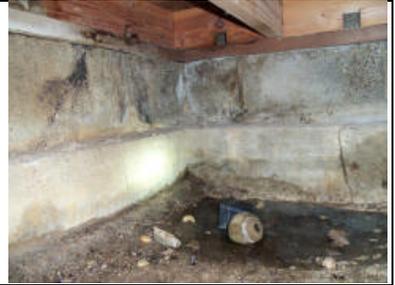
2.15 MOISTURE THROUGH WALL

This picture shows that water is migrating through the curb wall at the framing level. This is at the outside corner of the dining room.

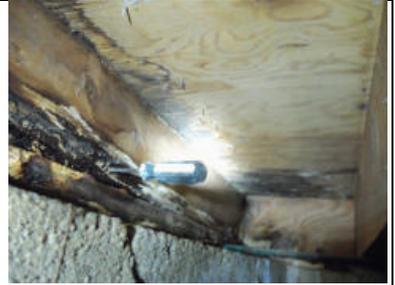
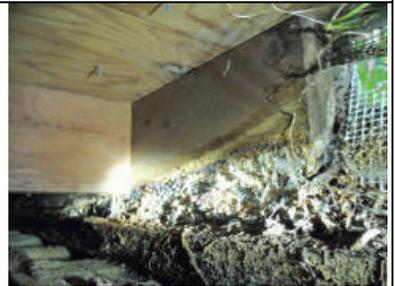
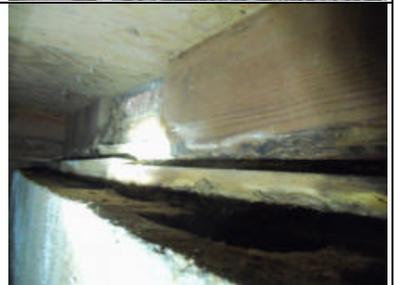
2.16 FRAMING:

[FE] [CR] When the soil level is too high on the exterior and the drainage is bad and water migrates onto the framing lumber at the edge of the house, deterioration and rot can be expected. The surprising thing was that with all the risks in some areas round this house that most of the framing lumber looks in good condition. There is one very substantial exception and that is at the back wall of the master bedroom in the area behind the spa equipment. This wood has a lot of deterioration and needs to be replaced. Also, the water intrusion needs to be stopped and the base way to do this is to lower the soil level and improve the drainage away from the house. See the termite report for any potential rot or termite activity. Under California law, they are responsible for any rot or termite activity or damage.

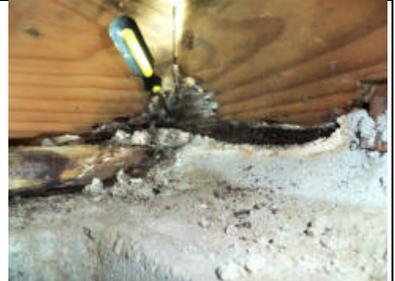
2.17

[CR] There is a small section of damaged wood at the front of the kitchen which would be at the back of the entry courtyard that has pants. The soil is just too high in this area and water is leaking onto the framing. The soil level and drainage clearly need to be improved in this area.

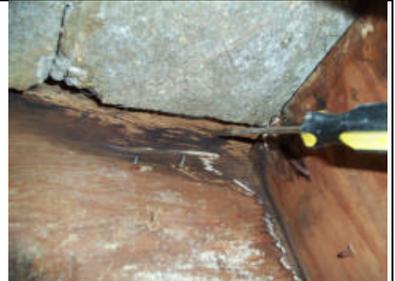
[CR] Another small section of damaged wood noted at the poll side of the master bedroom.

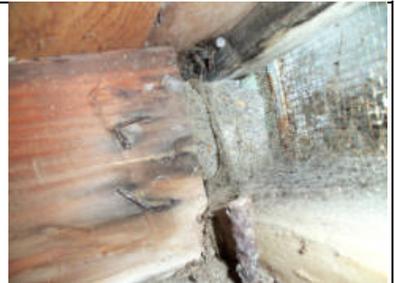
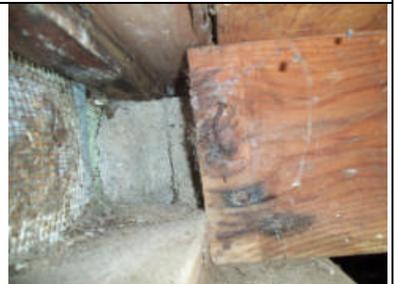
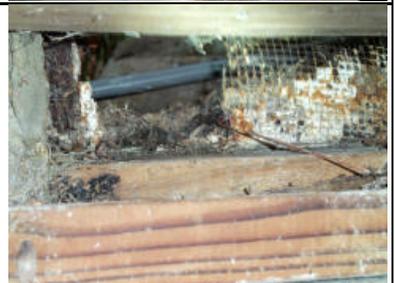
2.18 VENTS

[CR] The soil level outside the vents on the right and back sides of the house is too high and water and a little soil is getting in. This clearly increases the potential for rot. I was surprised to see that the wood in most of these areas was in good condition but the risk of rot increases with time. Lowering the soil level and improving the drainage is definitely recommended.

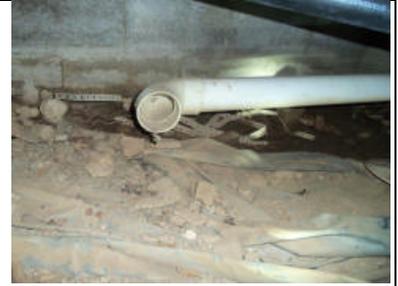
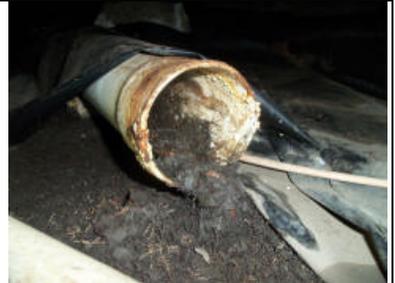
2.19 DRAINAGE

[CR] There is a drain line from the back corner of the patio that runs through the crawl space and out the front left side. A large section of that line has been removed and the water from the drain line just floods into the crawl space. This is one of the largest sources of water under the house and it is critical that the line be put back together. Unless there is an unforeseen complication, this should be relatively easy task.

The first picture show the unused lower section of the line. You can see on the foundation wall in the picture a high water mark. This entire area of the crawl space fills up with water when it rains hard. The second picture shows the other end of the pipe where the water comes out. Note the tree root running up into the pipe to get the water.

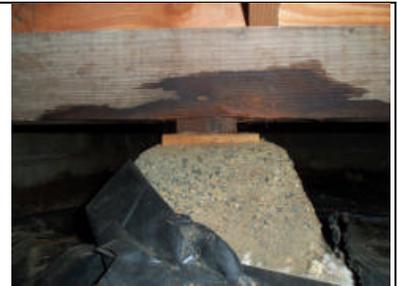
2.20 BEAMS:

This picture shows how the water from the soil migrates up through the concrete footing and the post onto the beam through capillary action. The beam not only looks wet, it was currently saturated. There were others with this issue but this was the best example. I did not see any significant damage to the wood in any of these but there is some risk of future damage if the water situation is not corrected.

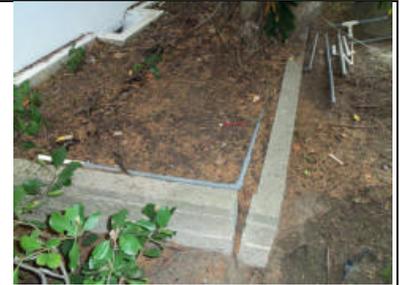
3.3 SOIL LEVEL

[CR] A raised planter enclosure adjacent to the foundation area and house has been added, which now raises the soil level outside the foundation. These planters are notorious for leaking through the back wall and into the framing cavity where they wet the wood and cause rot. I have seen substantial damage when walls have been opened up, and most efforts to waterproof the wall have high failure rates. The code does not allow a raised planter in front of a wood framed wall unless there is a two inch air space between the back of the planter wall and the house wall, and this planter does not meet that requirement. You should consider opening the wall to check for damage, and removing the planter or rebuilding it properly. An alternative is to lower the soil level six inches below the top of the foundation and leave the planter walls. This only works if water can not run off the roof and become trapped inside the planter.

This picture shows the planter area on the right side of the

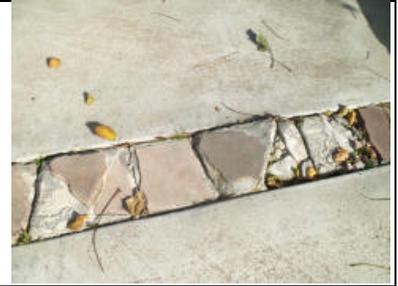
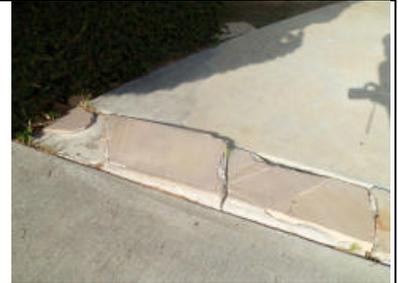
4.2 DRIVEWAY:

[CR] The slate bands in the driveway are in poor condition and need repair.

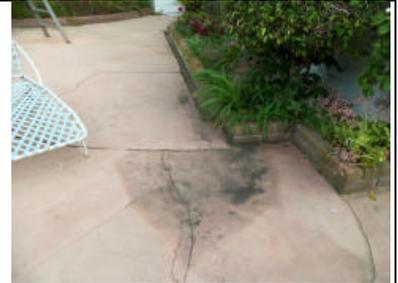
4.3 PATIO:

[Defect] The finish height of the patio is too high in relation to the wood framing that supports the outside wall. Standards specify that the finish elevation of any flatwork on the outside needs to be two inches below the level of any framing lumber or the floor level of the house to minimize the risks of moisture intrusion into the wood wall cavity and potential rot. It is hard to determine just how much risk this will create. It may not be cost effective to correct because the only solution will be to bust out the patio and lower it. It is difficult to predict how often this defect will manifest into a substantial problem. You need to decide whether you are willing to accept that risk or the expense of correction is worthwhile.

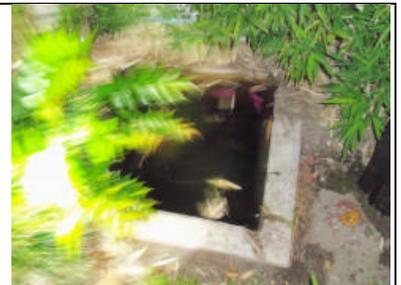
**4.7 POND:**

[FE] [CR] There is a small concrete basin in the planting area in front of the kitchen that is filled with water. I have no idea what this was intended for but recommend that it be removed.

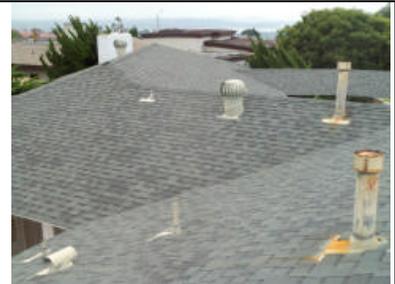
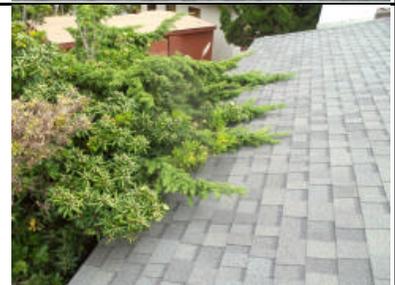
[CR] Trees or other plants need to be cut away from the roof as part of regular maintenance because they will often cause damage to the roof.

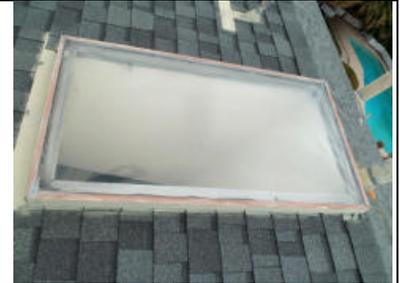
5.4 SKYLIGHTS:

[CR] The skylight over the master bedroom is coming apart at both upper corners and needs service and repair. If the corners can't be sealed and repaired, it may be necessary to replace the skylight. Also, the skylight is just sitting on the curb and not secured.

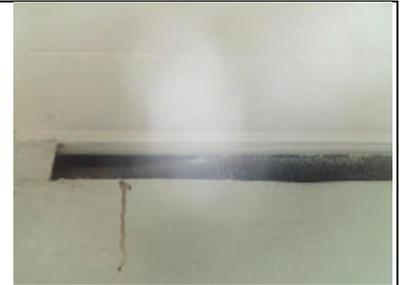
6.3 VENTILATION:

[CR] There were ventilation screens that were rusted out, damaged and/or missing and may allow insects, birds or animals to enter the attic space. 1/4 inch galvanized steel screen material should be used for repairs.

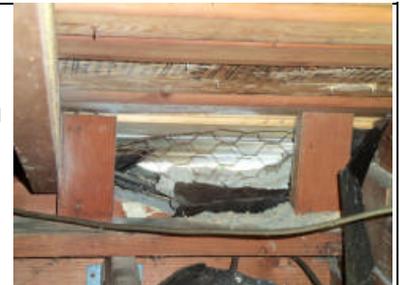
[FE] There is evidence of past or current rodent activity in the attic. The evidence is usually droppings, and often trails or tunnels in the insulation, and occasionally I may see a nest. I generally have no idea if there is current activity. You should consult a pest control specialist. I also recommend that someone make an effort to inspect the attic for small holes where a rodent can enter and seal or screen off any openings large enough to put a finger into. If rodents can get into the attic they can usually get into the house. Rodents often chew on electrical wiring and inspecting along the length of the wires is beyond the scope of my inspection, so I recommend that you have an electrician inspect all the vulnerable wiring.

The evidence of rodent activity can be old. This house used to have a cedar shake roof and it is almost impossible to

keep rats out of an attic with cedar shake roofs. The current roof is unlikely to let rodents enter but someone should still check for any small holes particularly around the edge or in any vent screens.

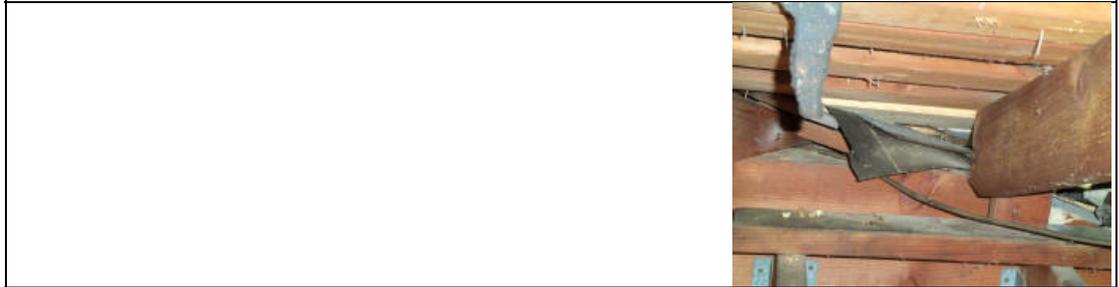
[CR] Besides the screens there are other holes that a rodent can enter and someone needs to check all the way around the eaves. The inside corner of the eave on the right side of the house has two large gaps up under the eave. Outside the laundry at the back of the garage is another area and someone needs to check more closely. The sheet metal in this area is over a large hole. It looks like something was removed but the hole remains and needs to be patched.

Both pictures show gaps at the inside corner on right side of house.

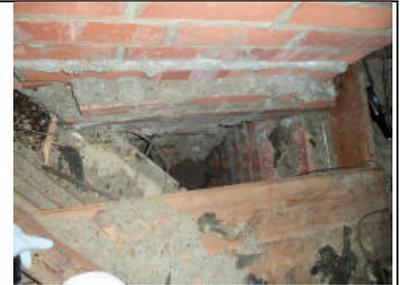
6.7 FIREPLACE FLUE:

[SC] The fireplace chimney was not properly fire stopped at the attic/ceiling location as required. The purpose of a fire stop is to restrict the supply of air to the space around the fireplace and flue. Without air a fire will not burn. You should not be any gaps or open space around the flue at the ceiling level, and there should be no way to look down into this space. Also, the space within two inches of the flue needs to be sheet metal or other approved non-flammable material. (A small gap up to 1/4 inch is allowed at the edge of the flue to the sheet metal.)

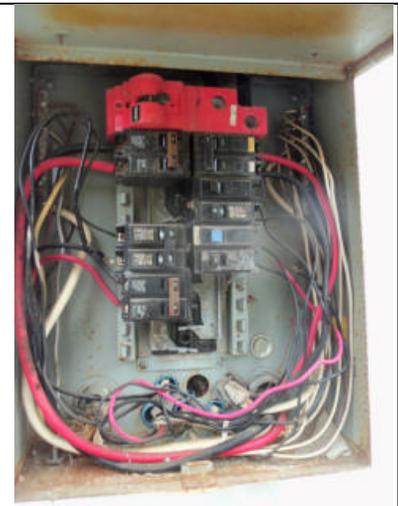
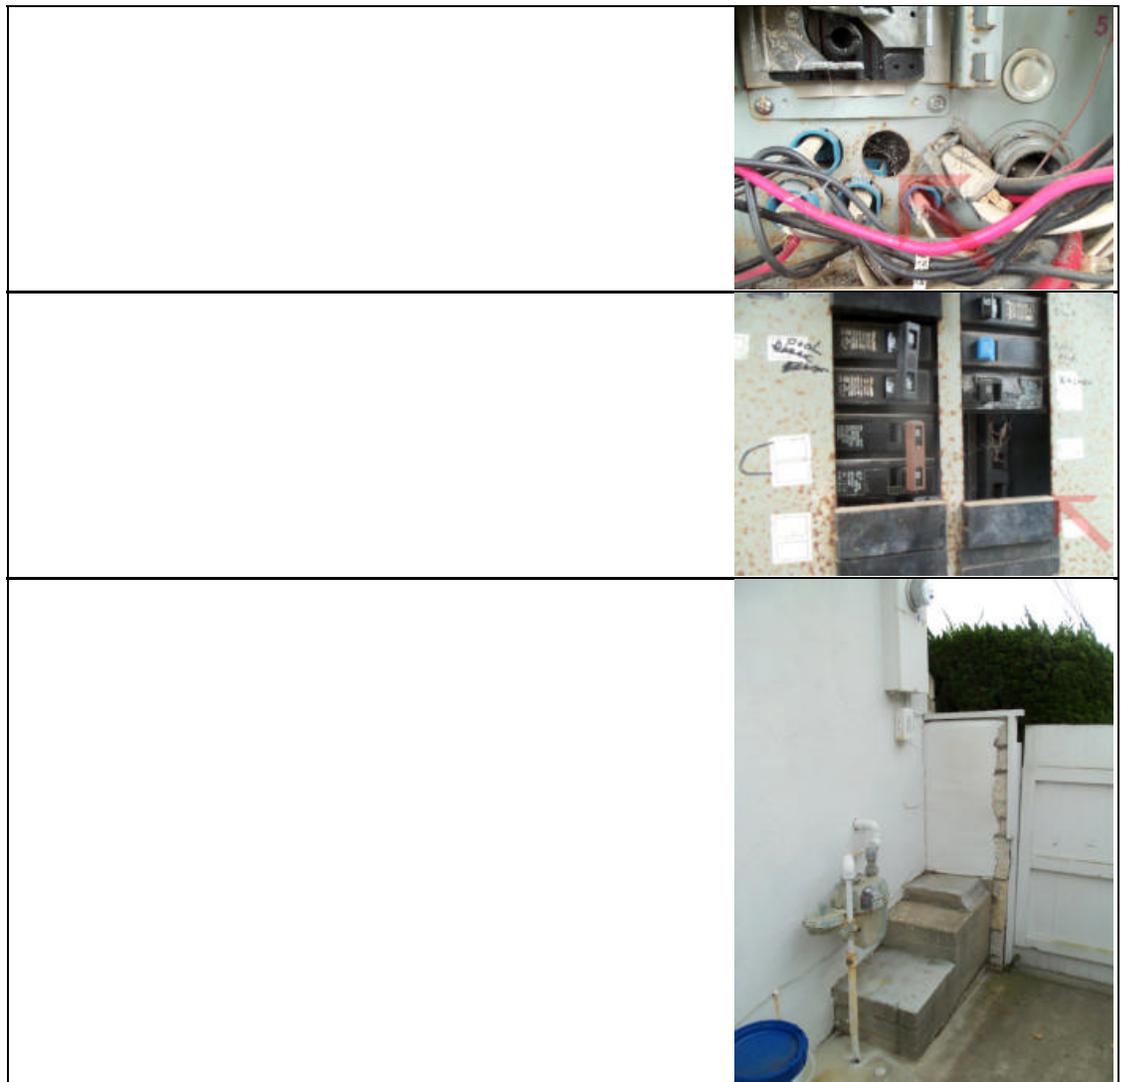
7.4 BREAKER PANEL:

The circuit breaker panel appeared to be professionally installed.
The main breaker and meter panel has been upgraded which is a very nice improvement for an older home and will give you the electrical capacity that modern homes need.
[SC] This panel lacks a clear flat working surface in front of the panel which could be a safety concern for someone working on the panel.
[CR] There were open knock-out holes and unused breaker slots in the panel that create gaps in the steel lining surrounding the breakers that should be filled in. There are standard plugs to fill in these gaps or holes that any electrician will have.

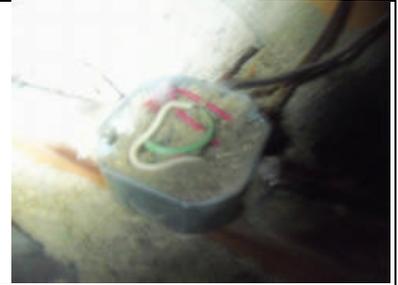
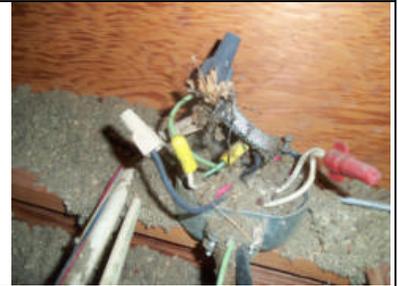
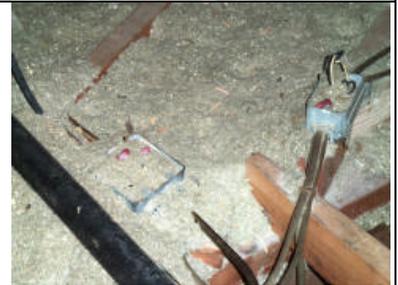
7.10 WIRING:

[SC] There were cover plates missing that need to be installed on junction boxes. The purpose of the box and cover is to contain any arc or spark, and protect the splice from physical damage and dirt. The electrician should check the wiring and make sure the box is clean before installing the cover plates. Cover plates were missing on many of the junction boxes in the attic.

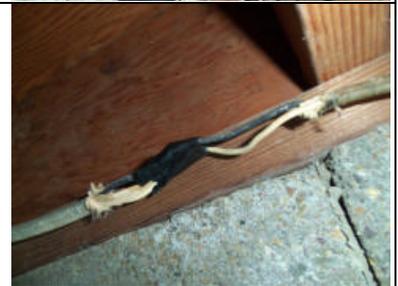
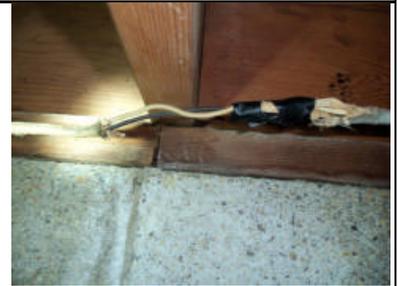
[SC] All splices in electrical wiring are required to be made inside of an enclosed junction box in order to contain any arc or spark, and to protect the splice from damage or contact with anything flammable. Whenever electrical wiring splices are exposed and not contained in a junction box, it is an indication of sub-standard workmanship, and I feel that an electrical contractor should check all the wiring alterations that were made for additional shortcuts or poor workmanship. The potential for serious damage, and loss of life, from fires due to faulty wiring is too great to take the chance with a lower standard.

There are two splices in the crawl space under the master bedroom on the pool side.

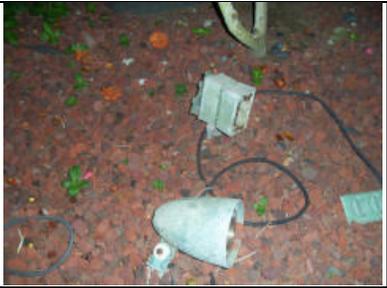
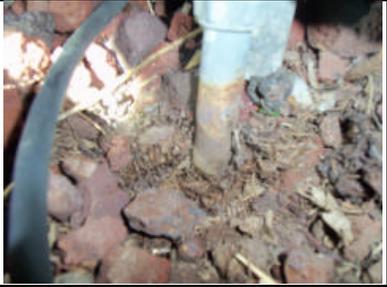
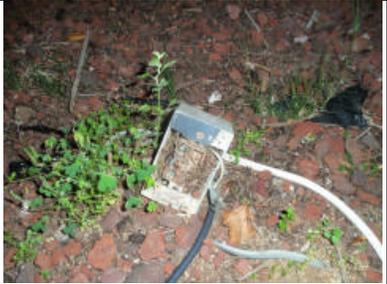
7.11

<p>[SC] Any and all of the old electrical wiring in the soil around the house is in bad condition and all needs to be removed.</p>

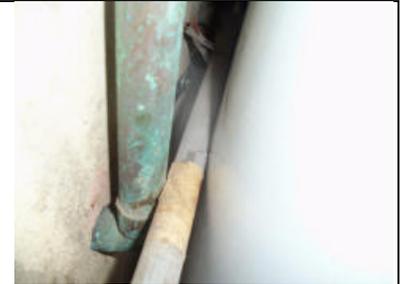
8.2 WATER LINES:

Copper water lines are noted where visible. This is the generally preferred system. But, unfortunately, copper is susceptible to corrosion and pin hole leaks can develop under certain circumstances. The copper water lines needs to be isolated from any contact with concrete or any cementitious product like stucco, and any steel products such as galvanized pipe, steel gas pipe, cast iron drain lines, steel straps, steel electrical conduits, or any sheet metal or other steel products. It is usually not possible for me to identify all points where the copper could be compromised by contact with these materials. Most of the time the solution is easy once you have found all the spots with contact. Wrapping the copper water line with electrical tape is one easy solution to keep the copper from contacting steel parts. (A wide plastic tape is made specifically for plumbers for this purpose.) Whenever you see the copper in contact with steel, you should use this simple solution. When there is any evidence of corrosion anywhere in the copper water system, a serious effort should be made to find and isolate the copper. The copper can also be attacked by certain aggressive soils, but unfortunately I have no way of testing the soil and this condition will usually go undetected. Fortunately, this soil condition is not a problem in most areas of San Diego County. The original galvanized water system has been replaced with copper and this is an important and valuable upgrade. (It is possible that there could be a little galvanized pipe remaining in a wall where I did not see it.)

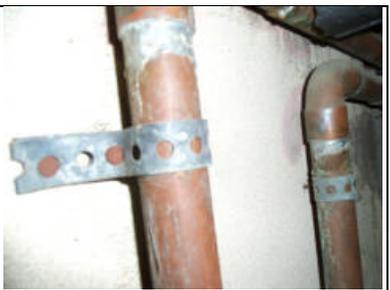
[CR] There are places where the copper water lines are in direct contact with steel and someone needs to inspect all the lines and isolate all points of contact. A plumbing tape, that is similar to electric tape but wider, is made specifically for this purpose. (Do not use duct tape.) I see a lot of leaks due to this problem and this task needs to be taken seriously but is generally ease to do. I can see the water lines touching steel products in the following locations: the steel gas line behind the water heater and the steel straps.

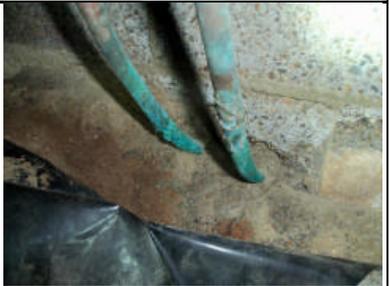
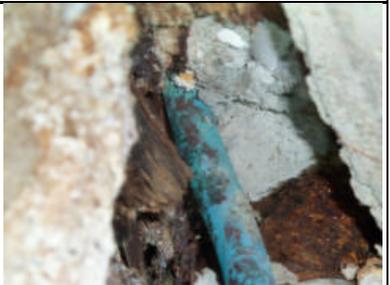
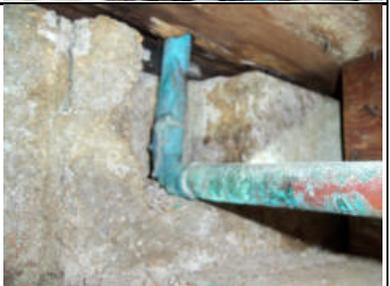
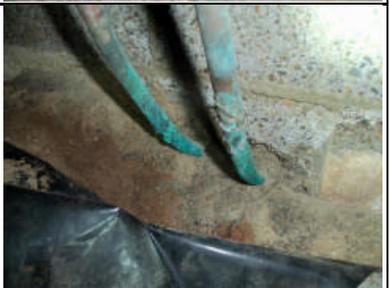
<p>[CR] I can see where there is concrete in contact with a copper water line and this will increase the potential for leaking. I can see corrosion on the copper line where it is in contact with the foundation from inside the crawl space.</p>

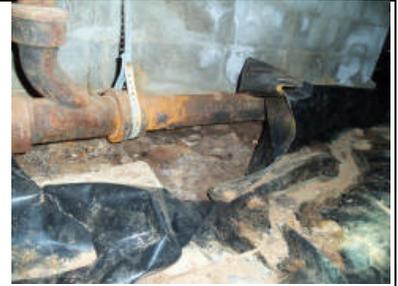
Read the handout on cast iron drain lines which is available on my web site at www.AllProHI.com. Parts of the drain line system have been replaced already but much of it still remains. Due to the age of the drain lines, any remaining cast iron needs to be considered at or near the end of its life expectancy, and you should budget for its replacement.

These pictures are representative of the general condition of the cast iron drain lines. Much of it is under the plastic and hidden and I couldn't inspect it. Where I pulled the plastic back, there was generally more rust and the plastic must trap the moisture and increase the rust.

[FE] I have no way of inspecting or evaluating any sections of the drain line below the soil level including the main line past the edge of the house in the yard. Consequently, you should seriously consider having these sections inspected further with a video camera so that you will have a better idea of their condition before you purchase the property. The cost of replacing the old line can vary greatly depending on how deep the line is and how difficult it is to get access for equipment to dig the trench. This work can do a lot of damage to any landscaping or hardscape. There are many plumbing companies that have the equipment to do this, however, I recommend Bill Hesketh of San Diego Pipe Inspection, (619-466-7374) because this is all he does. This is not a sideline for a plumbing business and since he does not do any repairs, he should be more objective. He is very experienced and charges about \$150.00 to \$200.00, which is substantially less than most prices I hear.

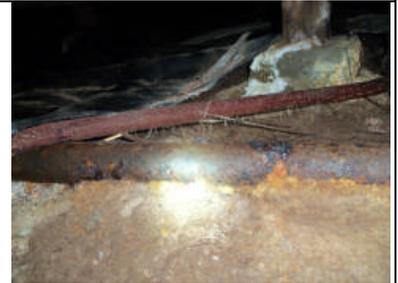
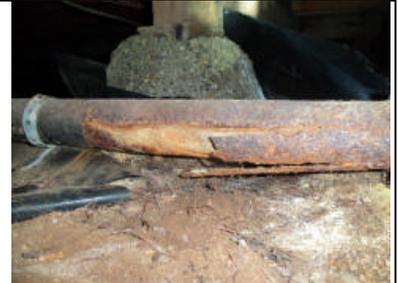
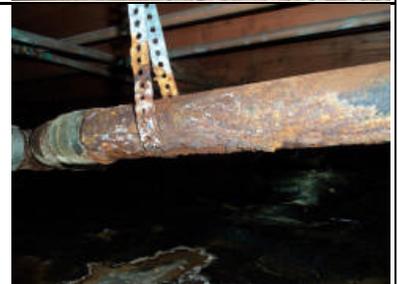
[CR] Some sections of the drain lines are rusted completely through and leaking and need to be replaced now. Someone will need to make a judgment to determine if it is better to replace all of drain lines and never need to worry about it again or just replace the sections that have currently rusted through.

Note the roof in the first picture. As roots grow larger under a house they can cause damage even uplifting and breaking a footing.

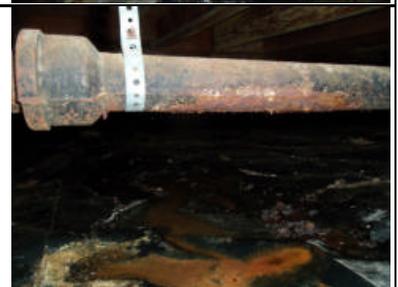
Note the water below this drain that leaked out of this rusted area.

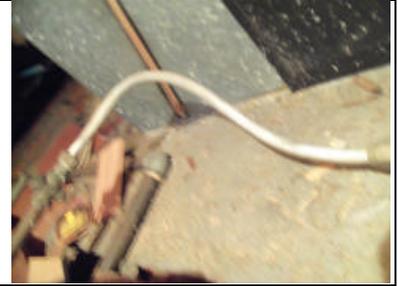
9.10 GAS SUPPLY:

[SC] The flexible gas connector was semi-rigid aluminum/brass tubing which is an old material that has been associated with problems and not approved for use any more. You should consider upgrading to an approved flexible gas connector.

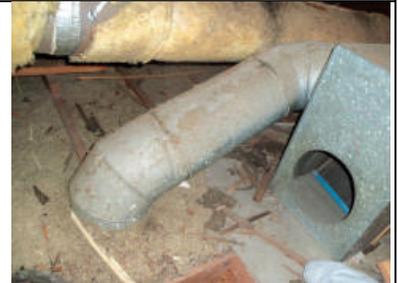
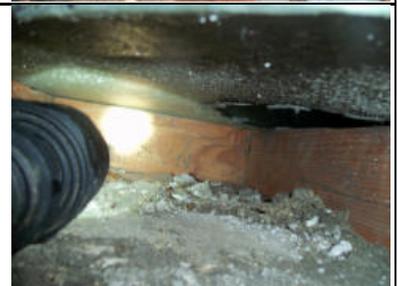
9.12 RETURN AIR:

..[FE] [CR] All of the return air is being drawn into the heater from the attic. I highly recommend that you talk to a heating contractor about this and have return air ducts added into the house. This will greatly reduce the efficiency of the system. This system had two return air ducts. One was completely removed and the air comes from the attic. The other was covered over and abandoned at the ceiling level in the master bedroom and is useless.

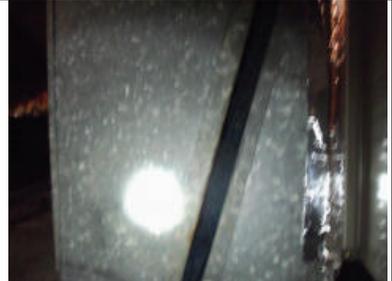
9.19 FILTER:

[CR] The filter is installed in the side of the return air plenum next to the heater. Where the filter slides into the plenum, there is a large slot that needs to be sealed to keep unconditioned air from being sucked into the heating system. It is not sealed. Generally there is a metal cap, but this is missing. Also, this can be a safety concern when the filter is close to the burner chamber because combustion gas (and possibly carbon monoxide) could be drawn into the air flow that circulates through the house.

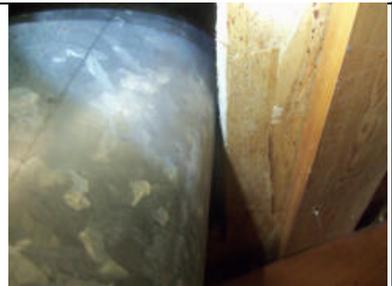
9.20 VENT:

[SC] The vent was too close to or in contact with combustibile materials, and this condition can be a fire hazard that needs to be corrected. The vent is too close at roof line. One inch clearance is required by code between the dual-wall vent and any wood or other flammable material. The vent is very close or even touching the wood and heat transfer is a clear risk.

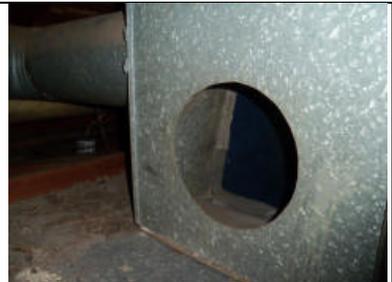
9.21 RETURN AIR:

..[FE] [CR] Most of the return air is being drawn into the heater from the attic. I highly recommend that you talk to a heating contractor about this arrangement and have return air ducts added into the house. This will greatly reduce the efficiency of the system. This system had two return air ducts like the other. One was completely removed and the air comes from the attic. The other is still intact but at least one seam at the ceiling line is open and needs to be sealed.

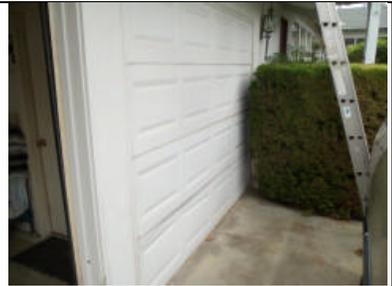
10.9 CONVERSION:

[Defect] [FE] The right side of the garage has been converted into the laundry room and this was probably done without a permit. Most garage conversions have certain weaknesses that you need to be aware of. A weakness very common to garage conversions is the possibility of water migrating up through the slab. A water barrier is required under a house slab, but not a garage, and ground moisture can migrate through the concrete. You may find some efflorescence or salt crystals that are left behind as the moisture evaporates. I can see evidence of moisture intrusion.

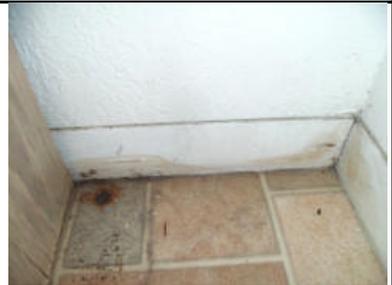
Another common problem is water leaking in at the base of the wall that was installed in front of the garage door. This wall sits directly on the original garage slab and the slab projects past the edge of the outside wall. Water running down the wall hits the slab and it is difficult to seal the base of the old door that is still in place, particularly long term, from water that wants to leak between the slab and the wall. I often see leaks on the floor along the outside wall. However, the water doesn't need to leak all the way in to cause problems. Moisture in the base of the siding or framing will increase the potential for mold, rot or termite activity. I can see evidence of this type of moisture intrusion. Besides the base of the old car door panel, water could leak in at the seam in the door panel. This is likely because the bottom door panel has been damaged and the seam no longer matches up.

The first picture shows the garage door that is still in place with the damaged bottom panel. the second picture shows water staining on the inside at the base of the wall.

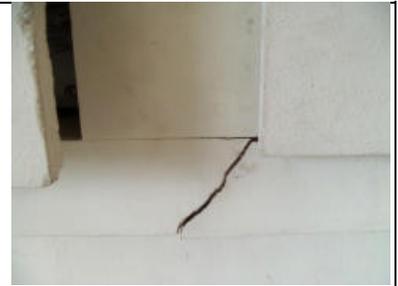
10.10 CABINETS:

[CR] The bottom rail of the cabinets is split in about the middle at the back of garage and needs repair.

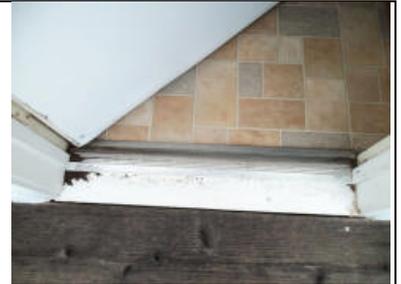
11.7 DOORS:

[FE] [CR] The door does not have a properly installed sill and this will increase the potential for water leaking onto the framing at the base of the door and this will increase the potential for rot in the framing or subfloor at the base of the door. Have a specialty door installation contractor evaluate the door sill further and correct as needed. The sill needs to slope to the outside to provide a path for water that flows down the face of the door. Anything less than a distinct slope from the outside face to the door to the outside edge of the wall below the sill is only asking for trouble. The door sill needs to be replaced. There is evidence of leaking. See the termite report for any potential rot or termite activity. Under California law, they are responsible for any rot or termite activity or damage.

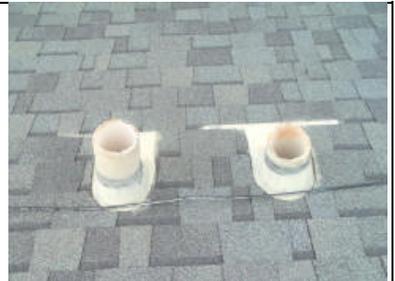
12.9 VENT:

[SC] The vent cap is missing on top end of the vent and it needs to be replaced to keep rain and debris out of the vent.
[RU] Recommended Upgrade: The original transite (cement-asbestos) vent is still being used to vent the water heater. The specifications for many new water heaters do not allow the use of the old transite vent because it increases the chance of the flue gas condensing and dripping back onto the water heater and causing corrosion. The flue gas in a new water heater is cooler than the older styles and is more likely to condense. To reduce this risk, I recommend installing a new dual-wall sheet metal vent when a new water heater is installed.
[SC] The vent was too close to or in contact with combustible materials, and this condition can be a fire

hazard that needs to be corrected. One inch clearance is required by code between the dual-wall vent and any wood or other flammable material. The vent is too close at roof line. The vent is very close or even touching the wood and heat transfer is a clear risk.

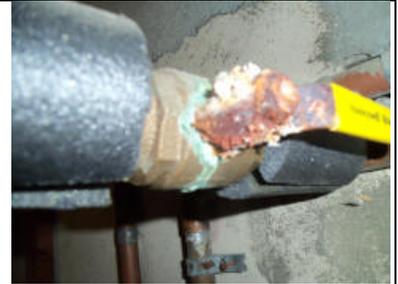
12.10 WATER LINES:

[CR] There was substantial corrosion noted to the shutoff valve above the tank. This corrosion can be expected to get worse, and could start to leak at any time. You should have a plumber check it and replace as needed.

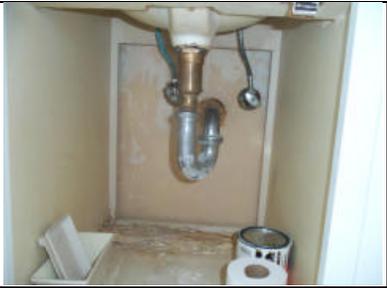
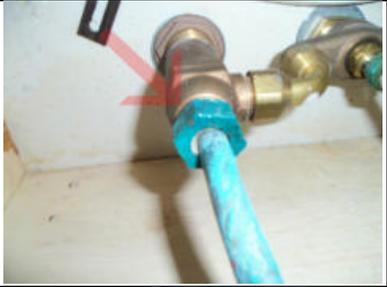
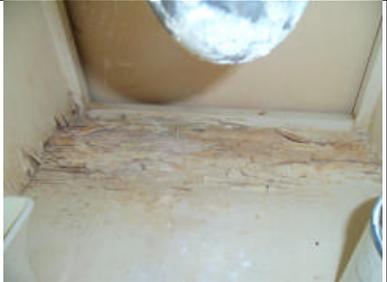
13.8 UNDER SINK:

<p>[CR] There is a small leak at the top of the hose to the hot side of the faucet. and there is water damage to the base of the cabinet below.</p>

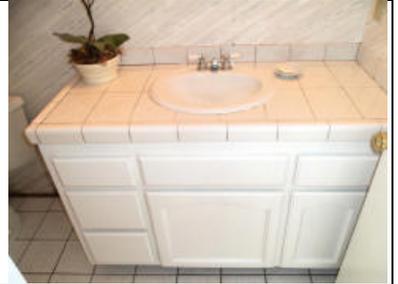
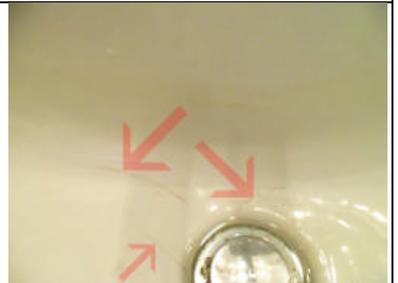
13.15 SINK:

[CR] There is a crack noted in the porcelain sink. This will weaken the sink and make failure more likely in the future and consideration should be given to replacing it at this time. However, it does not appear to have failed at this time. Two small cracks are noted in the base behind the drain.

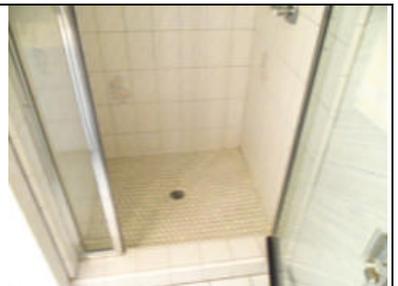
13.20 SHOWER:

The shower has a tile floor and walls. It is outside the scope of this inspection to water test the shower pan or determine the integrity of the shower pan or lining below the tile. The tile grout is porous and this shower pan is what waterproofs the shower floor. Unfortunately, it is not visible for inspection, and leaks can go undetected. The shower generally appeared serviceable. A cracked tile is noted at the back left corner but the chance of this effecting the shower pan is remote. A chipped tile is also noted which is a cosmetic concern.

[CR] The drain grate was loose. The threads for the screws appear to be messed up and this could make correction difficult.

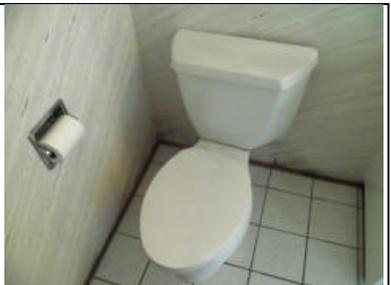
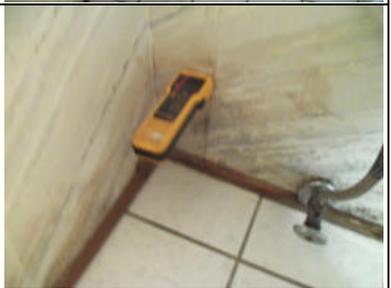
13.23 COMMENTS:

[FE] [CR] There is staining and discoloration on the wall around the toilet. With my moisture meter, I can confirm that there is excess moisture in the wall material. The wall material will need to be removed to allow the interior wall to dry and evaluate the source of the leak. The leak will need to be repaired. See the Mold Statement in the Introductory Notes section at the beginning of this report for additional important information.

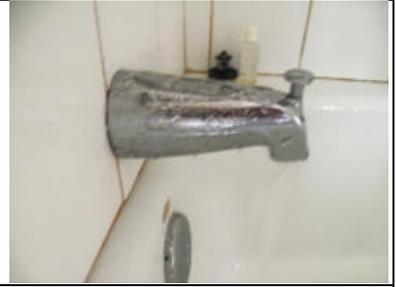
13.34 TUB/SHOWER FIXTURES:

[CR] The shower diverter operated poorly and needs to be repaired or replaced. Water continued to flow out of the tub spout in shower mode and the tub spout should be replaced to conserve water. (Be sure to check for and remove any set screw before taking off the tub spout if you try this repair yourself. Only some have a set screw at the base next to the tile wall.)

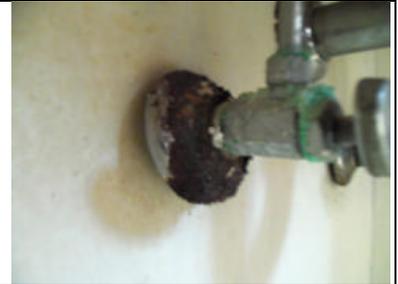
13.43 UNDER SINK:

There were no active leaks noted in the drain or trap. There was some corrosion noted below the sink but no active leaking when I tested it. However, the corrosion will get worse and leaking can be expected at some point in the future. You should keep an eye on it and provide maintenance as needed.

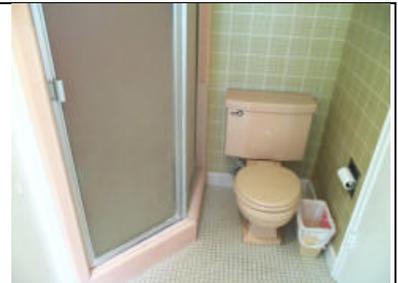
13.46 SHOWER:

[CR] [CR] The shower pan leaks and it needs to be replaced. The shower pan is a waterproof lining under the tile floor and up the base of the shower walls. Replacing the lining is a substantial task because the tile needs to be removed and replaced. Sometimes contractors will replace only the floor and bottom rows of wall tiles to save money. I too often see leaks at the cold joint where the new and old tile meet when this is done, consequently I feel it is more prudent to replace all the tile up the shower walls at the same time.

The shower pan was replaced once already but I can tell the new one leaks because there are water stains on the new plywood that was installed at the same time as the shower pan. The leaking appears to be small but unfortunately replacing the shower pan is the only solution that I am aware of. The leaking is visible from the crawl space below the shower.

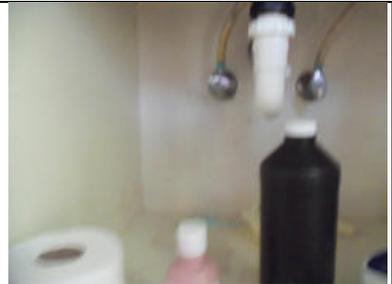
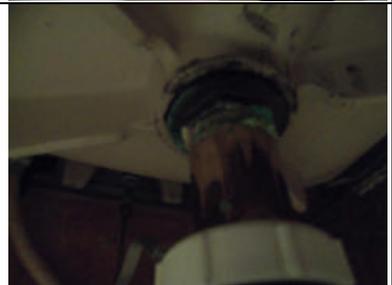
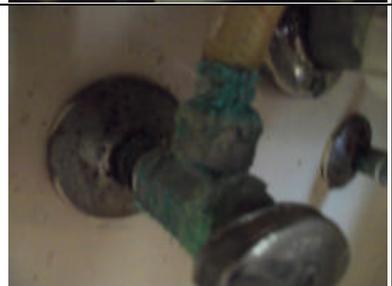
13.55 UNDER SINK:

There were no active leaks noted in the drain or trap. There was some corrosion noted below the sink but no active leaking when I tested it. However, the corrosion will get worse and leaking can be expected at some point in the future. You should keep an eye on it and provide maintenance as needed.

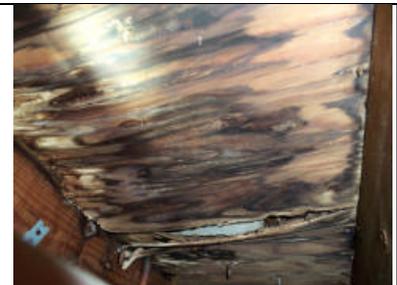
13.58 SHOWER:

[CR] [CR] The shower pan leaks and it needs to be replaced. The shower pan is a waterproof lining under the tile floor and up the base of the shower walls. Replacing the lining is a substantial task because the tile needs to be removed and replaced. Sometimes contractors will replace only the floor and bottom rows of wall tiles to save money. I too often see leaks at the cold joint where the new and old tile meet when this is done, consequently I feel it is more prudent to replace all the tile up the shower walls at the same time.

These pictures are under the shower. It looks like the shower was installed without a shower pan or any waterproof lining at all. Make sure the contractor confirms these pictures are for this bath before busting it out. This is a huge crawl space and it very unlikely but not impossible that this could be for a different shower.

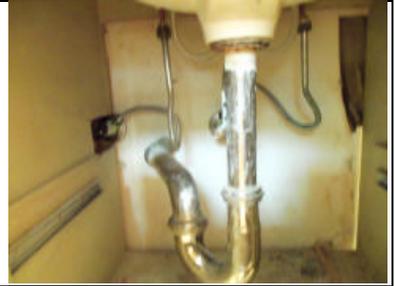
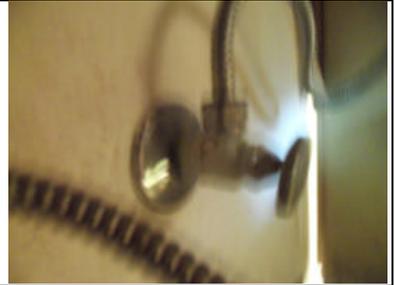
13.67 UNDER SINK:

There were no active leaks noted in the drain or trap. There was some corrosion noted below the sink but no active leaking when I tested it. However, the corrosion will get worse and leaking can be expected at some point in the future. You should keep an eye on it and provide maintenance as needed.

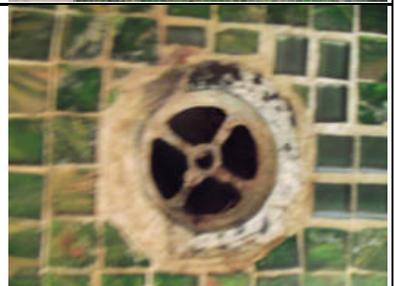
13.70 SHOWER:

The shower has a tile floor and walls. It is outside the scope of this inspection to water test the shower pan or determine the integrity of the shower pan or lining below the tile. The tile grout is porous and this shower pan is what waterproofs the shower floor. Unfortunately, it is not visible for inspection, and leaks can go undetected. There is no crawl space under this shower.
 [CR] The drain grate was missing and needs to be repaired or replaced. There used to be a tub stopper for this drain so that this shower could be filled to be tub.
 [CR] A few of the tiles have come loose.

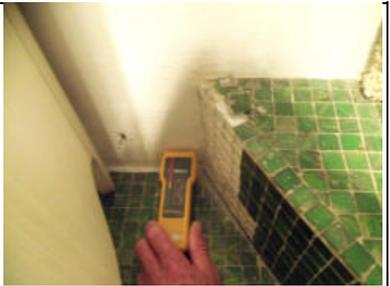
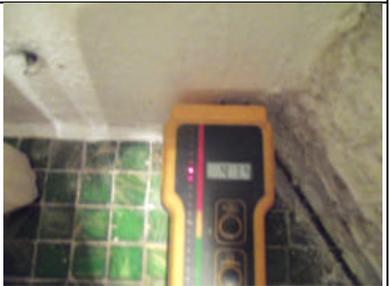
13.73 WALLS/CEILING:

<p>[FE] [CR] Moisture is migrating up through the wall at the end of the tile step. This has caused a section of tiles to come off. The moisture meter shows a moderate rise in moisture in the wall panel at this time. I strongly suspect that moisture is migrating up through the porous concrete block foundation and then onto the wall material. This is another good reason to keep the crawl space dry and control the water around the house.</p>

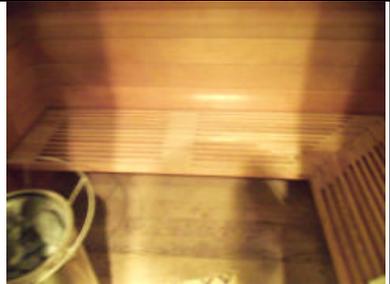
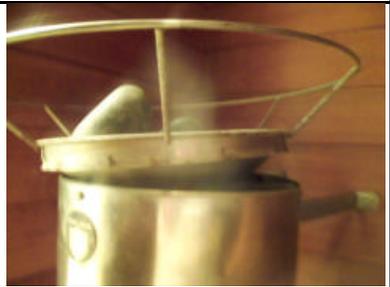
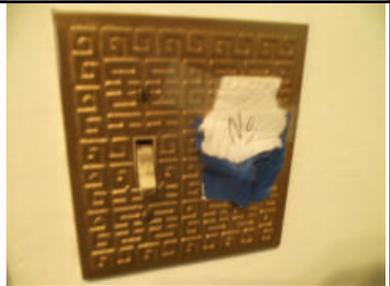
[FE] The top of the steam unit is not sitting square and needs further evaluation and repair as needed. The switch outside the sauna has tape over it and a note not to use. Ask sellers if they are aware of problems with the sauna. I did not test it. Also, the door is out of square and binds.

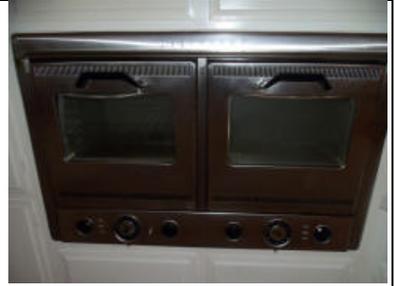
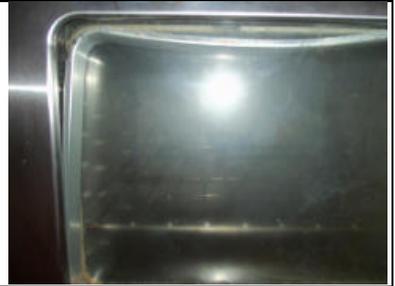
15.3 OVEN:

Type: Electric
[FE] Due to my general observation of the oven, and any items specifically listed here, an appliance repair contractor needs to inspect the unit more thoroughly and perform general service and make any repairs that they feel are needed. The right oven would not come on at all and the door springs that keep the door closed are weak. The bake element in the left oven operated but not the broil. The gaskets around both oven windows has warped and the glass has fogged up between the two panes of glass.

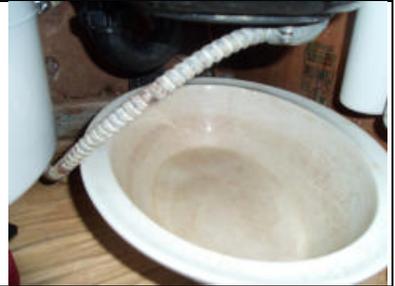
15.7 GARBAGE DISPOSAL:

[CR] The garbage disposal needs to be replaced. It leaks.

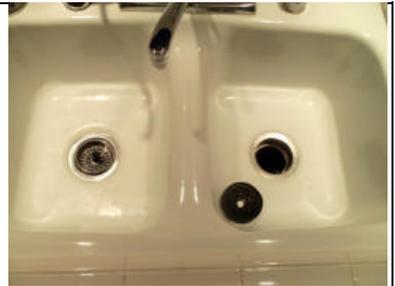
15.8 SINK:

Type: Cast Iron with a porcelain finish OK.

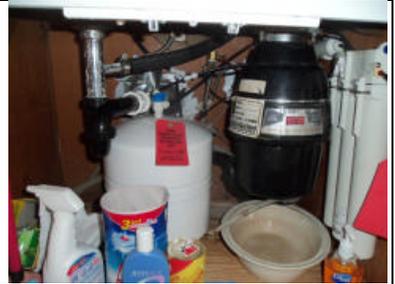
15.10 UNDER SINK:

There were no active leaks noted in the drain or trap. See note on garbage disposal above.

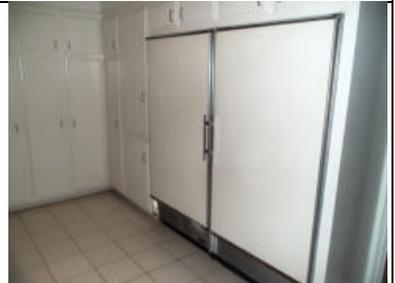
15.14 REFRIGERATOR:

The refrigerator functioned. It is older and should be considered in the later part of its life.
[CR] The coil under the bottom of the unit is very dirty with lint and needs to be cleaned to improve energy efficiency.

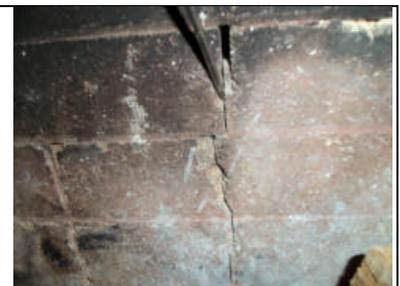
16.5 FIREBOX:

[FE] There are small cracks or gaps in the brick walls or through the grout lines inside the firebox that could be caused by overheating, poor installation, or some movement in the fireplace. The fireplace needs further evaluation by a fireplace contractor or certified chimney sweep who specializes in fireplace repair. The cracks may just need to be sealed or patched with special heat-resistant mortar or caulk, but they could be a symptom of a larger problem. (You should ask the contractor about the advantages of installing a heat shield to minimize risk of further damage.)
