All Pro Home Inspections

STANDARD RESIDENTIAL INSPECTION AGREEMENT

Client Name: Mark & Amy Dream
Inspection Address: 1234 Dreamer Street
Dreamville, CA 92100

Date: August 9, 2011
Time: 8:00 AM

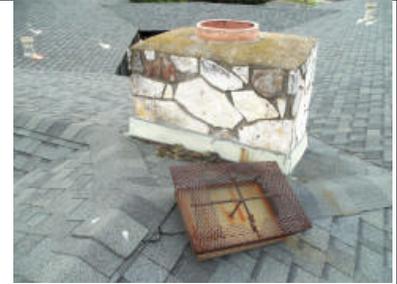
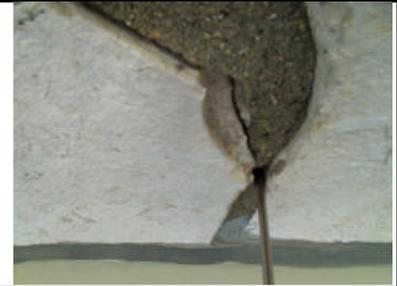
[SC] There is a chimney cap and spark arrester laying on the roof next to the fireplace. This needs to be installed.

[CR] The mortar cap on top of the chimney was cracked or deteriorated and minor repair or maintenance is needed. Any cracks need to be sealed including any gap between the mortar cap and the stone face, and the mortar repaired or replaced to slope to the outside edge to prevent water intrusion into the brick structure below. Moisture leaking in through from the top can wet the steel reinforcing, causing the steel to rust and expand which is the leading cause of cracks around the top of the chimney. After the cracks are sealed and mortar repaired, you should consider sealing the entire top surface. There are products designed specifically for this such as Crown Seal. Ask your fireplace contractor or chimney sweep. The earlier repairs are done, the less chance of serious and more costly repairs later on. The third picture shows a crack on the sidewall above the roof.

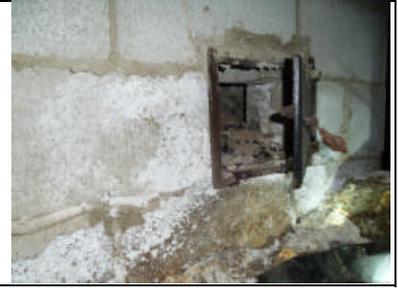
16.10 ASH DUMP

[CR] The ash dump door was open in the crawl space and the dump was full and needs to be cleaned out. I could not see the ash dump in the fireplace because of a pile of ashes.

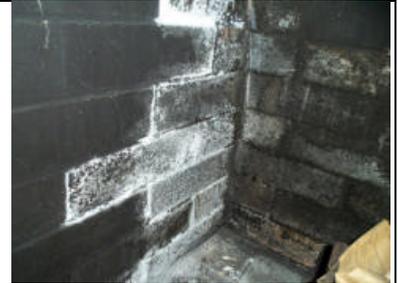
16.13 FIREBOX:

[FE] There were moisture stains, or efflorescence (white mineral salts) noted inside the fireplace. This is an indication of moisture intrusion which should be avoided. Any substantial damage can takes several decades, but prevention is advised. Installing a rain cap, and checking for cracks in the mortar chimney cap, or shoulders is advised. Moisture intrusion can range from inconsequential to a problem that eventually causes critical damage.

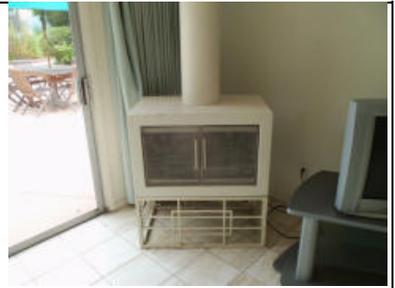
16.18 TYPE:

[FE] This is a wood burning stove. I do not see these often enough to have much experience with all the many models that are available. Each model has specific installation requirements. You should consider having further evaluation by a specialist with wood stoves. Cleaning the flue regularly is critical because a build up of creosote can cause a chimney fire that can warp the flue and cause a failure in the flue. It is usually not possible for me to inspect the flue, so I always feel that it should be cleaned by a certified chimney sweep who is very experienced with wood stoves and can evaluate the stove for any other problems.

[FE] I don't know what the clearance requirements are between this fireplace and any wall that is not protected by tile or other non-flammable surface but suspect that the side walls could need to be protected.

[SC] I am sure that having curtains in direct contact with the side of the stove is a bad idea and needs to be corrected before this fireplace is used.

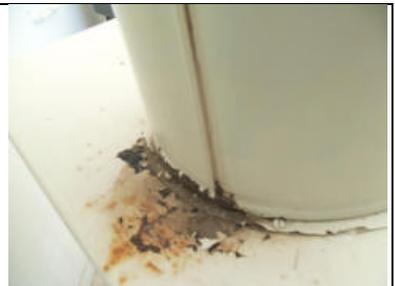
16.20 FLUE:

I am reasonably comfortable that the leaking that caused the rust in the picture is from the previous roof.

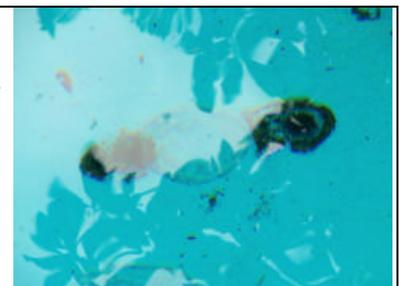
17.2 POOL LINING:

[FE] The plaster appears to be really old and past its expected or useful life. I recommend that you have a pool plastering contractor give you a cost estimate to re-plaster the pool at this time. The plaster is very rough and soft and there are places where the plaster has deteriorated all the way through to the concrete. The concrete is fairly porous and the purpose of the plaster is to

waterproof the pool. When water migrates through the concrete it can cause rust to the reinforcing steel. It looks like there could be a couple of rust spots on the bottom of the pool.

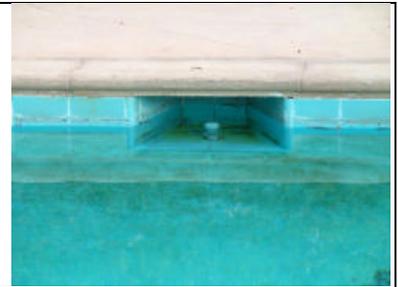
17.4 SKIMMER:

[FE] The skimmer was an old style we don't use any more and currently isn't being used and will need to be replaced. Replacing the skimmer housing could add about \$1,500.00.

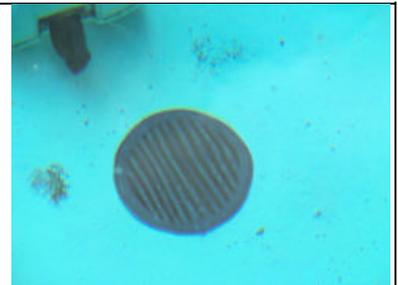
17.6 POOL DRAIN:

[SC] The drain cover(s) were the old type of design that present a safety hazard because the suction could trap a person against the drain . I recommend the cover(s) be replaced with the current design to improve safety. Also, today, a pool requires at least two drains.

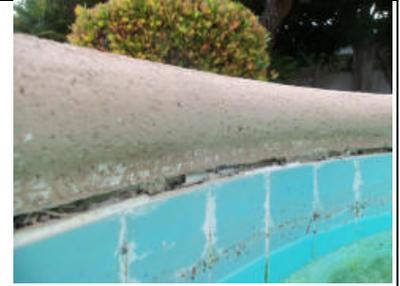
17.8 COPING:

[FE] Ask the pool plastering contractor if the coping will need to be replaced when the rest of the work is done. One problem is that it is usually impossible to find new coping to match these old coping blocks and if some sections need to be replaced, then it may all need to be replaced to match. This would raise the cost. The section of coping in the picture has popped up about half an inch. There is no expansion joint between the coping or cap material around the edge of the pool and the deck. The purpose of this expansion joint is to allow for differential movement between the pool and the deck and minimize the risk of cracking to the pool.

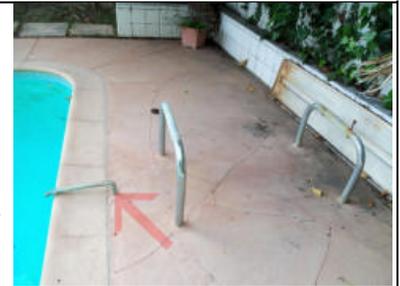
17.10 DIVING BOARD:

[SC] The diving board has been removed, but the stand or mounting brackets still remain and this can be a trip and fall hazard that needs to be removed. There should be nothing sticking up above the deck surface that someone could trip on. Remember this is a play area where people and the deck surface are wet. Under the old diving board location is the pool fill pipe and this will also need to be removed and a new one installed. See arrow in picture. Also, note the old board is leaning up against the retaining wall in the right of the picture.

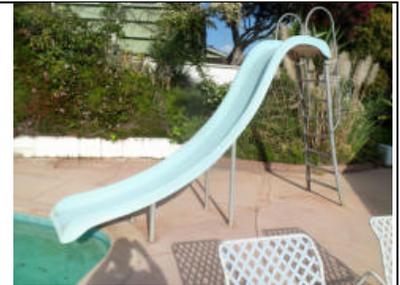
17.11 SLIDE:

[SC] Slide accidents are common. I recommend inquiring with your insurance company regarding available coverage. Some insurance companies require that slides be removed. [FE] The slide was loose or not properly mounted and the surface is deteriorated and would need further evaluation and repair if it was to be used.

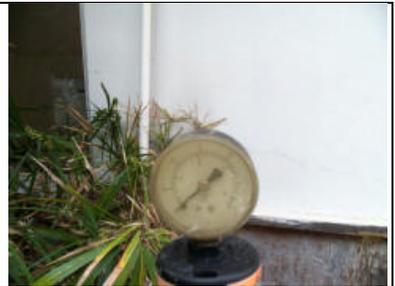
17.15 GAUGE:

[CR] The pressure gauge failed to function and needs to be replaced .

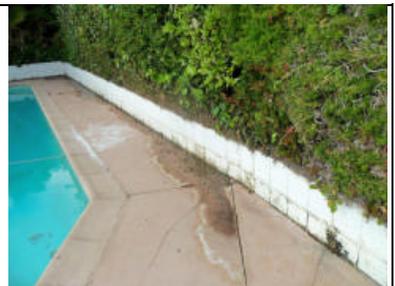
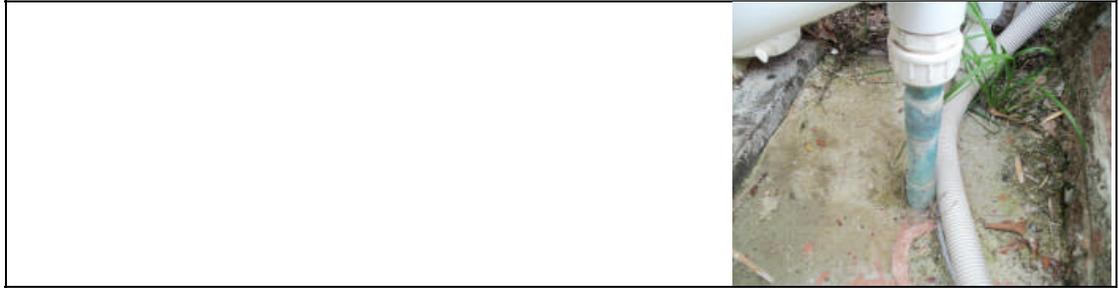
17.17 VISIBLE PIPING:

[FE] The return water line into the pool is the original pipe. I seldom see them this old and it may need to be replaced. This line runs along the right side of the pool under the deck. This deck has standing water on that appears to be leaking through the planter area to the right of the pool. I can't rule out that all this excess water could be from a leak on this return line. There are other potential causes for this water and further evaluation is needed to determine where it is coming from and correct it.

It is worth noting that the water doesn't appear to come through the top portion of the wall or over the top of the wall. It seems to seep up thorough the bottom. Also, note

the whitish area on the deck starting at the gap between the coping and the deck. This indicates that water has seeped up through this gap in the past leaving the mineral deposits behind when the water evaporates.

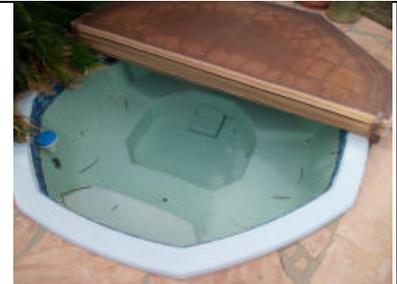
17.23 GENERAL CONDITION:

The spa generally appears older. As the spa ages, you should expect higher maintenance costs and reduced remaining value.

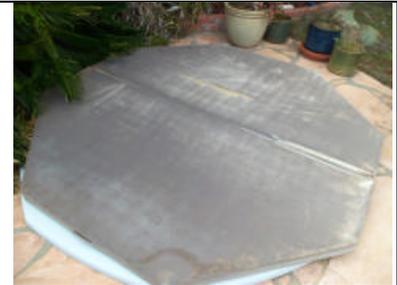
17.25 COVER:

[CR] The cover generally looked old, damaged, or torn and you should consider replacing it at this time or budget for a new one.

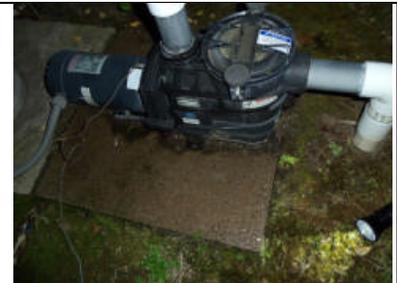
17.26 PUMP:

The filter pump/motor functioned but there wasn't much force to the jets and someone accustomed to a more modern spa will be disappointed.
[CR] The pump leaked. It may just need a new seal.

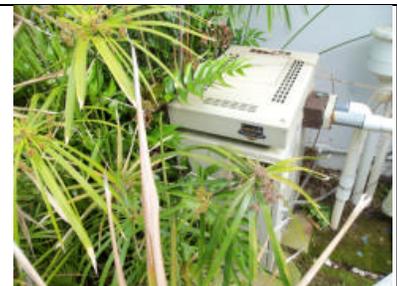
17.27 HEATER

[SC] [FE] The heater is covered with plants and this is a fire hazard and the plants need to be removed. The heater is older and did not come on and needs further evaluation.
