All Pro Home Inspections

STANDARD RESIDENTIAL INSPECTION AGREEMENT

Client Name: Pool Lover
Inspection Address: 1234 Pool Street
Bonita, CA 91902

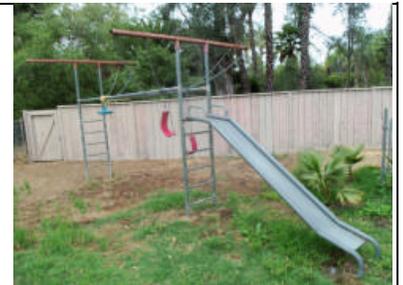
1.13 NOT INSPECTED:

The following items were not included as part of this inspection and no representations are made as to there present or future conditions: the sump or septic system that is off the back corner of the pool house; the mechanical awning that is attached to the back edge of the house; and the playground equipment; and the hole house vacuum which was not plugged in and I didn't find any hose or attachments for it.

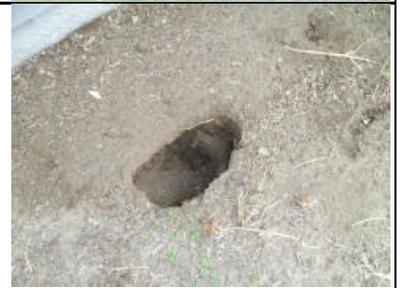
[FE] I was walking around the back of the pool house and the ground had a lot of soft spots that I figured were due to gofer tunnels, then I stepped in one spot and sunk about a foot.

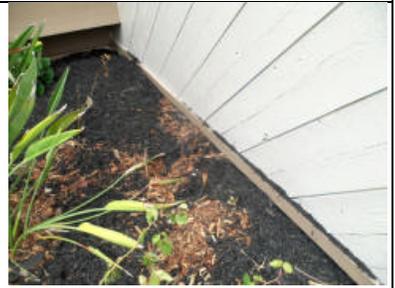
3.4 SOIL LEVEL

[CR] The soil level is too high next to the house and foundation and the soil needs to be lowered around the house in several places. This will require the removal of substantial amounts of soil, and any grass or plants, in the effected areas around the house, in order to meet the minimum requirements stated above. This can be a substantial task.

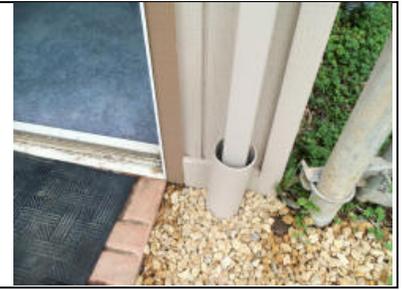
[CR] This picture shows how high the soil level is in relation to the floor level of the pool house. The soil level is too high all the way around and needs to be lowered and the area around this building re-graded. The soil level needs to be a minimum of 6 inches below the slab level. This will be a substantial task.

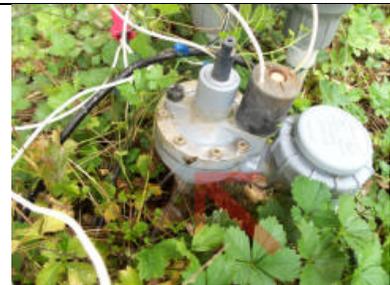
[CR] A sprinkler valve on the side of the pool room is also leaking badly.

[CR] The unregulated pressure in the water system is about 130 PSI. 130 PSI is much too high for a sprinkler system and this is probably why there are so many leaks at the sprinkler valves and other problems with the sprinklers. Sprinklers need to be at 60 PSI just like a house.

The picture shows the leaking valve which is at the side of the pool house. This is likely due to the very high pressure in the system.

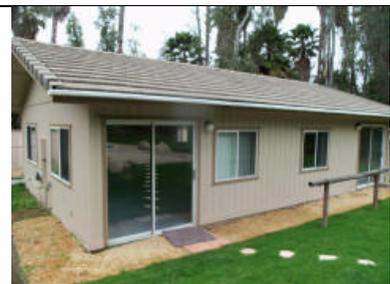
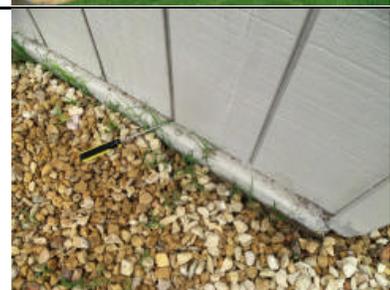
4.1 EXTERIOR WALL

[Defect] The slab projects past the edge of the outside wall on the pool house. Any water running down the side of the wall hits this lip. It is difficult to seal the base of the wall, particularly long term, from water that wants to leak between the slab and the wall, and I often see leaks on the floor along the outside wall. However, the water doesn't need to leak all the way in to cause problems. Moisture in the base of the siding or framing will increase the potential for mold, rot or termite activity.

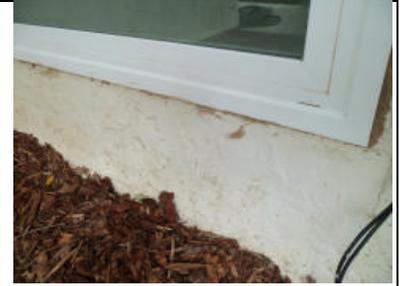
[NOTE] The stucco at the back of the master bathroom extension is crude, uneven and there doesn't appear to be any weep screed and this makes me concerned about the general quality of this addition and makes me suspicious that it wasn't permitted.

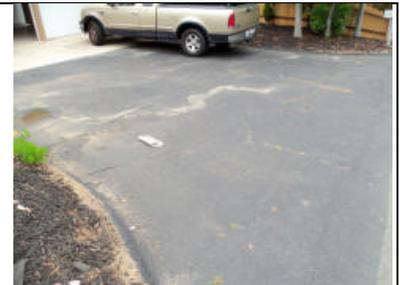
4.4 DRIVEWAY:

[CR] The asphalt driveway had reached the stage where maintenance is recommended. I recommend patching and slurry sealing to improve appearance and maximize its service life.

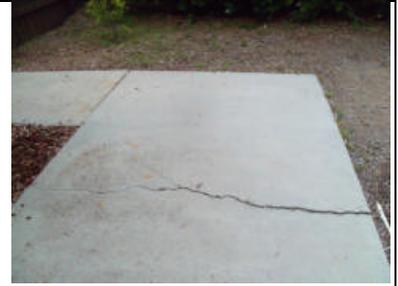
4.5 SIDEWALKS:

[CR] There are cracks in the sidewalk that indicate movement in the soils below. They indicate some movement over the years, and further movement can be expected, but the sidewalk is still functional for use at this time. Poor drainage and over-saturation of the soil under the concrete are usually the most likely cause of the cracking and movement and Improving the drainage is always recommended to minimize the chance of future movement. Any recommendations in the grading and drainage section need to be followed.

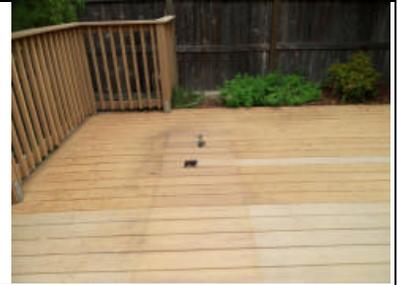
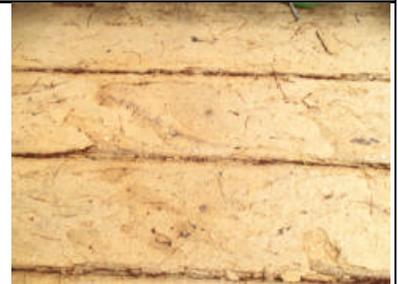
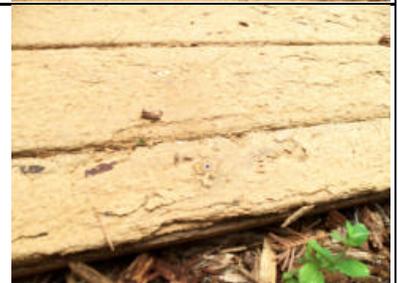
4.6 WOOD DECKS:

[CR] There is substantial damage to the composite decking and many of the boards need to be replaced towards one end with an odd board in another area also bad.

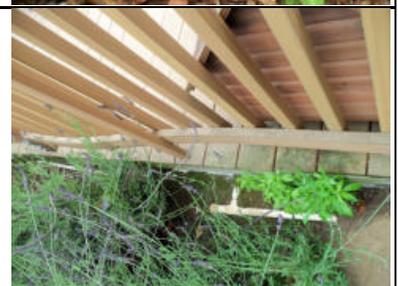
The bottom rail on the wood deck railing was constrained without any ability to expand and so it warped to relieve the pressure from expansion.

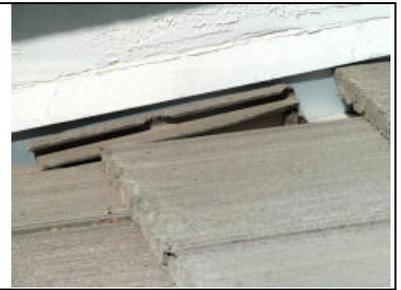
This picture is over the master bath. The tile was not secure along the edge of the wall and moved.

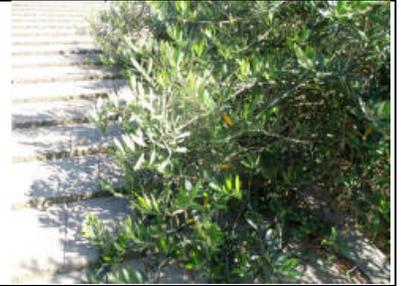
[CR] Cut the tree branches away from the roof. This is by the master bath.

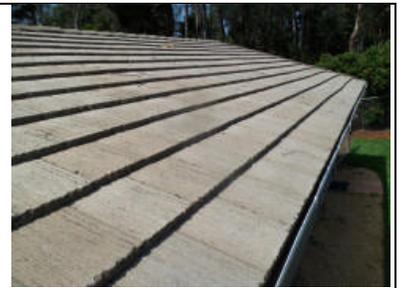
5.5 POOL HOUSE

The roof over the pool house the same concrete tile as the house and appears serviceable.

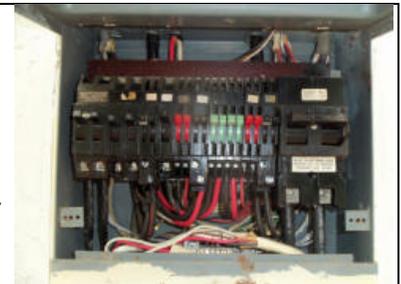
7.4 BREAKER PANEL:

[SC] [FE] A Zinsco TM or SylvaniaTM-Zinsco electrical panel is installed in this building. Serious electrical hazards have been reported with these electrical panels. It is not possible to detect these hazards in the home inspection because damage is not visible until the breakers are removed or tested. A licensed electrician who is familiar with this equipment should be called to inspect the panel for fire and shock hazards. The only way to eliminate these risks is to replace this equipment. Additional information about these hazards is available at a building research website: www.inspect-ny.com/electric/Zinsco.htm.

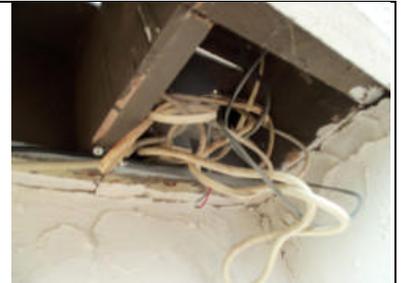
[SC] There is an electrical line that runs to the old location for a barbecue that needs to be removed. It connects with a plug to the back outlet. It is currently unplugged but if plugged in would energize wires that were cut off at the deck level.

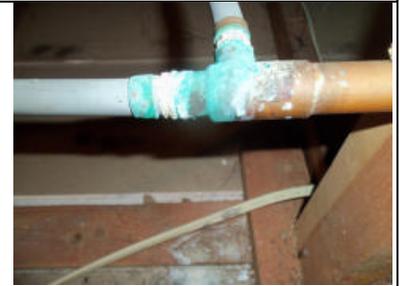
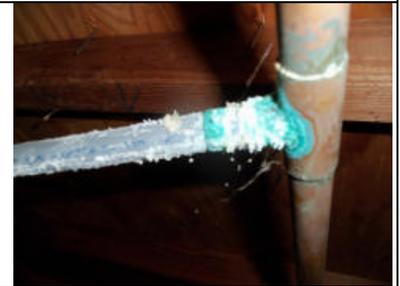
[CR] There is also a section of galvanized pipe being used on the pool house and this is inside the water heater closet and runs to a hose bib. This also has high failure rates and should be replaced. The dielectric coupler in this picture is rusting and failing.

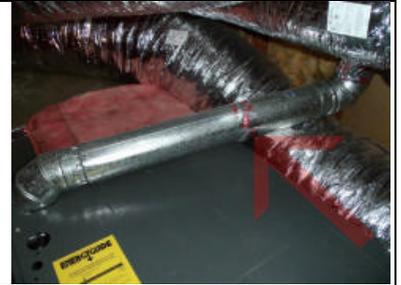
**9.6 VENT:**

[FE] The vent needs further evaluation by an HVAC contractor. Dual wall vent can not be cut and fitted and it looks like the section over the top of the heater was cut and fitted back together with tape. Also check the transition connection to the larger section that runs through the roof.

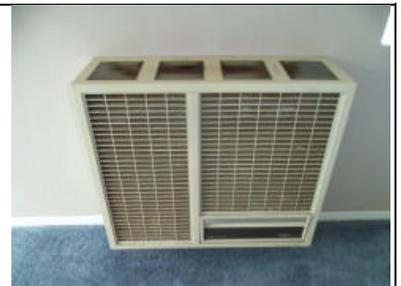
**POOL HOUSE.****9.7 LOCATION:**

Direct vent wall heater located in living room.

[SC] A carbon monoxide detector is recommended in any home with a gas heater. It could save a life if the heat exchanger fails or there is poor drafting. This is particularly important when a heating system is older and this heater is older.

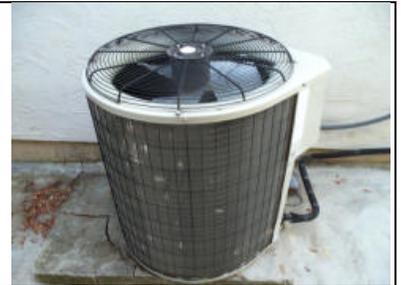
10.1 LOCATION:

The unit was located on the right side of the building.

[FE] The power to the condensing unit was turned off, shut down or nonfunctional. I do not check the system any further when it does not operate. The power may just be off or the entire system may need to be replaced. You definitely need further evaluation by an HVAC contractor. I will not turn the power on to a unit that is not energized. The power is supposed to be on for 24 hours before starting up an A/C condenser to make sure the refrigerant is in a fluid state.

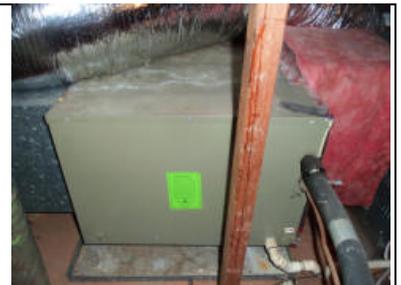
10.5 COIL:

[FE] The part of the air conditioner called the coil and sits in the attic next to the heater is much older than the heater and appears older than the compressor on the outside.

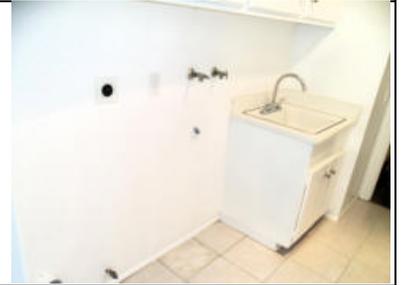
12.1 LOCATION:

Interior laundry room next to garage.

[FE] There is evidence that there was past leaking from the laundry. From inside the garage, it looks like water was flowing down the face of the concrete from the laundry. Water likely ran under the wall from the laundry and there is risk of moisture damage inside the wall. I recommend that a hole be cut in the drywall to check for any possible mold or other damage inside the wall. See the Mold Statement in the Introductory Notes section at the beginning of this report for additional important information.

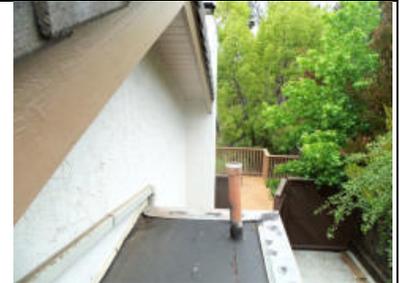
13.10 VENT:

[RU] Recommended Upgrade: The original transite (cement-asbestos) vent is still being used to vent the water heater. The specifications for many new water heaters do not allow the use of the old transite vent because it increases the chance of the flue gas condensing and dripping back onto the water heater and causing corrosion. The flue gas in a new water heater is cooler than the older styles and is more likely to condense. To reduce this risk, I recommend installing a new dual-wall sheet metal vent when a new water heater is installed.

[SC] The vent needs to be extended so that the vent cap or termination is at least 2 feet higher than the elevation of any roof or wall within 8 feet of the vent. The reason is that a wind blowing against the wall could adversely effect the vent and prevent the escape of combustion gas by pushing air down the vent. See section 806.4 UMC-96.

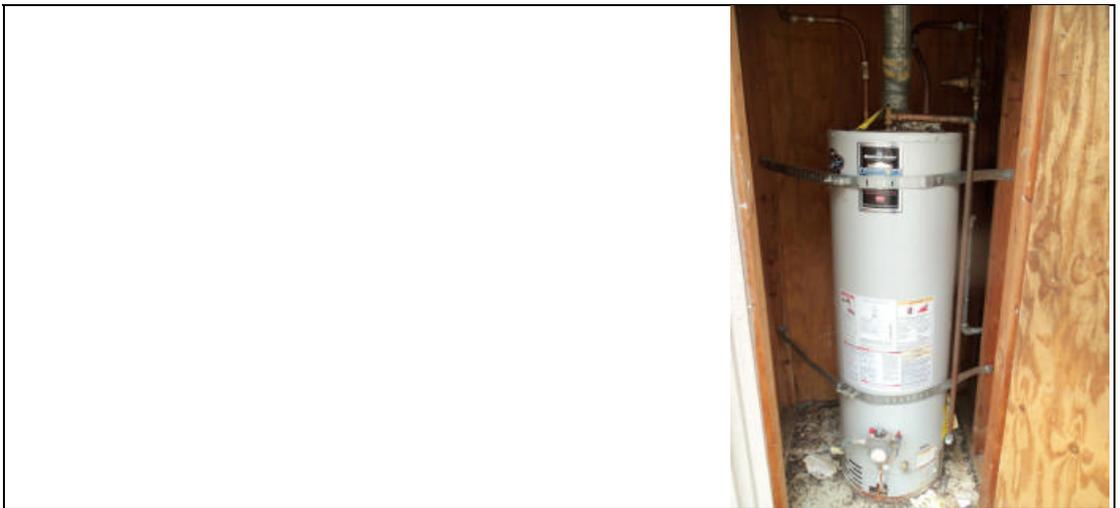
BACK UNIT.**13.11 PICTURE**

[SC] The vent was too close to or in contact with combustibles materials, and this condition can be a fire hazard that needs to be corrected. Six inches of clearance is required between a single-wall vent connector and any wood or other flammable material. The vent is very close or even touching the wood and **heat transfer is a clear risk.**

[SC] The vent needs to be extended so that the vent cap or termination is at least 2 feet higher than the elevation of any roof or wall within 8 feet of the vent. The reason is that a wind blowing against the wall could adversely effect the vent and prevent the escape of combustion gas by pushing air down the vent. See section 806.4 UMC-96. **[SC]** The flue vent pipe needs to extend at least 5 feet above the appliance vent hood or down draft diverter. This is the code minimum required to provide proper venting. The vent either needs to be replaced or extended.

[SC] Single wall vent is not allowed to run through any ceiling, or any partition, or inside any concealed space, or in the open air on the outside of the building. It is only permitted for the section from the water heater to where the vent exits the room or enclosure. All other sections need dual-wall vent installed to replace any single wall sections.

[SC] The combustion air supply to the water heater appeared inadequate. The free flow of air to the water heater is critical for proper combustion and venting. Without proper air supply, incomplete combustion and carbon monoxide are common problems. This is important and correction is required. The basic requirement is to have two openings into the closet or any confined space, one opening in the upper 12 inches and the other in the lower 12 inches of the enclosure. Each vent is to have 100 square inches of clear opening into the water heater area. **[SC]** The code requires one fresh air intake vent, that measures 100

[FE] The plywood on the inside of the closet is covered with black staining. Further evaluation is needed to determine the cause of the staining and make corrections. See the Mold Statement in the Introductory Notes section at the beginning of this report for additional important information.
[CR] Also, there are a lot of rodent droppings that need to be cleaned out and the closet sealed to keep them out.

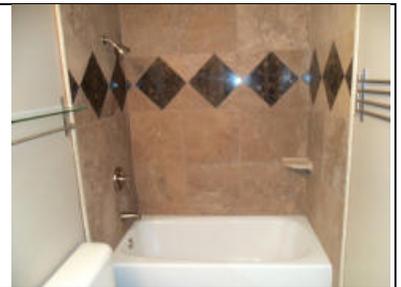
14.35 TUB:

[FE] This shower appears to have natural stone tile. Some stone tiles are not appropriate for showers because they do not hold up to the spray of water and I have seen surface deterioration in previous inspections on stone tiles. Another problem with stone tiles is that they are porous or have rough surfaces that can be difficult to clean or are prone to the growth of mold or mildew. You should consult the tile manufacturer for this tile to see if it is approved for use in a shower. **The stone in this shower is so porous and deeply pitted that it will be very difficult to clean. I would also be concerned about the amount of water migrating through the stone and challenging whatever water barrier is behind the tile.** Unless the walls behind the tile was waterproofed, which is not likely, there is risk of water migrating into the wall. Only non-porous tiles should be used in a shower.

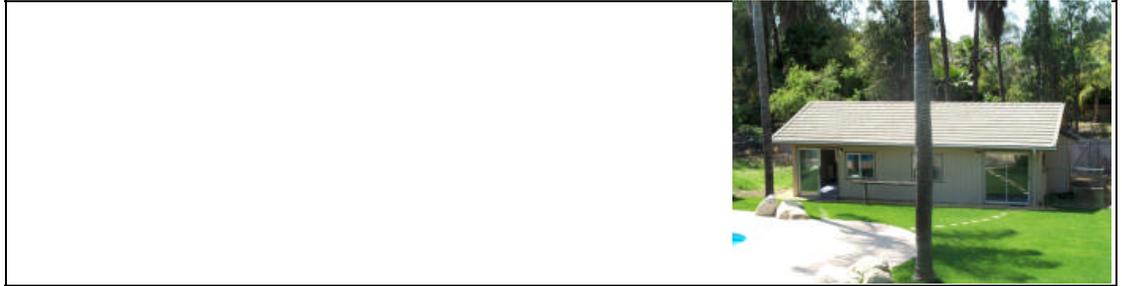
POOL HOUSE.**15.5 PICTURE**

[FE] [CR] Condensation or staining was noted between the glass panes in at least one of the dual-pane windows. I recommend that you have the bad panels replaced and all of the windows checked more closely by a window company. The sliding glass door panel on the bedroom and another on the living room slider are bad.

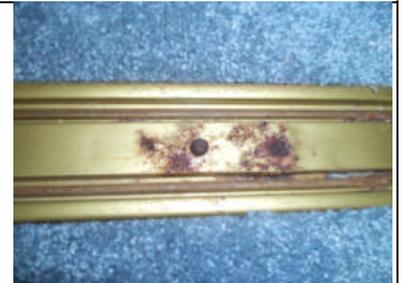
[FE] I am suspicious that moisture is migrating up through the slab of the pool house and recommend further evaluation. The tract for the bedroom closet door has rusted in several places and this was caused by moisture. The carpets are relatively new. I recommend pulling up some of the carpet to look for evidence of moisture migrating up through the slab. This is beyond the scope of this inspection. Slabs under a house have a plastic liner to prevent moisture coming up. If this is missing and the drainage around the house is bad as it is here, then moisture can easily migrate up through the slab and cause this rust in the tract.

[FE] I also suspect that there could be some unevenness in the living room floor and recommend that this be checked

with a level or the carpet lifted to see if there are any cracks.

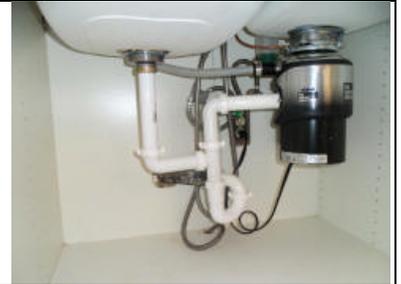
16.10 UNDER SINK:

[CR] An active leak was noted below the sink or it looks like it has or could leak at any time and repair is needed. There are at least two active leaks and the drain material used is not a good choice and I would recommend replacing it with the thick walled black ABS material which will be much less prone to leaks.

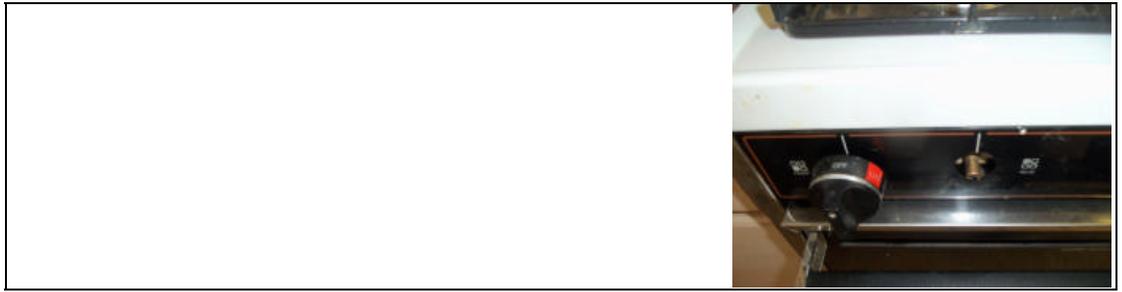
16.15 STOVE:

<p>Type: Gas with electric igniter The cooktop/range burners functioned. There were common signs of aging and wear. [CR] One of the control knobs or dials was missing and need to be replaced.</p>

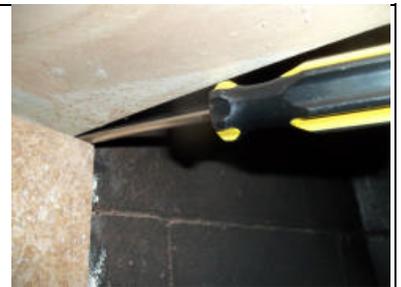
17.14 FIREBOX:

[SC] There are a couple of smaller gaps in this fireplace that also need to be sealed.

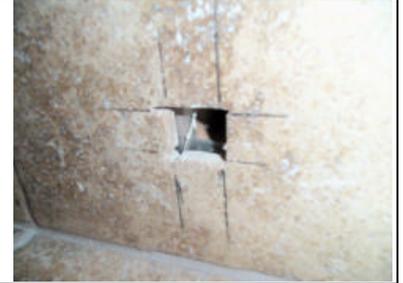
17.17 GAS LINE:

There is gas provided to the fireplace.
[CR] The escutcheon or trim that normally goes around the gas valve is missing. The hole that was cut for the gas key is too small and won't fit a standard escutcheon and this will make it more difficult to add one. The stone face will need to be cut with a hole saw for stone.

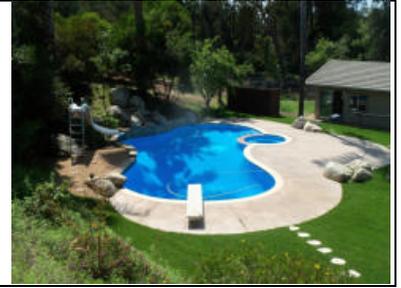
[FE] This pool has recently been painted. Well over 90 percent of all painted pools were done by sellers as an inexpensive way to make the pool look better for sale. They are very seldom done by a professional. They are seldom done well and tend to have short lives. Even professionals using paints designed for pools have failures with painting pools and this is why so few professionals will paint a pool. I do not recommend it. In this pool, I can see many small to medium sized bubbles between the paint and the plaster. These bubbles are likely to pop or break open relatively quickly and more can develop. The plaster below had some blistering or deterioration that is visible even with the paint but it is difficult to determine the condition of the plaster very well now that it has been painted. I definitely recommend further evaluation by a pool plastering contractor who can give you a price to re-plaster the pool and a best estimate of how long the paint can last.

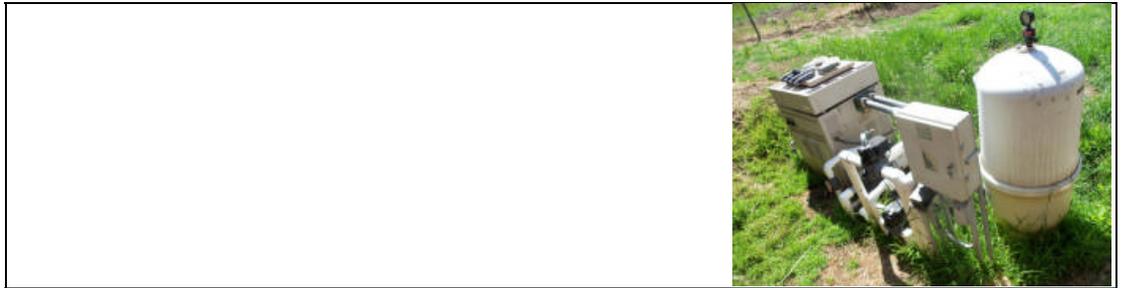
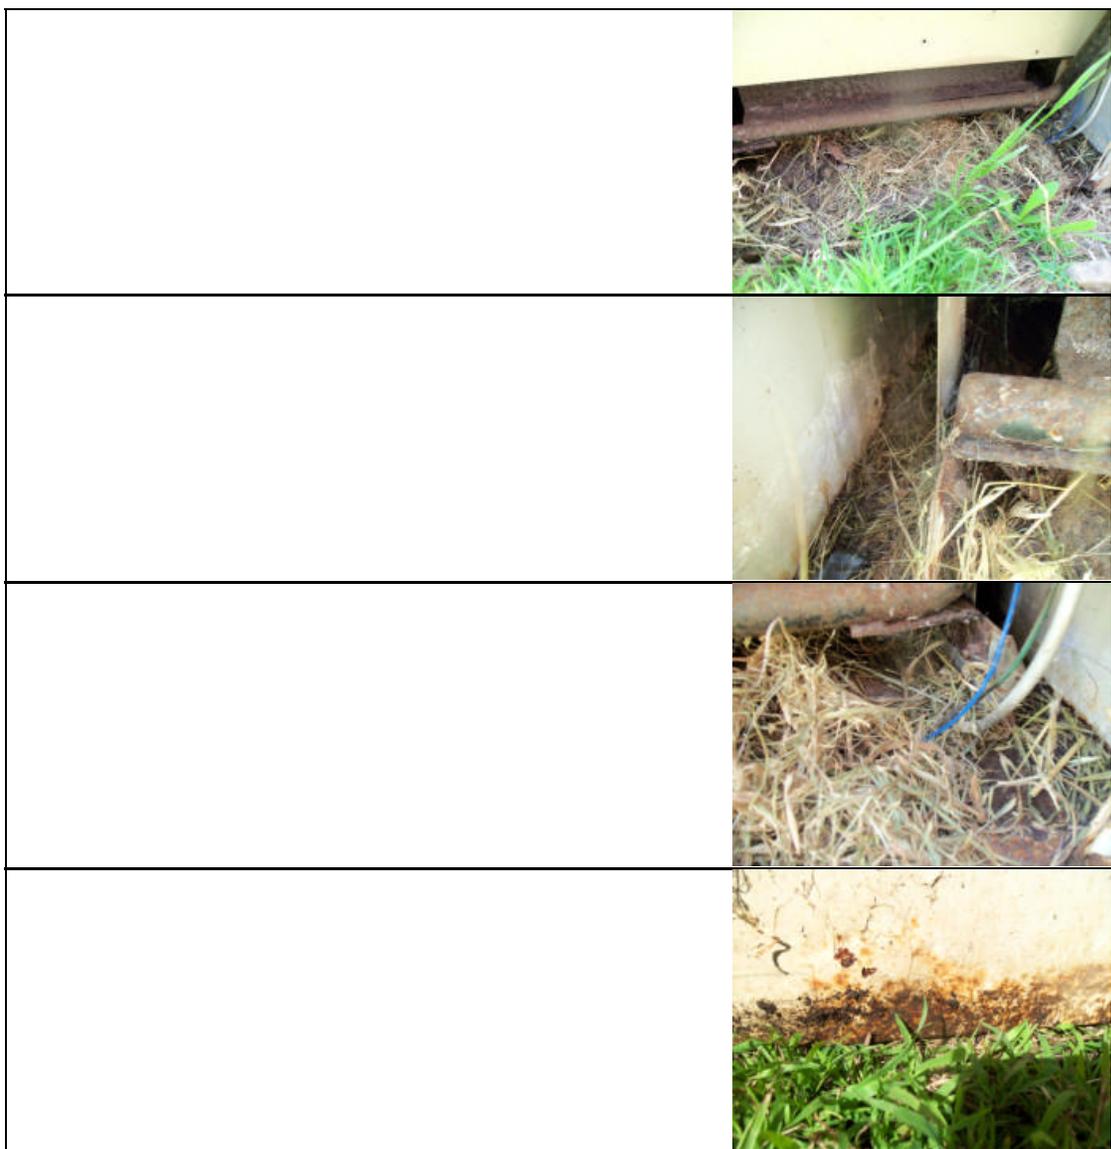
18.9

The heating system is relatively old and is close to, or past, its original design life. It could require repair or replacement at any time and you should budget for replacing it. I can not predicting how long this unit could last. Any unit of this age needs to be inspected and serviced annually by a professional.

[FE] The heater failed to function and further evaluation is needed by a pool heating equipment contractor. This is an old heater with lots of rust and I suspect the entire unit may need to be replaced. You should have further evaluation at this time and before the close of escrow.

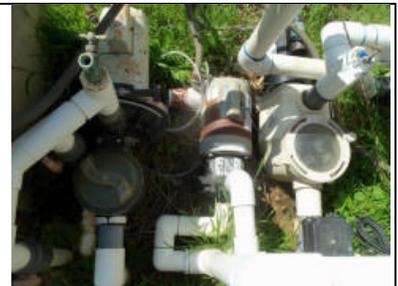
18.15 SPA JETS PUMP:

The pump motor was rusted or deteriorated and should be considered in the later part of its expected life, but it did function at this time.

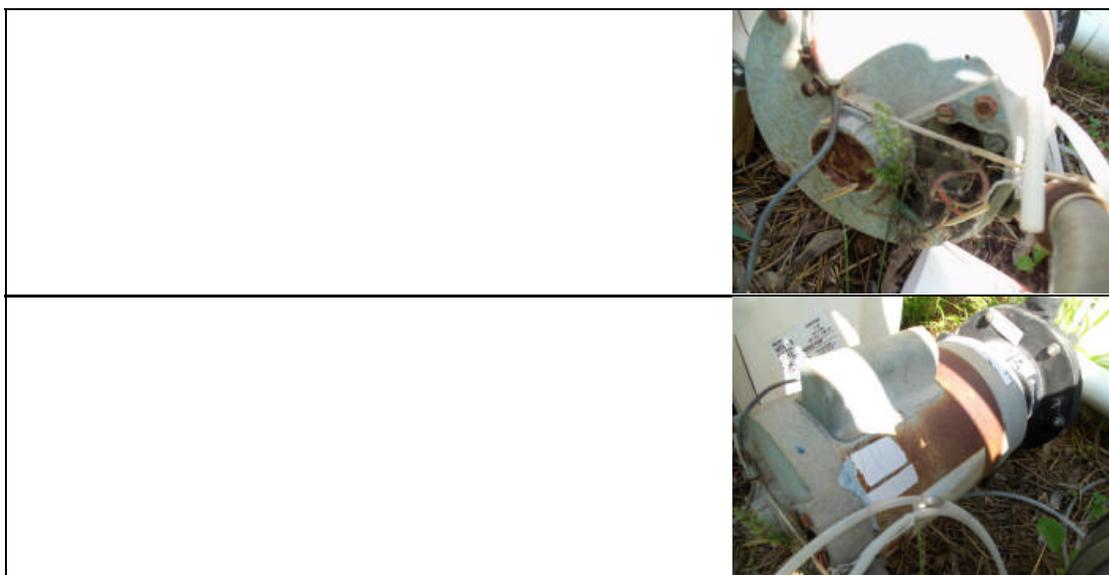
[FE] The pump motor failed to function and needs further evaluation and may need to be replaced. It is old.
 [FE] The waterfall itself needs further evaluation. I am concerned that a substantial amount of water will leak through the waterfall when it is on. There are cracks in the mortar and I do not know if there is any waterproof lining under it.
